Technical Service Bulletin (TSB)
Incorrectly Routed Wheel Speed Sensor Wiring

REFERENCE:	TSB: 05-003-25 GROUP: 05 - Brakes	Date:	July 11, 2025	REVISION:	–
VEHICLES AFFECTED:	2025 (DP) RAM 4500/5500 Cab Chassis This bulletin applies to vehicles built on or after February 05, 2025 (MDH 0205XX) and on or before March 31, 2025 (MDH 0331XX) equipped with a 6.4L V8 HEMI Upgrade HD Engine (Sales Code ESL).			MARKET APPLICABILITY: <input checked="" type="checkbox"/> NA <input type="checkbox"/> MEA <input type="checkbox"/> SA <input type="checkbox"/> IAP <input type="checkbox"/> EE <input type="checkbox"/> CH NOTE: This bulletin applies to North America markets.	
CUSTOMER SYMPTOM:	Customers must experience a Malfunction Indicator Lamp (MIL) illumination and the vehicle must exhibit/set the following Diagnostic Trouble Code (DTC): <ul style="list-style-type: none"> • C0031-1D - Left Front Wheel Speed Sensor - Circuit Current Out Of Range. Customers may comment on one or more of the following: <ul style="list-style-type: none"> • Brake warning indicator illuminated on the Instrument Panel Cluster (IPC). • Electronic Stability Control (ESC) indicator is illuminated.

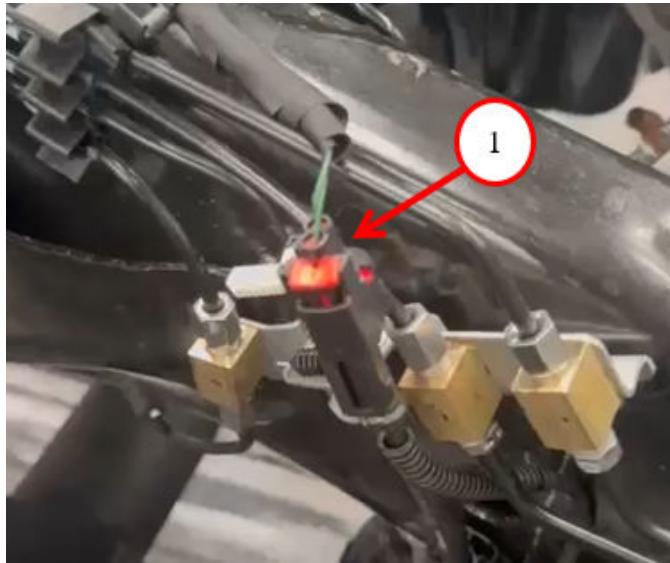
Fig. 4
ABS Wire Harness Connector

1 - ABS Wire Harness Connector

5. Disconnect the Anti-Lock Brake System (ABS) wire harness connector [Fig. 4](#).

13. Connect the ABS wire harness connector [Fig. 4](#).
14. Install the left front wheelhouse splash shield. Refer to the detailed service procedures available in DealerCONNECT/Service Library under: Service Info> 23 - Body / Exterior / Shield, Splash, Front Wheelhouse / Installation.
15. Clear DTCs.
