SIB 84 03 25

Interference Noises During Calls

E-Series	Model Description	Affected Option Code
G09	BMW XM Sports Activity Vehicle	Without SA 5AX – Highway Assistant

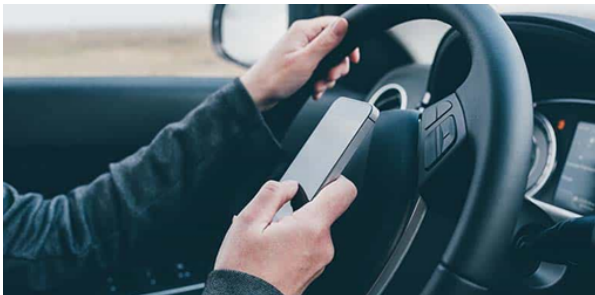
The first step is to verify the interference is truly caused by the VDP module. The following steps are necessary to prove the VDP module is the cause of the complaint:

1. Verify the issue is currently present by initiating a phone call during test drive with a paired mobile device. During the call, the call recipient must report that interference is present on the call.
