SIB 54 01 25

CONVERTIBLE TOP DOES NOT OPEN AFTER SITTING IN THE SUN FOR A LONG TIME

E-Series	Model Description	Production Date
F91	M8 Convertible	SOP (Start of Production) – September 18, 2023
G14	8 Series Convertible

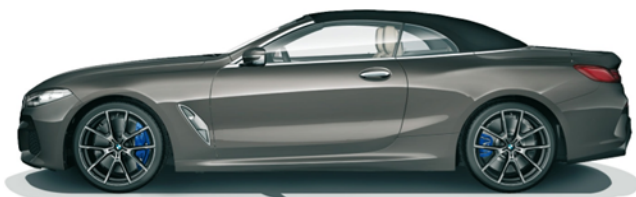
When the vehicle is parked in the sun for long period of time, the convertible top will not open.

Note: While pressing and holding down the top's actuation button for a normal top opening cycle-

- The side windows open
- The rear bow folds upwards
- The convertible top unlocks at the front bow
- The convertible top compartment lid moves backwards

but the convertible top does not open.

If the convertible top is pushed upward by hand in the A-pillar area, the convertible top opens.

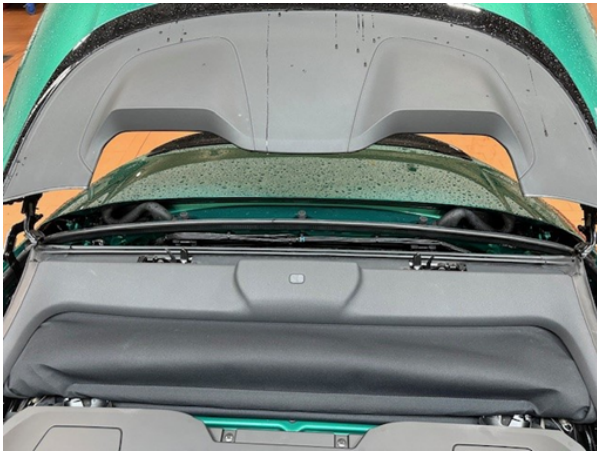
Note: The following fault code may be stored (805091 – Functional limitation: Timeout while unlocking/locking).

1. Connect a BMW approved battery charger to the vehicle.
2. Read any fault codes from the vehicle using ISTA.

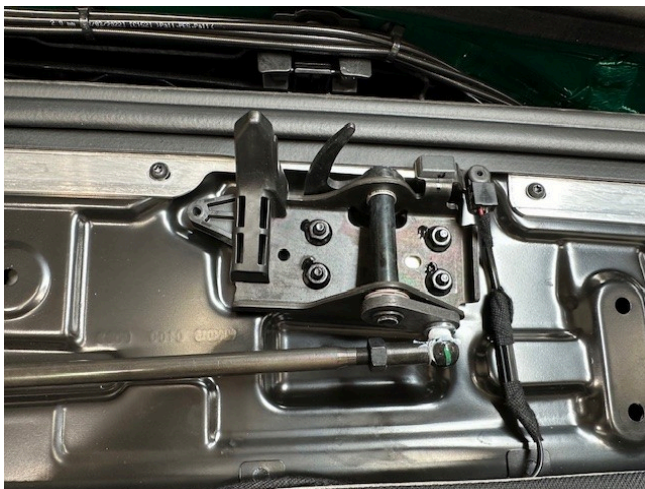
Note 3: If the gap dimension is set to 1.5 mm at the largest gap between the Hall effect sensor and the drive arm, the smallest play may result in a collision and/or cause damage to the Hall effect sensor.

2. Using a pry bar, slightly adjust the gap dimension.

Caution: Only deform the drive arm by prying upwards in small increments. Move the motor's drive arm to the **UNLOCKED** and **LOCKED** position and remeasure the gap between the Hall effect sensor and drive arm. Be sure that no contact occurs between the drive arm and Hall effect sensors. Aim for a gap dimension of 1.5 mm.

Note 1: When aligning the tool, make sure not to damage the wiring to the Hall effect sensor.

Note 2: If surface damage occurs on the carrier plate and/or drive arm, apply corrosion protection.
