Technical Service Bulletin

Topic	Window Drop Glass Operation Continental GT/GTC 25-26MY
Market area	Bentley: worldwide (2WBE),China 796 VW Import Comp. Ltd (Vico), Beijing (6796)
Brand	Bentley
Transaction No.	2075821/3
Level	EH
Status	Released for publishing
Release date	Jul 18, 2025

Retailer glass reset procedure for New GT/GTC

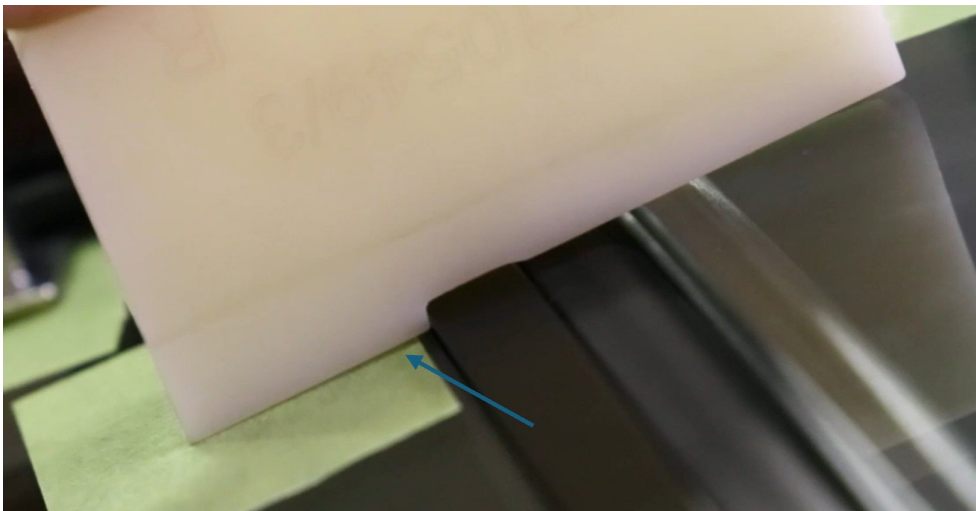
Figure 10

If the tool (WT10549/3) does not sit flush against the rear window then this shows rear window is more than 2mm inboard (more than -2mm), check this by holding the tool on the front window and measuring gap between the rear glass and the tool (as shown in figure 10)

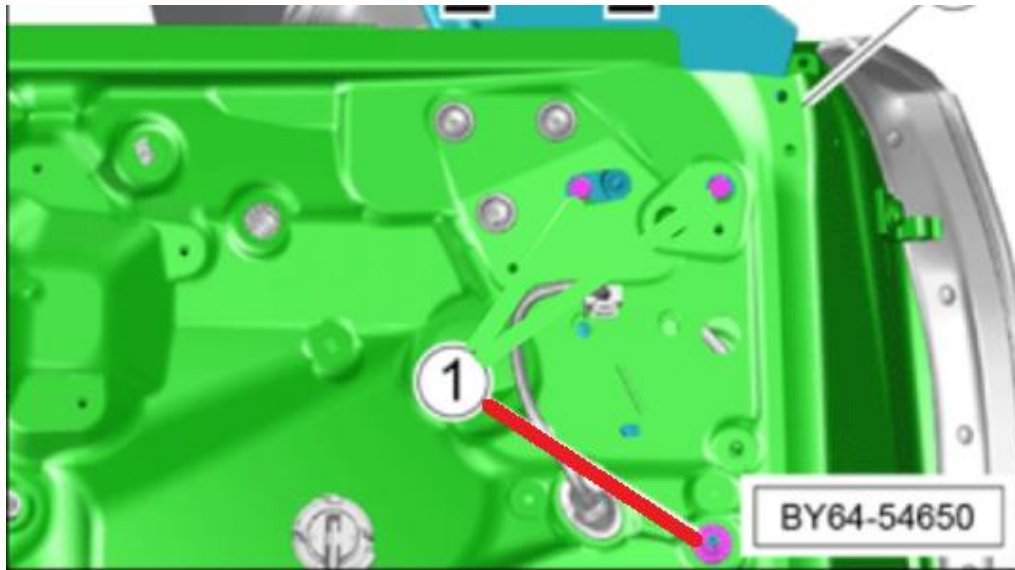
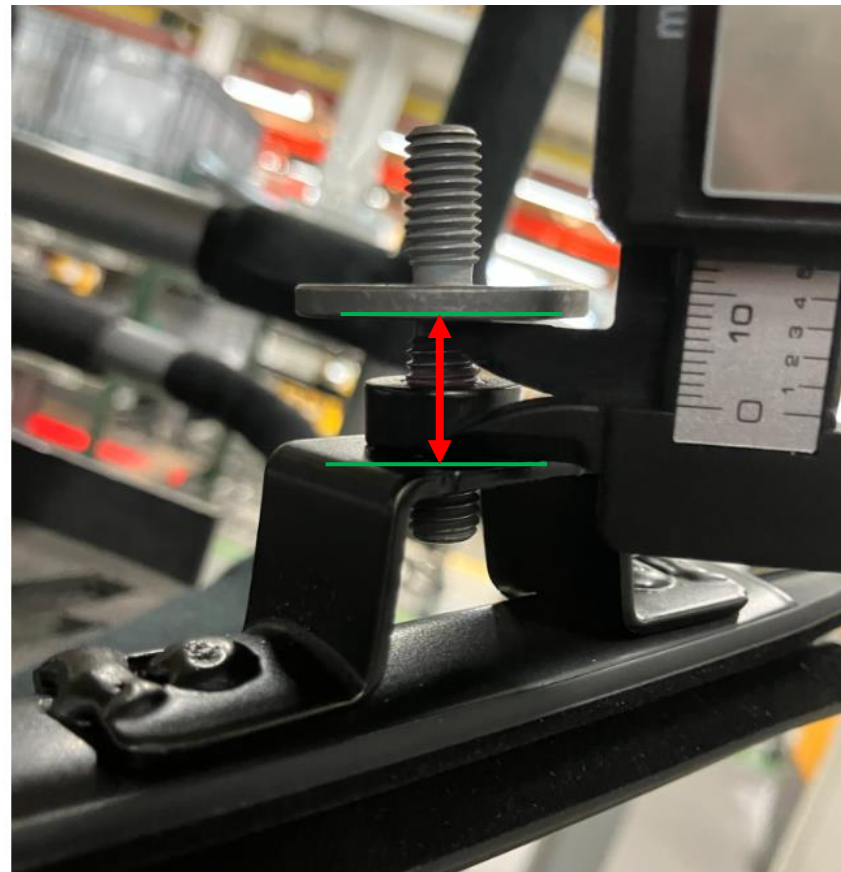
Image for reference, glass does not require removal from vehicle

To reset this adjuster without removing the quarter glass, loosen the lock nut, screw the adjuster all the way in clockwise until it bottoms out on the frame, then unscrew anti clockwise 4 complete turns then set height and profile to ELSA specification before moving on to the next step.

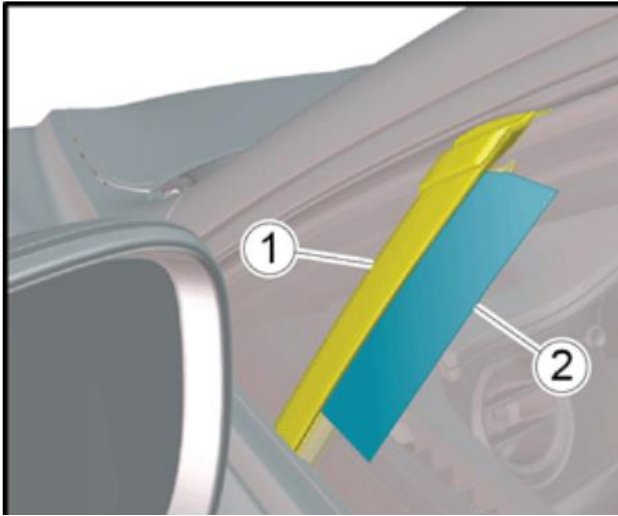
- **Measuring front glass intrusion into front division bar**

Example of incorrect fitment:
10mm intrusion into division bar seal not achieved. Only 6mm seen, front and rear side glasses will be too far rearwards, potentially clash condition between rear of rear glass and cant rail/roof seals

When reinstalling front drop glass ensure tape is applied at 10mm from front edge and align this with the previously set quarter glass division bar.

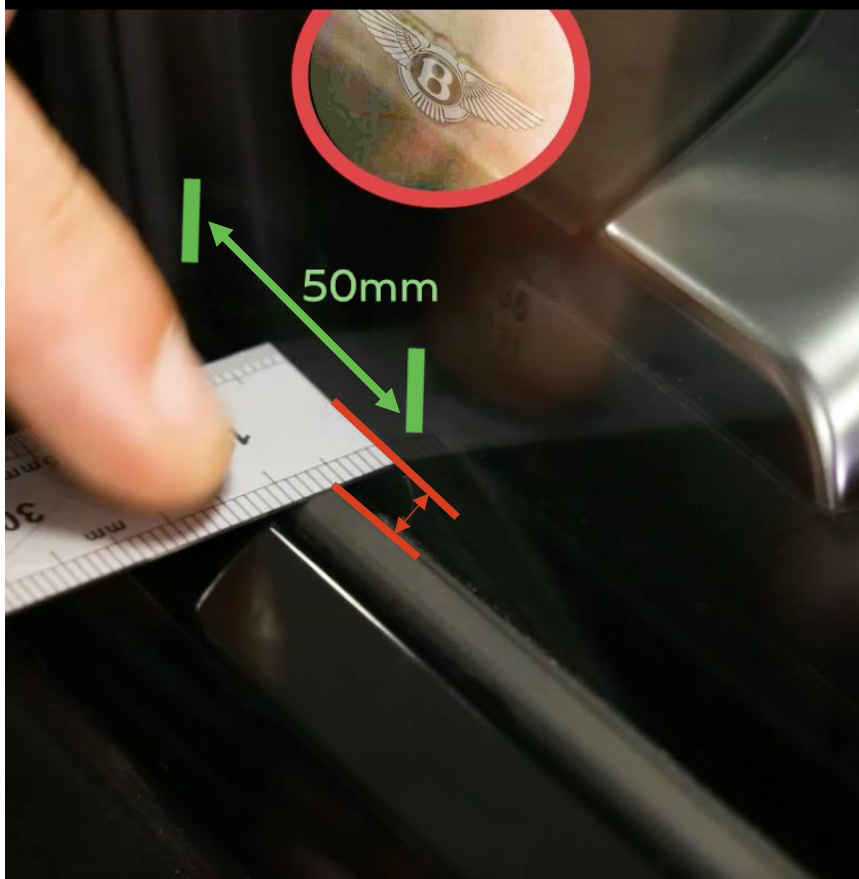
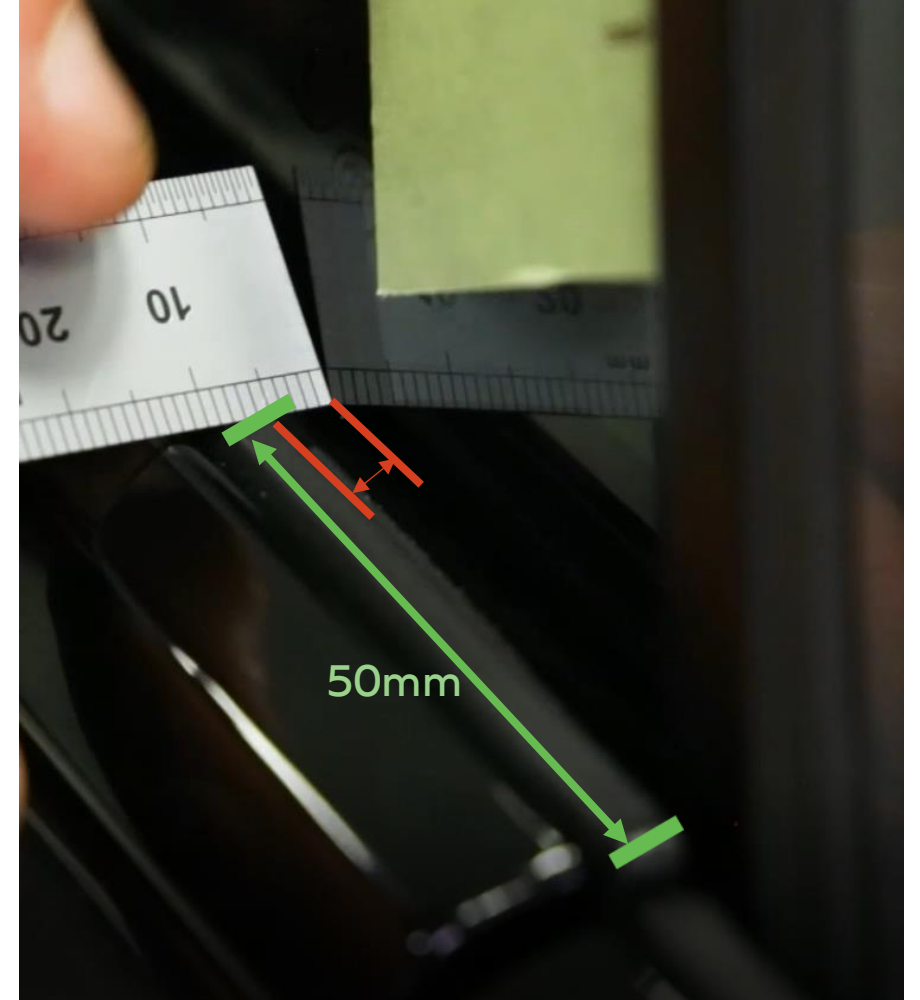
- **Wastrail measurement checking/resetting**

2mm at rear edge would have been set to achieve specified flush/2mm underflush profile condition between front and rear glasses, the rear quarter glass mirrors this taper condition. This potentially increases the risk of false anti trap as rear window/seal does not engage with front window at the correct angle. Suggested to set to specification on problem vehicles as per next slide. If both windows are set between 4-6mm then the flush/2mm underflush profile can be easily achieved.

Set waist rail gapping to between 4-6mm as mentioned in Glass setting guide videos on E-Academy and also check for parallelism along front and rear windows to door/quarter. 50mm from edge of Wastrail seal, roughly underneath the Bentley wings.

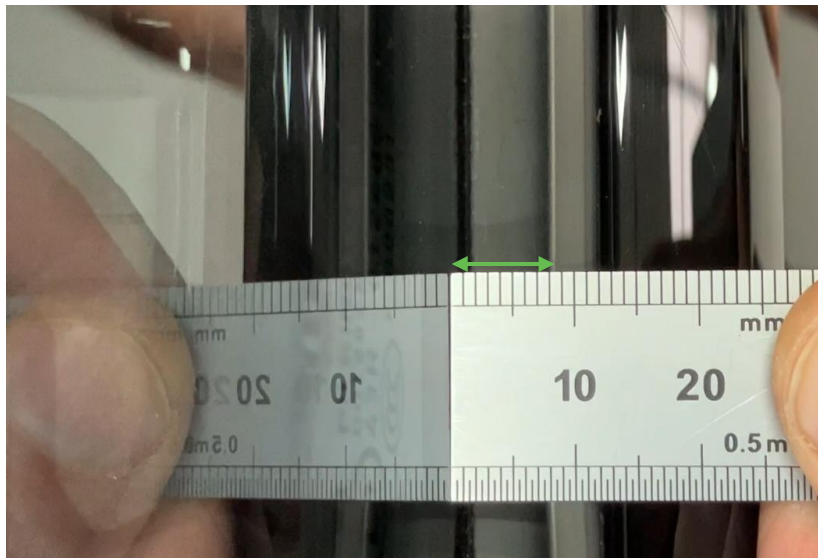
When setting front to rear window profile and waist rail measurements ensure that the front window does not move outboard excessively when the rear window closes as this will increase current draw on the rear motor during the period where it is monitoring for it's end stop, excess current draw in this zone can cause a false anti-trap scenario.

RHF window, front window closed, rear window open. Note gap

If more tension is required to resolve a wind noise or water ingress then aim for no more than 0.25mm of outboard movement.
