STAR ONLINE PUBLICATION

Case Number: S2405000002 Rev. C

Symptom/Vehicle Issue: Brake Light Switch Service Information.

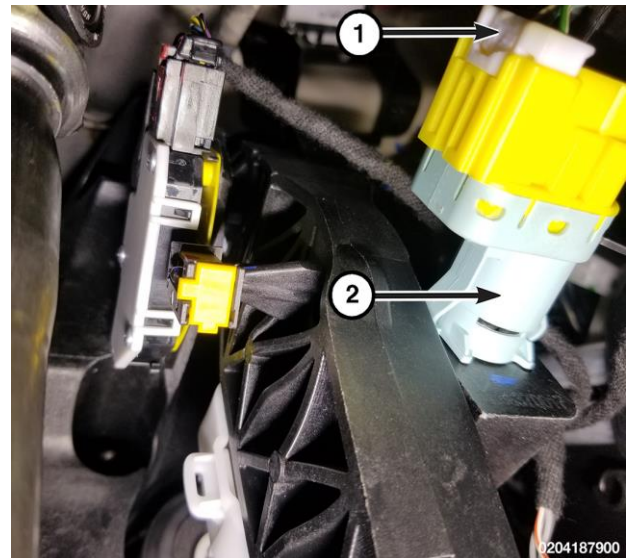
<<<NOTE>>> Check for any distance / space between the switch plunger and the Brake pedal. If the booster loses pressure, the pedal will sag, allowing the plunger to extend further. If the pedal sags too much, the plunger will reach its max extended distance, and the brake switch cam tabs will be damaged if removed in these conditions.

1 - Wire Harness Connector

2 - Brake Lamp Switch

1. Remove the steering column opening cover ([Refer to 23 - Body/Instrument Panel/COVER, Steering Column Opening/Removal and Installation](#)).
2. Disconnect the brake lamp switch wire harness connector.
3. [Press the brake lamp switch against the bracket while rotating the switch housing clockwise 45° to align the tabs to the keyed hole in the brake pedal support bracket.](#)
4. [Pull the brake lamp switch straight out of the keyed hole and remove it from the vehicle.](#)
