SIB 64 04 25

SERVICE ACTION: MODIFY HARNESS ROUTING AT THE NEXT NANOFILTER REPLACEMENT

This Service Information Bulletin (Revision 3) replaces SI B64 04 25 **dated July 2025**.

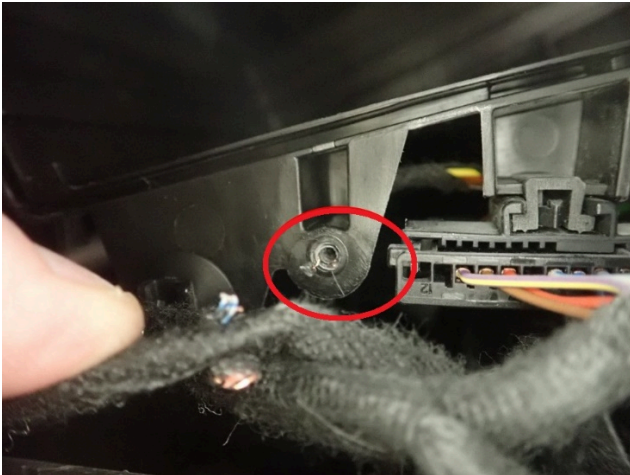
With the harness pulled out of the way, you can see the screw mounting hole for the cabin air filter cover.

Double check the routing of the harness prior to installing the screws for the cabin air filter cover.
