SERVICE BULLETIN

NUMBER: 15-236-18R
DATE: 12/04/18
REVISED: 07/10/25

SUBJECT: Reprogramming File Availability for Optimization of Harman Gen 3.1 and Gen 3.1α Audio and Navigation Head Units

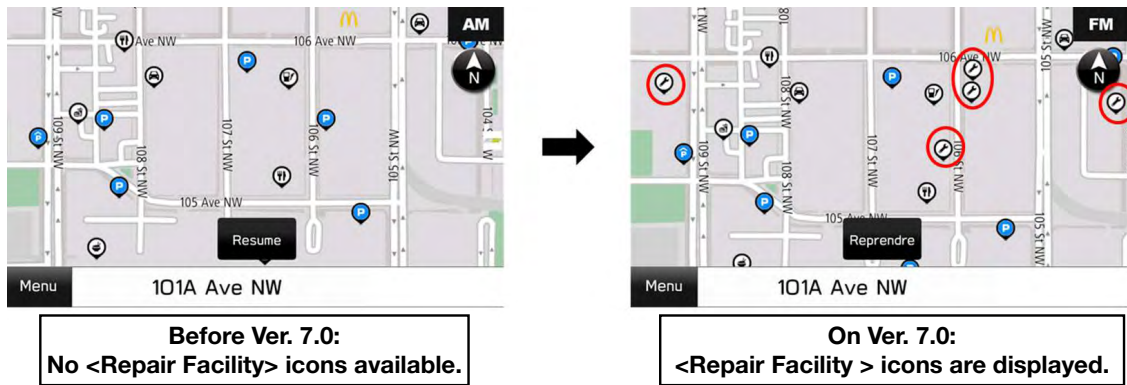
NOTE 4: Displaying Repair Facility POI icons:

- 7) When an iPhone (CarPlay allowed) is connected using USB, the system moves to CarPlay screen no matter what is set in the <Auto Show Connected Device> menu in Setting. The Setting menu of <Auto Show Connected Device> is applicable only on Android Auto. See **NOTE 3** below.
- 8) Repair Facility POI icons are now shown on the NAVI map display. See **NOTE 4** below.
- 9) Activation Code Not Accepted by Navigation System when updating Map Data

<Repair Facility> Icons can be displayed in the NAVI Map.

<Repair Facility> Icons can be turned On or OFF by going to: Settings > Navigation > POI Icons.

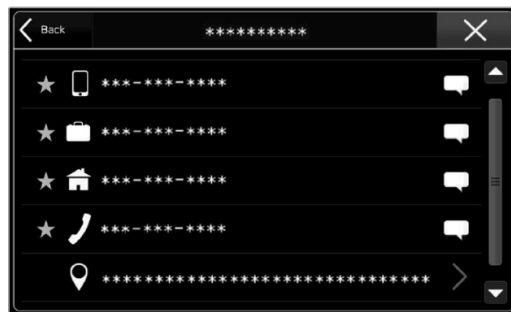
- 1) AM/FM radio station presets are lost.
- 2) Favorite Phone Contacts list is lost.

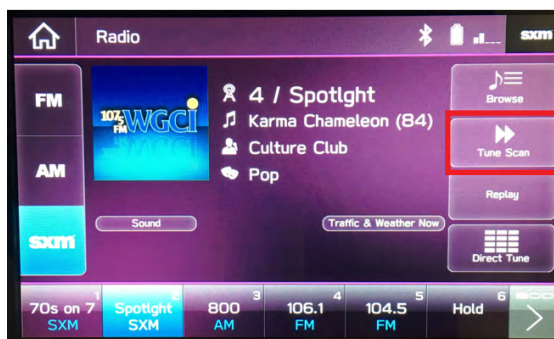
<Scan> previously displayed on SXM screen was changed to <Tune Scan> (a.k.a. SEEK).

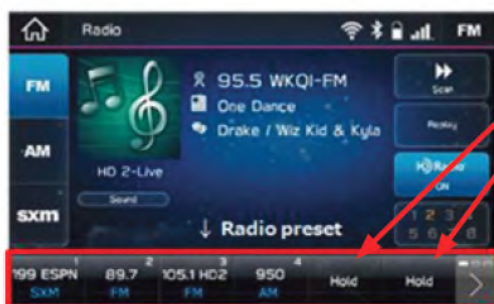
- 1) Station presets are lost. Touch buttons read “Hold”. (Applicable for software versions Rel 4.18.25.50 (or before)). Included in software version Rel_U1.18.38.50.
