SERVICE PROGRAM BULLETIN

APPLICABILITY: 2017 MY Forester (turbo) **NUMBER:** WRA-25R
 2017 MY WRX **DATE:** 06/27/25

SUBJECT: Rear Catalyst (Center Exhaust Pipe) **REVISED:** 07/31/25
 Non-Compliance

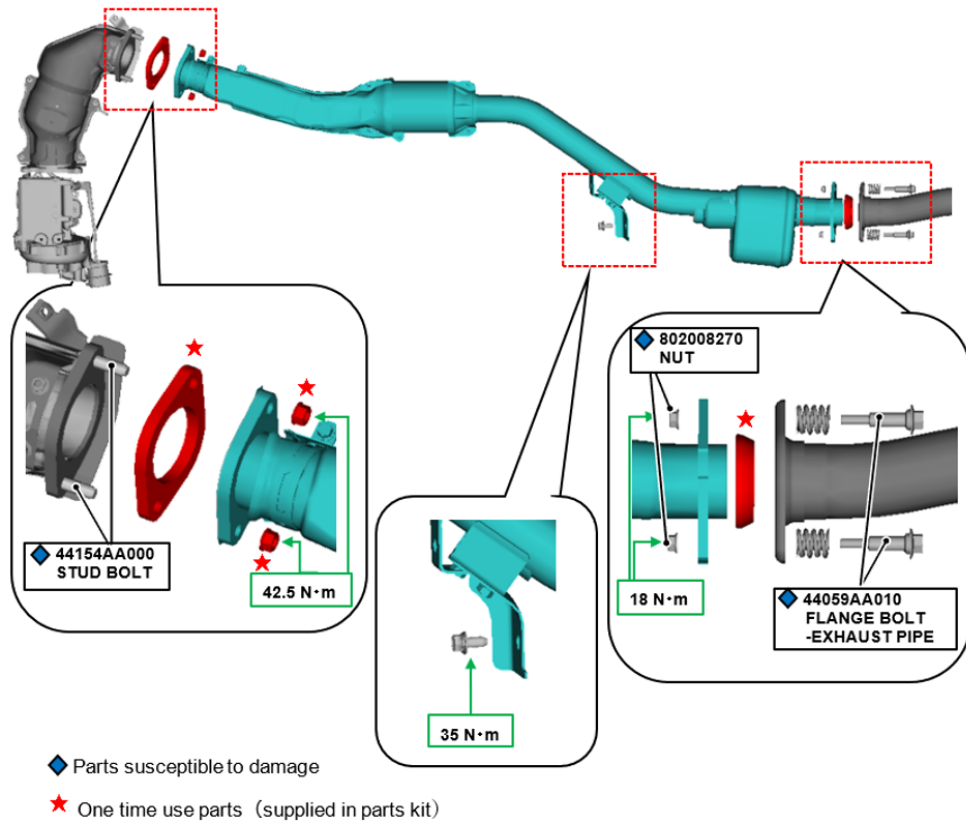
Defective Part

The performance of the rear catalyst (Center Exhaust Pipe) may cause the affected vehicles to exceed exhaust emission standards.

Subaru will replace the rear catalyst (Center Exhaust Pipe) with an improved one on all affected vehicles. Subaru will also reprogram the Electronic Control Unit (ECU) on affected vehicles equipped with a manual transmission. This repair will be performed at no cost to the customer.
