HYUNDAI
Technical Service Bulletin

GROUP	NUMBER
ENGINE MECHANICAL	25-EM-008H
DATE	MODEL(S)
JULY 2025	SANTA FE (NC)

SUBJECT: ENGINE NOISE INSPECTION & REPLACEMENT
(WARRANTY EXTENSION TXX8)

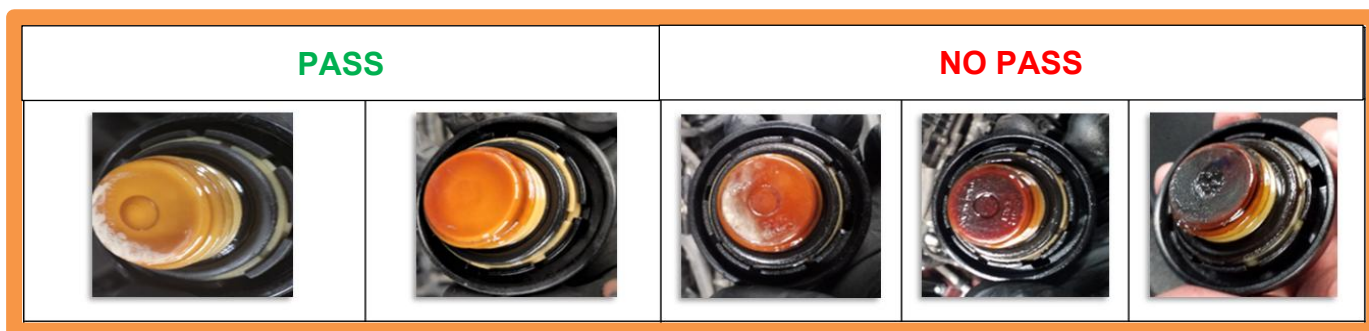
- A. If the BCT result is **PASS**
- Save a screenshot of the result.
 - Reinstall all parts in the reverse order of the removal process and replace non-reusable parts.
 - Follow a normal diagnostic procedure if both front and back banks show a **PASS**.
 - Do **NOT** remove the front rocker cover.
- B. If the BCT result is **NO PASS**
- Save a screenshot of the result.
 - Inspect the oil cap condition to determine **PASS** or **NO PASS**.
 - **PASS** – proceed to the next step.
 - **NO PASS** – remove the rear bank rocker cover and provide images of the valvetrain and inside of the cover. Include a sticky note of the repair date.

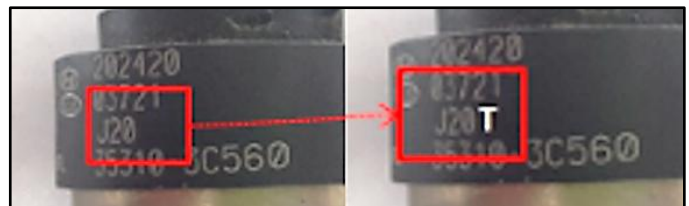
Select the appropriate tip seal according to the existing fuel injector part number.
Use of the incorrect tip seal may result in a critical fuel leak.

Tip-Seal Part Identification as shown on the right.

4. During the replacement, install the applicable injector tip seals based on the marking on each injector. Since both seals are included in the kit, use the table below to match the applicable part.
