Title: S13 Gear Housing Leak (By The Air Compressor)

Applies To: S13 Integrated Powertrain LT RH HX

The purpose of this document is to properly identify and repair a leak at the rear gear housing boss.

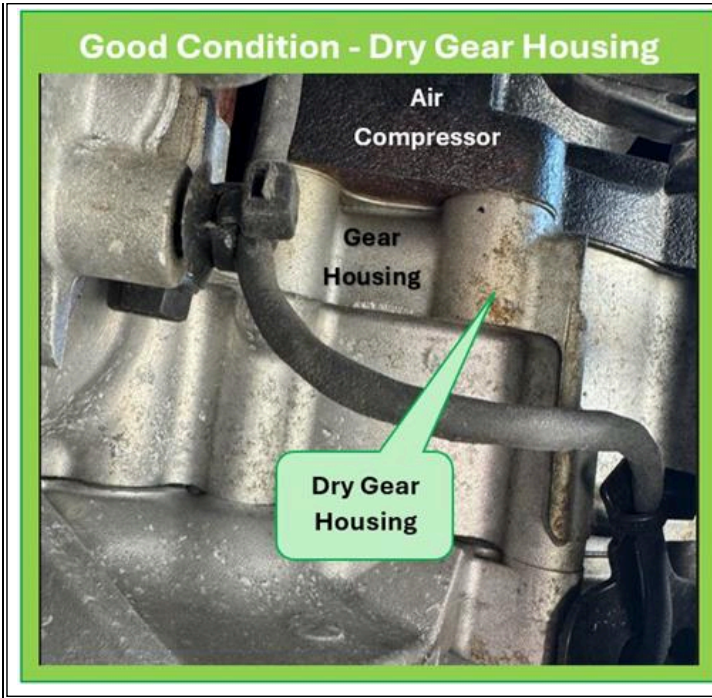
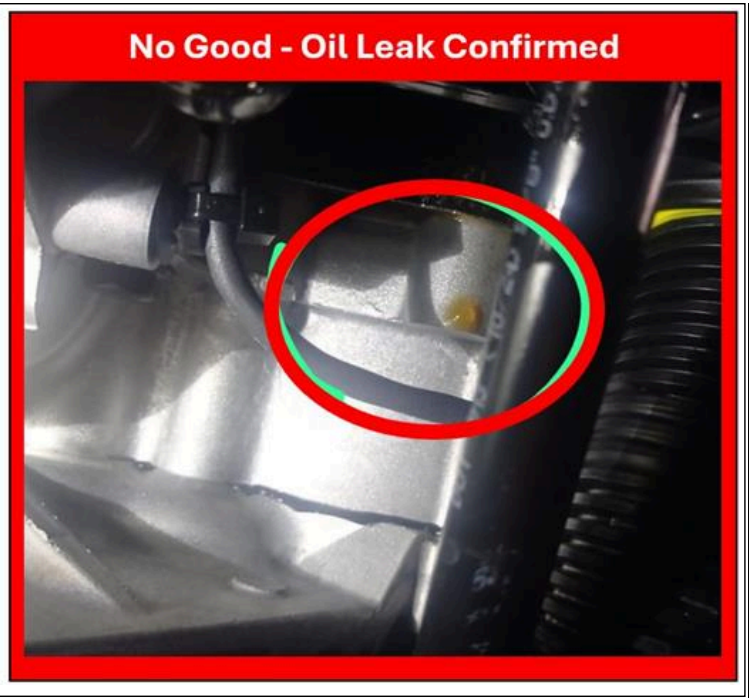
Step	Action	Decision
1	<b>DIAGNOSTIC:</b> Per Figure 1 below, inspect for oil being present at the bottom of the gear housing near the air compressor	<b>Yes:</b> Go to step 2
	<b>YES/NO QUESTION?</b> Is oil present at the bottom of the gear housing at the area as shown in Figure 1?	<b>No:</b> Reference <b>IK1201505</b> for other leak locations

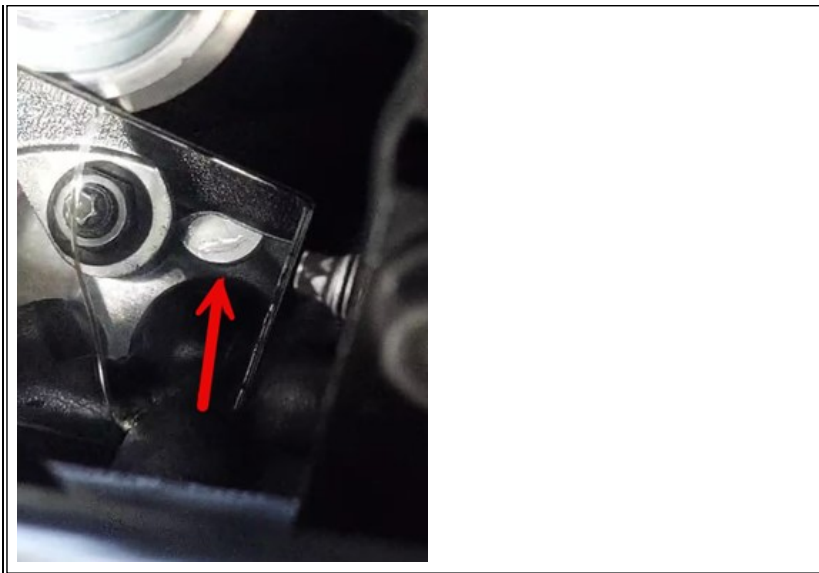
Figure 2 - Using a mirror to inspect between the lower compressor stud and the block
