GROUP	MODEL
ELE	2025MY K4 (CL4)
NUMBER	DATE
385	August 2025

TECHNICAL SERVICE BULLETIN

SUBJECT: **BODY DOMAIN CONTROLLER (BDC) REPLACEMENT (CA2507)**

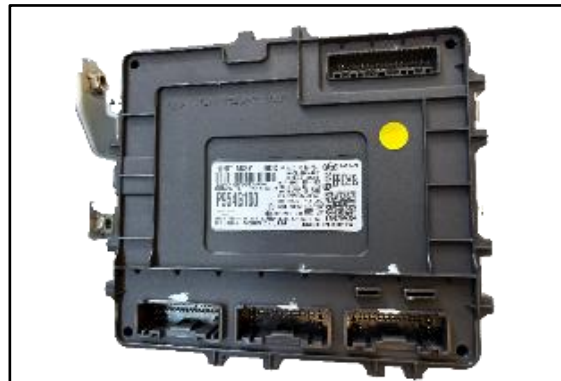
This bulletin provides information regarding the Body Domain Control unit (BDC) on certain 2025MY K4 (CL4) vehicles manufactured from June 1, 2024 through May 1, 2025. Due to a communication issue between the key fob and the BDC, the affected vehicles may exhibit a NO START condition when the ignition 'START' button is pressed accompanied by the inability to move the shifter out of the Park (P) position; however, all other Key Fob functions such as the Lock/Unlock, Trunk Release, Alarm and Remote Start continue to operate normally. Follow the procedure outlined in this publication to replace the Body Domain Control unit 'BDC'. Before conducting the procedure, verify that the vehicle is included in the list of affected VINs.
