HYUNDAI

Technical Service Bulletin

GROUP CAMPAIGN	NUMBER 25-01-044H
DATE AUGUST 2025	MODEL(S) KONA ELECTRIC (SX2 EV)

SUBJECT: BDC SOFTWARE UPDATE (SERVICE CAMPAIGN TCWA)

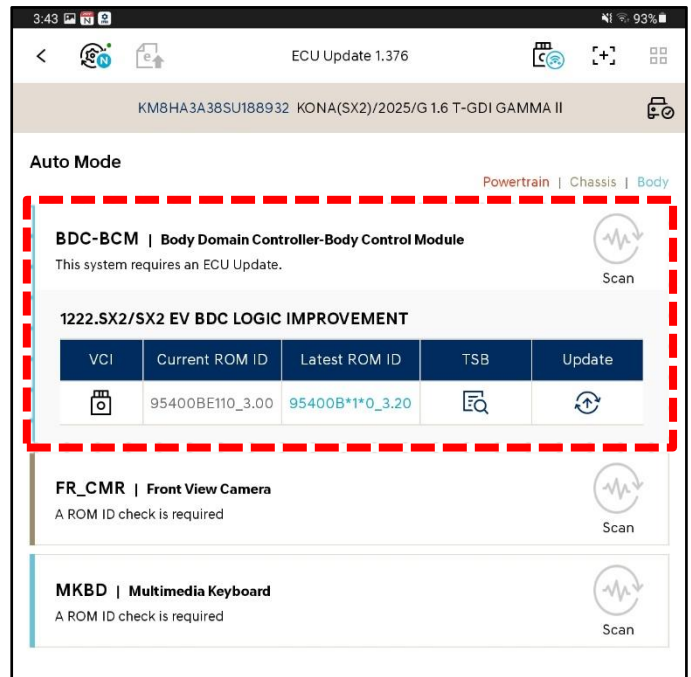
2. Select the **BDC-BCM** system to scan the vehicle's current ROM ID and then begin the update.

Check the current ROM ID version and compare it to the ROM ID Information table before attempting to perform the software update.

If the update fails, remove the power connector from the in-cabin fuse box or disconnect the negative (-) battery terminal for at least **5 seconds** and reassemble it to retry the update.

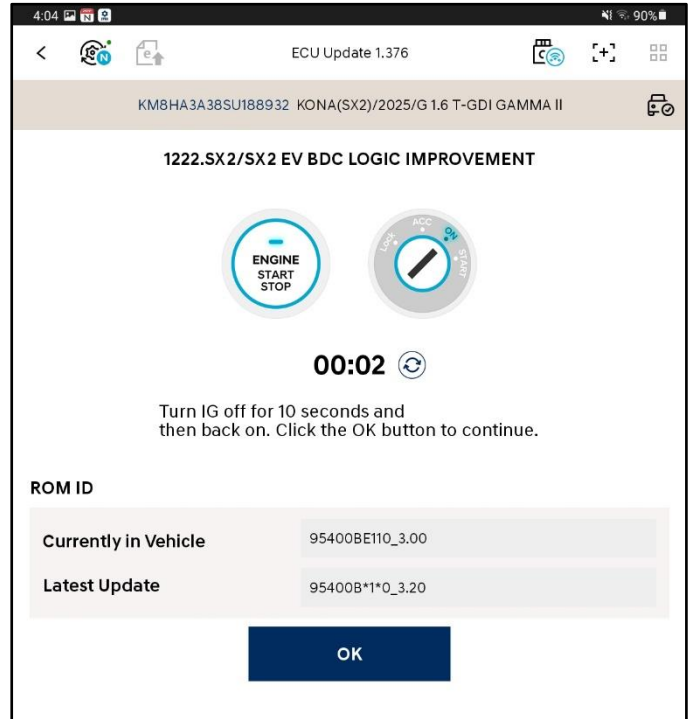
- After the ECU update process shows **100%** complete, follow the prompts on the screen to cycle the ignition for the prescribed time.

Use the **Refresh** button to reset the timer.

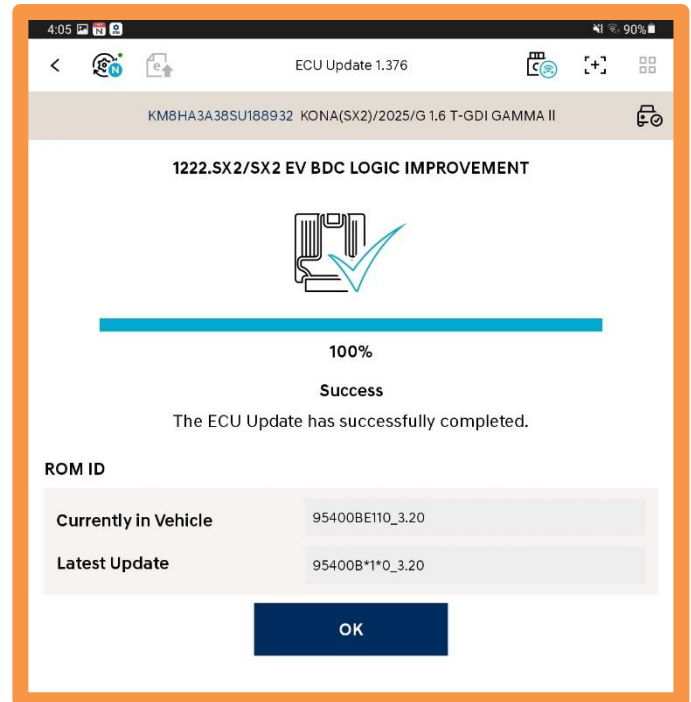
Take a screenshot of the ECU update complete screen using your tablet and upload to STUI.
