GENERAL MOTORS  
DCS 7293  
URGENT - DISTRIBUTE IMMEDIATELY

Subject: N252510321 - Service Update  
ECM Software Update

## N252510321 ECM Software Update

<b>Condition</b>	Certain vehicles listed above will receive a software update to add to the existing Check Engine Light a Driver Information Center (DIC) warning message if DTC P0016 sets.
<b>Correction</b>	Dealers will reprogram the Engine Control Module (ECM). Owners who have accepted applicable terms and conditions will have the opportunity to accept these software changes using wireless over-the-air (OTA) technology without having to bring their vehicle to a dealership. Alternatively, owners may have their vehicle serviced at a GM dealer to receive these software updates.

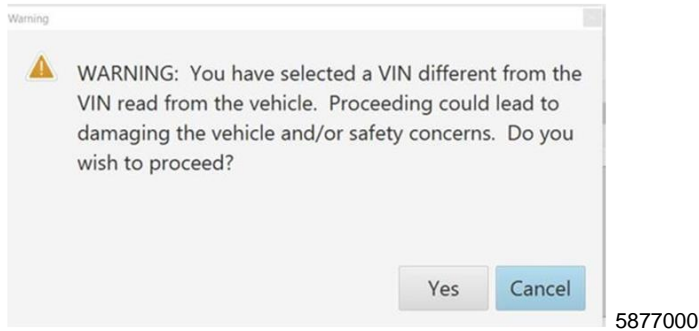
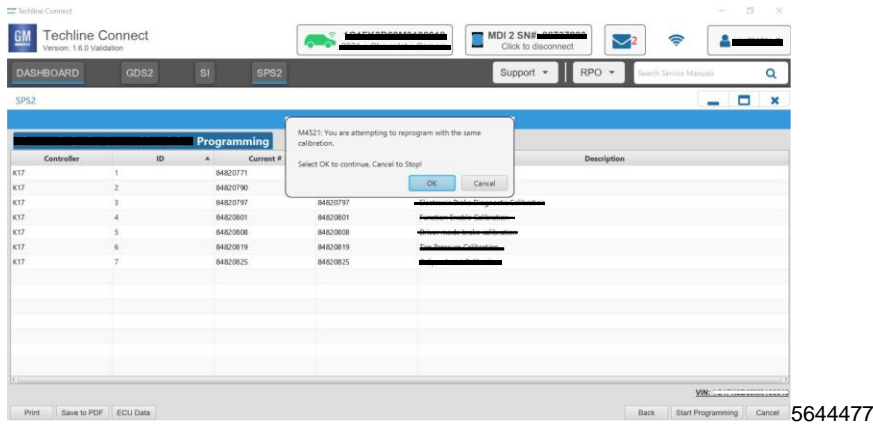
**Important:** Techline Connect screens shown above.

**Important:** If the same calibration/software warning is noted on the TLC Summary screen, select OK and follow screen instructions. After a successful programming event, the WCC is located in the Service Programming System dialogue box of the SPS Summary screen. No further action is required. Refer to the Warranty section of the bulletin.
