MAS004847 RU 25-23

Rapid Update 802 GranTurismo – Cooling Fan Terminal Inspection

VEHICLES INVOLVED: GranTurismo (M189), GranCabrio (M190) MY24 MY25

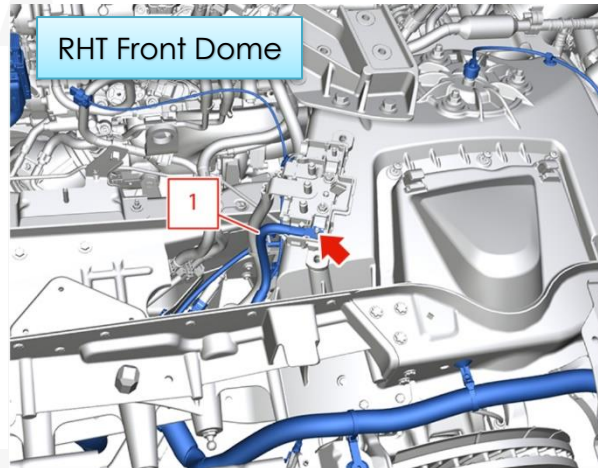
3. Inspect Terminal Orientation

- **Correct Configuration:** Terminal wiring is routed cleanly, seated properly, and clear of adjacent components. No further action is needed. Release the vehicle (**Figure 1**).
- **Adjustment Needed:** Terminal appears to be flipped (**Figure 2**) or in contact with surrounding components.

- Disconnect the battery following TechDocs procedure (8.20.001).
- Remove the retaining nut.
- Flip the terminal over so that it is seated properly as per **Figure 1**.
- Install a new nut and torque to specification.
- Reinstall all other components as needed.
