# Service Information Bulletin

B52 09 20

## HEAD RESTRAINT AND/OR BACKREST OF 3<sup>RD</sup> ROW SEATS CANNOT BE FOLDED DOWN

E-Series	Model Description
G07	X7 Sports Activity Vehicle

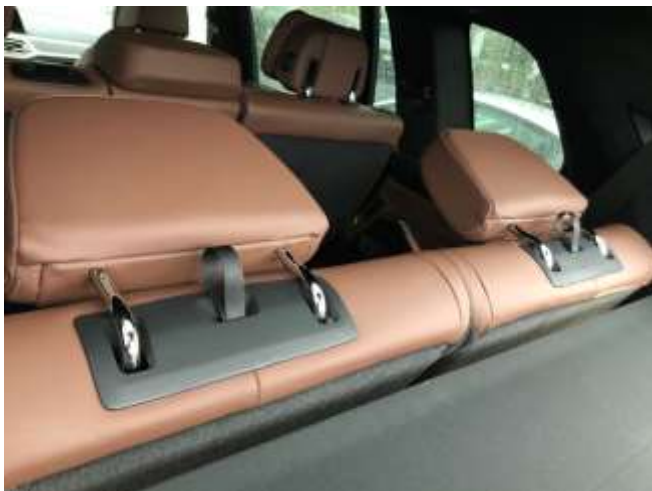
1. Head restraint cannot be folded down:

- B. **ONLY IF** the cable is moving fully but the headrest is not folding, then replace the folding module of the head restraint (#2 in picture).

See **REP 52 30 118** Remove and install/replace folding module of left or right head restraint.

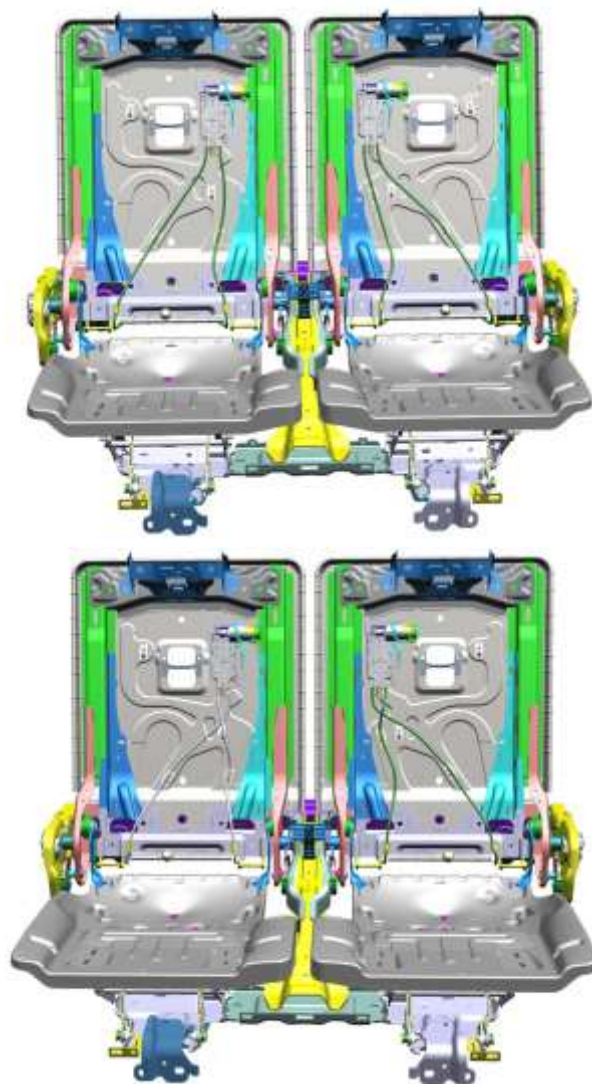
**Cable routing FROM February 2023 shown.**

Replacement parts are all the new shortened design cable and require a new routing to install in vehicles produced prior to February 2023.

replace the Bowden cable for the headrest (shown in yellow in picture).

See **REP 52 30 253** Replace Bowden cable for left or right head restraint (Bowden cable unlocking device for head restraint).

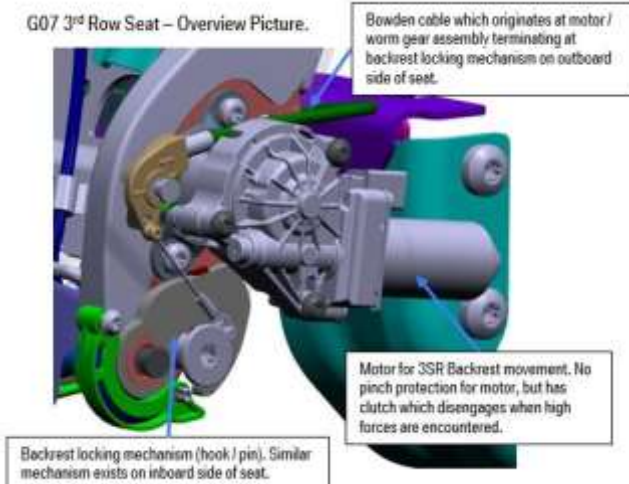
G07 3<sup>rd</sup> Row Seat – Overview Picture.

2. Third-row seating cannot be folded down:

Check if the latch (the fastener on the left or right side) of the third row of seats is open or closed? (this is the hook/pin shown in green in picture)

**YES** (Latch is **open**) = Replace drivetrain of backrest tilt adjustment.

See **REP 67 31 635** Remove and install/replace drivetrain for backrest tilt adjustment of third-row seating (left or right) (according to vehicle diagnosis)

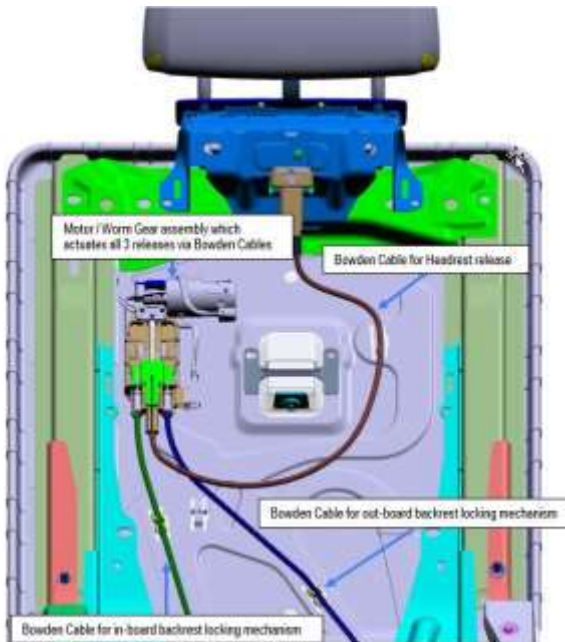
An improperly positioned or missing compression spring prevents the seat backrest from locking completely.

Is the drivetrain for the backrest release (actuator) broken?

**YES** = Replace only the drivetrain for backrest release (actuator).

See **REP 67 31 645** Remove and install/replace drivetrain for backrest release of third-row seating (left or right) (according to vehicle diagnosis)

**NO** = Replace BOTH the Bowden cable(s) and drivetrain for backrest release (actuator).

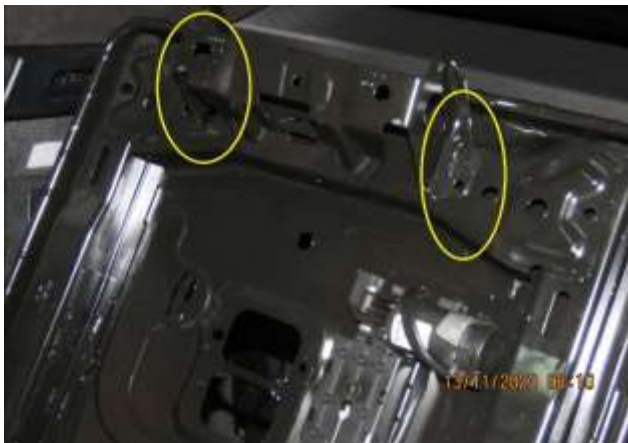
If any of the welds did not penetrate well this bracket may make noise.

Replace seat frame assembly if necessary.

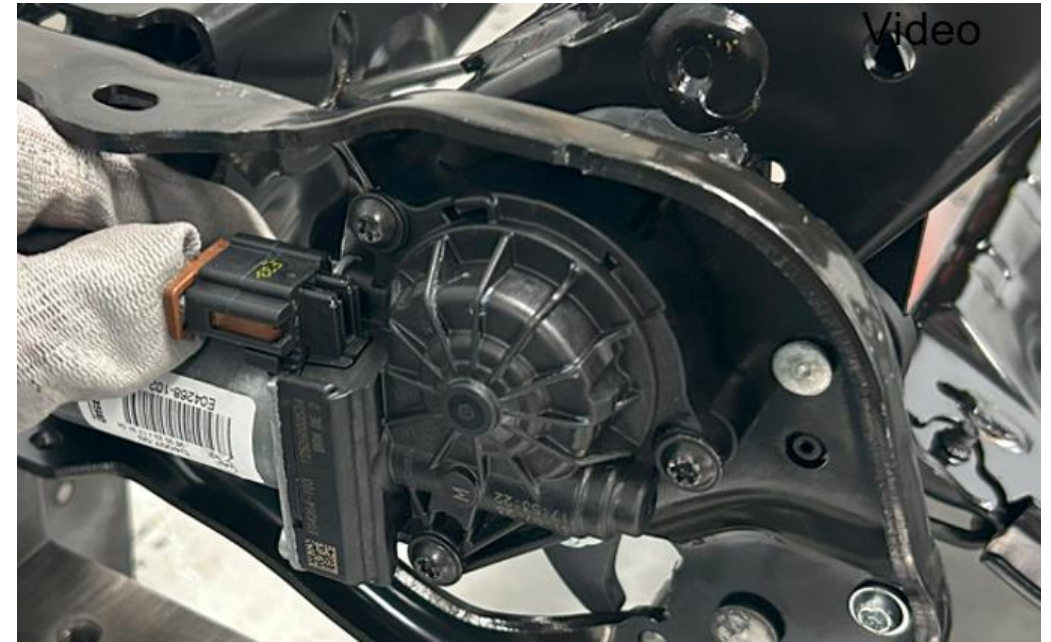
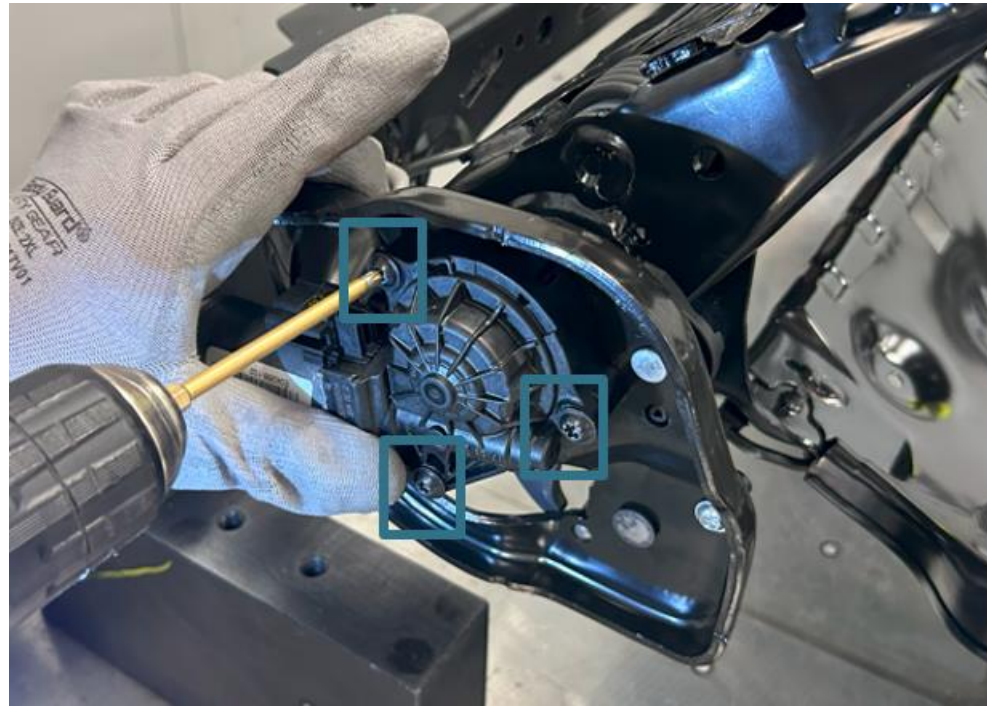
5. The gear tooth assembly may be damaged.

1. To remove the LVN Seat back rest folding motor first disconnect the brown electrical connector.
2. Remove the 3 T-20 screws from the motor.
3. Firmly grasp the LVN motor and begin to pull it out of the frame by gently rocking it up and down.
4. You can also move the back rest a little at the same time to get the gear teeth to disengage.
