HYUNDAI Technical Service Bulletin

GROUP BODY	NUMBER 25-BD-011H
DATE AUGUST 2025	MODEL(S) SANTA CRUZ (NXT)

SUBJECT: TONNEAU COVER FUNCTION: INSPECTION & REPAIR

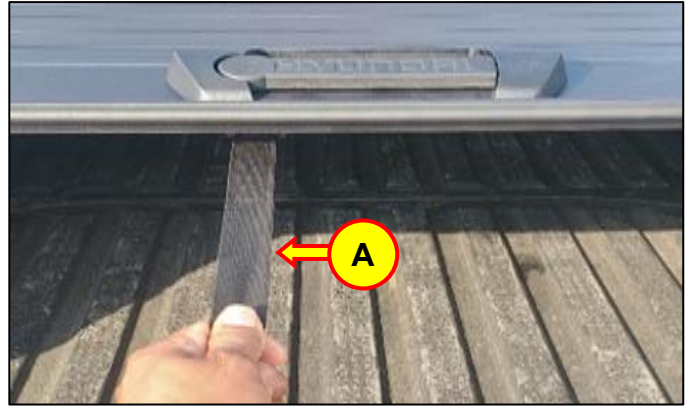
1. Open the tailgate and use the pull strap (A) to close the tonneau cover.

Ensure that the latch pins on both sides lock securely at the end of the bed rails.

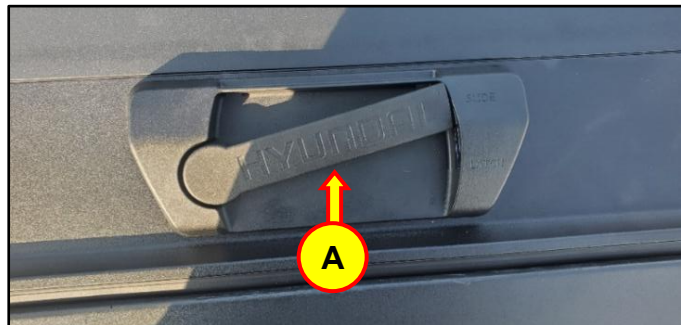
1. Put the tonneau cover latch (A) into the open position.

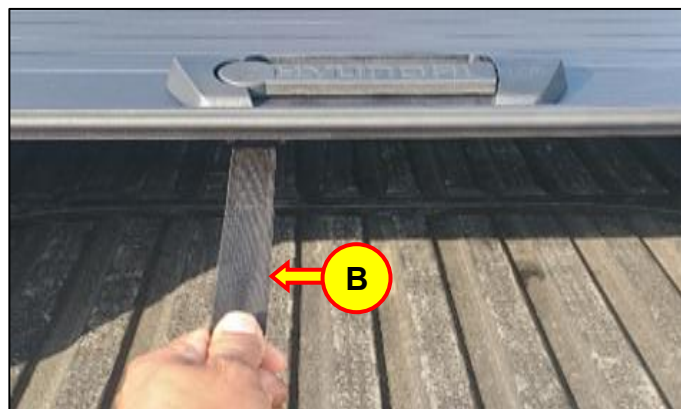
3. Use the pull strap (B) to close the tonneau cover.

4. If the tonneau cover requires excessive effort to close, then proceed to the [Tonneau Cover Repair](#) procedure on the next page.
