Service Alert

Subject: MELTED OR WARPED MIRROR COVER OR OUTSIDE TRIM	Service Alert No.: SA-039/25
	Last Issued : 08/21/2025

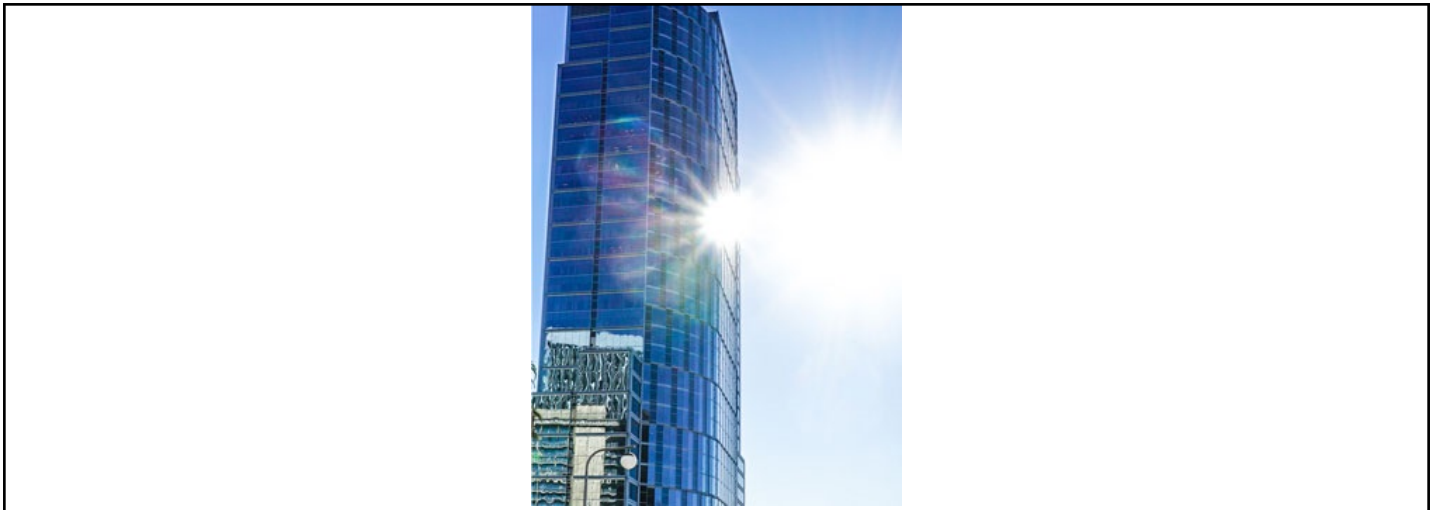
Some vehicles may experience exterior trim heat damage such (melted, separating, etc.) when parked near a glass building or Low-E windows. This may be caused by the sun's reflection.

If a structure's windows create enough of a curve, the concave glass can focus the sun's rays onto a small area and acting like magnifying glass direct the sunbeams into a hot pinpoint of light. This magnification of the sun's rays can cause damage to vehicle trim (see examples). Additional information and exemplar images regarding this phenomenon can be found by performing a google search.

Repair or replace the affected part(s) as needed. If the customer regularly parks the vehicle where there is exposure to such conditions as described in the description above, explain to the customer that parking location may need to be reconsidered.
