HYUNDAI Technical Service Bulletin

GROUP CAMPAIGN	NUMBER 25-01-048H
DATE SEPTEMBER 2025	MODEL(S) SEE BELOW

SUBJECT: CLUSTER SPEEDOMETER SOFTWARE UPDATE
(SERVICE CAMPAIGN TDQ)

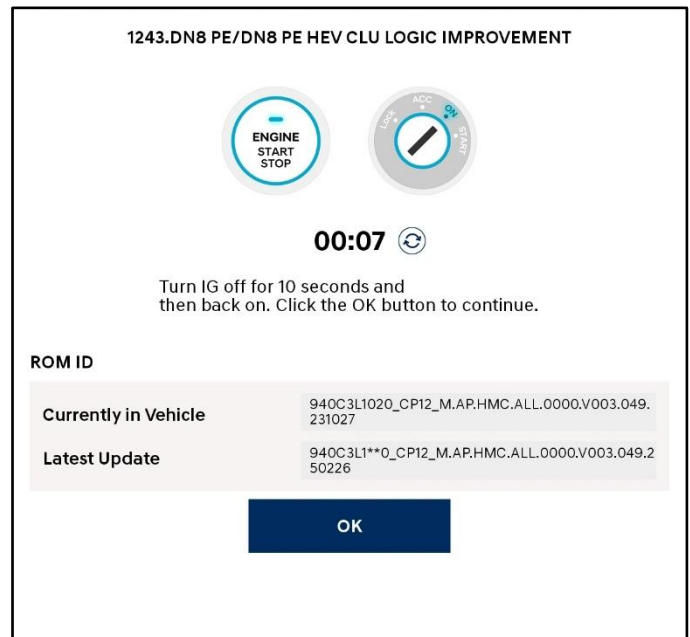
4. OTA initialization (A) should perform automatically:
 - If OTA initialization performs automatically, then proceed with the service procedure.
 - If the OTA initialization process fails, complete it manually under: **S/W Management > CCU_CCNF - Central Communication Unit (CCNF) > OTA Initialization (B).**

Follow the instructions on the screen.
