<b>HYUNDAI</b> <b>Technical Service Bulletin</b>	GROUP <b>CAMPAIGN</b>	NUMBER <b>25-01-058H</b>
	DATE <b>SEPTEMBER 2025</b>	MODEL(S) <b>SANTA FE (MX5A) SANTA FE HYBRID (MX5A HEV)</b>
<b>SUBJECT:</b> POP, TICK, OR CREAK NOISE FROM RIGHT FRONT SUBFRAME MOUNTING STUD (SERVICE CAMPAIGN 9C4)

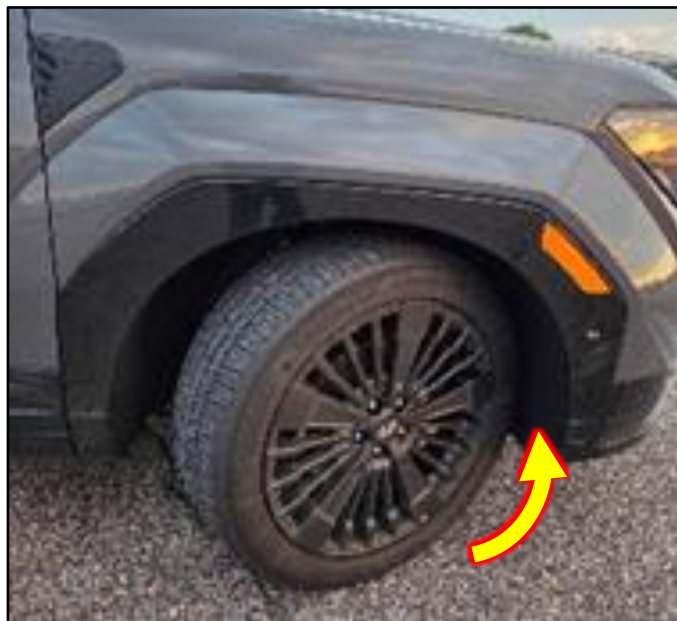
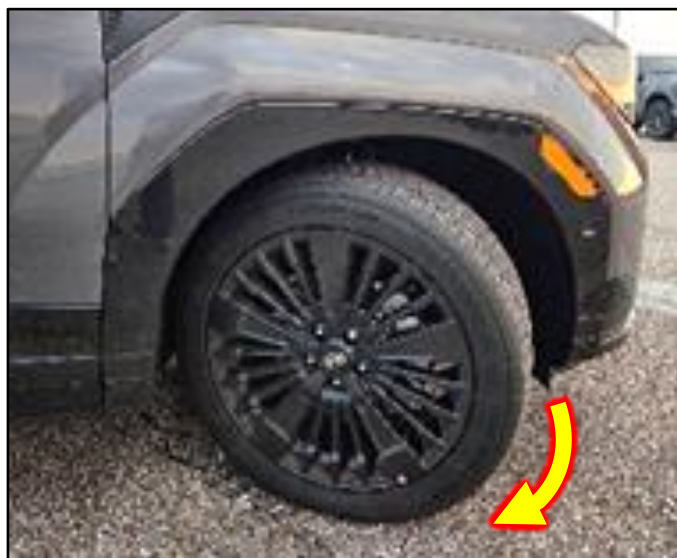
4. With foot on the brake, shift the vehicle into **DRIVE** and listen for a distinct **pop**, **tick**, or **creak** noise.
  - If the noise is heard, shift vehicle back into the **PARK** position and turn **OFF** the engine.  
Proceed to the [Visual Inspection for Weld on RH Front Subframe Mounting Stud](#) procedure.

- If the noise is **NOT** heard, shift vehicle back into **PARK** and proceed to the next step.

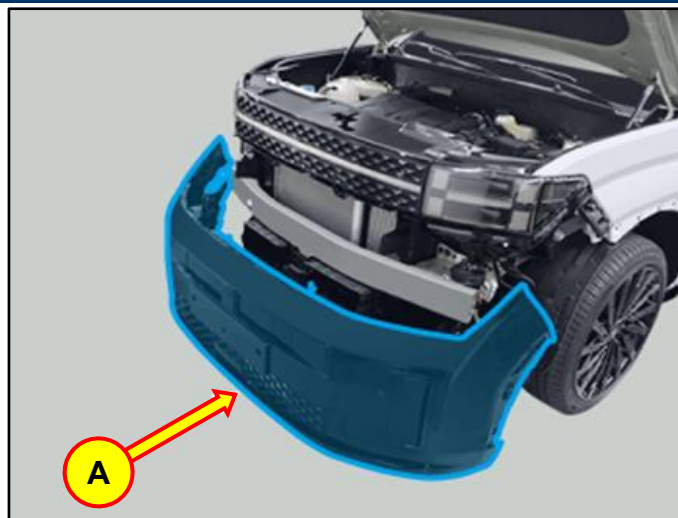
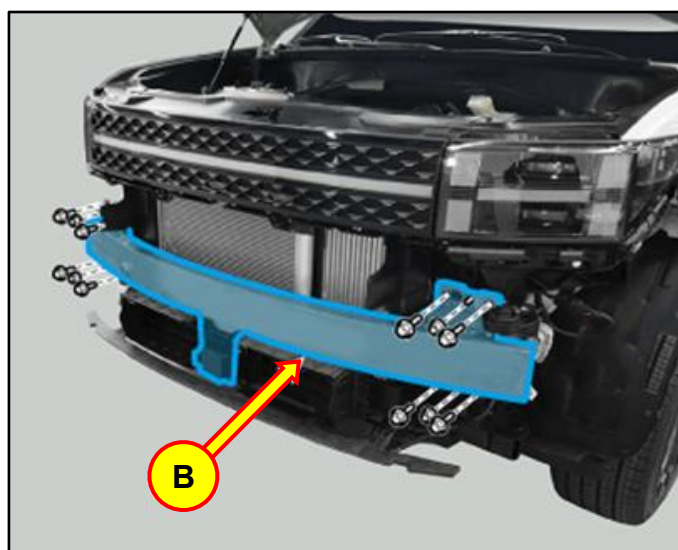
1. Remove the front bumper (A) by referring to the shop manual:
  - **Body (Interior / Exterior / Electrical) > Front & Rear Bumper > Front Bumper Assembly > Removal and Installation**
2. Remove the front bumper beam assembly (B) by referring to the shop manual:
  - **Body (Interior / Exterior / Electrical) > Front End Module > Front Bumper Beam Assembly > Removal and Installation**

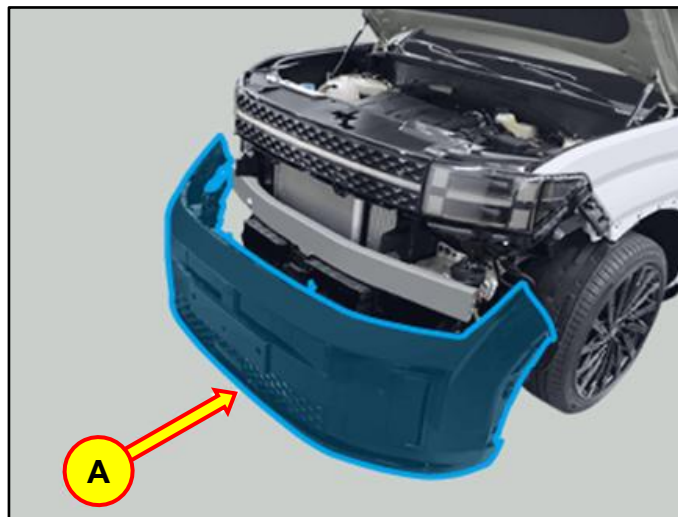
1. Remove the front bumper (A) by referring to the shop manual:
  - **Body (Interior / Exterior / Electrical) > Front & Rear Bumper > Front Bumper Assembly > Removal and Installation**

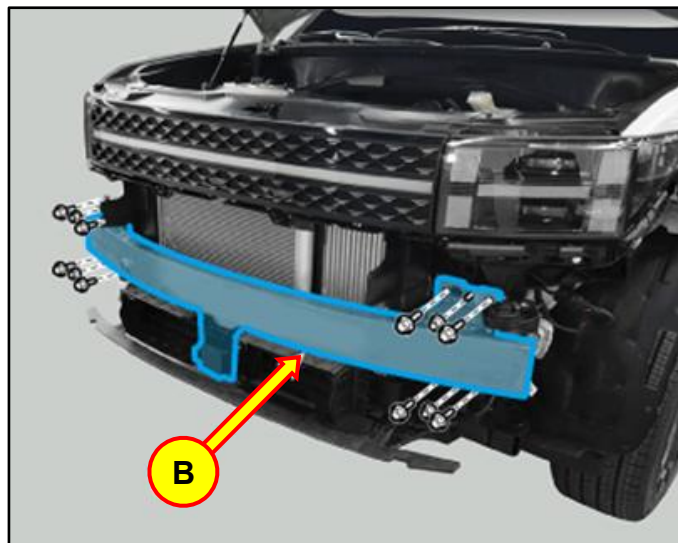
2. Remove the front bumper beam assembly (B) by referring to the shop manual:
  - **Body (Interior / Exterior / Electrical) > Front End Module > Front Bumper Beam Assembly > Removal and Installation**
