GROUP	MODEL
	ELE	2023-2024MY Sportage (NQ5 HEV)
	NUMBER	DATE
	399	September 2025

TECHNICAL SERVICE BULLETIN

BMS DISCHARGE LOGIC IMPROVEMENT

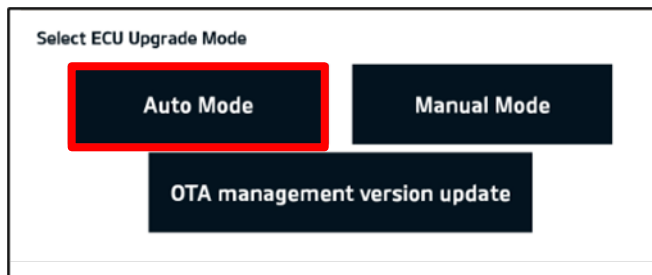
Note: In some case, the 'Manual Mode' installation option may be required **ONLY** if the 'Auto Mode' function fails or is otherwise noted above.

The required software must be installed by selecting the **'Auto Mode'** ECU Upgrade option.

- If the automatic upgrade fails, turn the ignition 'OFF' for about 10 seconds then place it back in the 'ON' position to reset the control unit **BEFORE** performing the manual upgrade.
- After the upgrade is completed, a 30-second IG-OFF period is required to finalize the procedure.
