GROUP	MODEL
BOD	2025MY EV9 (MVa)
NUMBER	DATE
343	September 2025

## TECHNICAL SERVICE BULLETIN

### SERVICE ACTION: OUTSIDE DOOR HANDLE COVER SCREW REPLACEMENT (SA627)

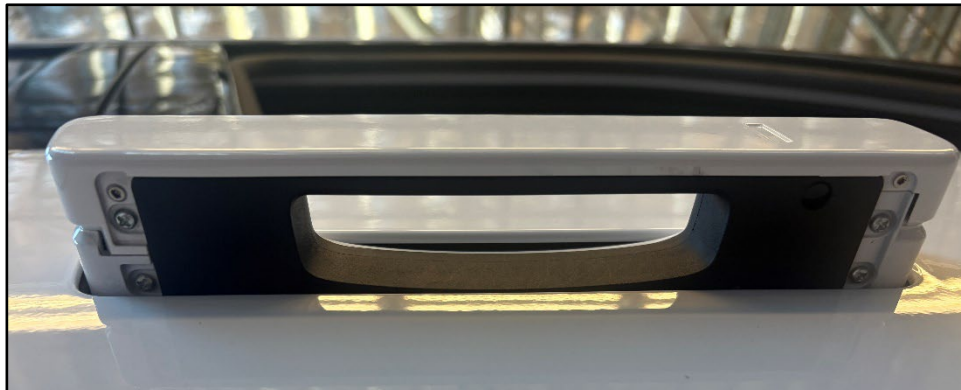
This bulletin provides instructions to replace the outside door handle cover screws on certain 2025MY EV9 (MVa) vehicles, produced from May 30, 2024 through November 19, 2024, which may result in rust or corrosion marks under door handle, particularly in vehicles located in rainy and snowy climates. Follow the procedure outlined in this publication to replace all four (4) outside door handle screws (15 total) on the subject vehicle. Before proceeding, verify that the vehicle is included in the list of affected VINs.
