<b>HYUNDAI</b> <b>Technical Service Bulletin</b>	GROUP <b>BODY ELECTRICAL</b>	NUMBER <b>25-BE-018H</b>
	DATE <b>SEPTEMBER 2025</b>	MODEL(S) <b>VENUE (QX)</b>
<b>SUBJECT:</b> INOPERATIVE HORN ASSEMBLY REPLACEMENT (WARRANTY EXTENSION TXXU)

**This TSB supersedes 24-BE-018H to revise the Applicable Vehicles, Parts Information, Warranty Information, and Service Procedure sections.**

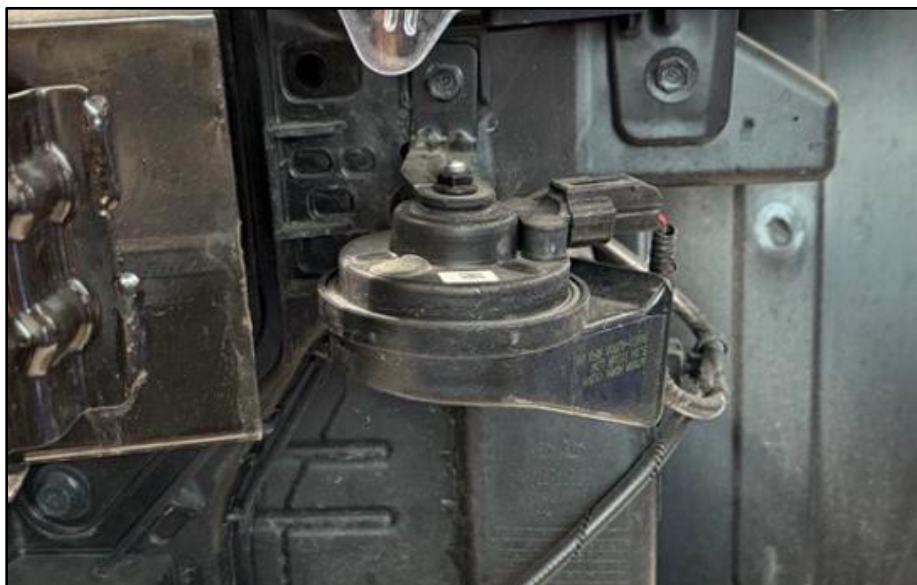
**Description:** Certain Venue (QX) vehicles may have an inoperable horn that may be caused by foreign substances causing internal parts to oxidize.

This bulletin provides instructions on the replacement of the inoperable horn.
