SIB 64 05 25

HVAC FLAP LINKAGE NOT FULLY CONNECTED

E-Series	Model Description		
G45	X3 Sports Activity Vehicle

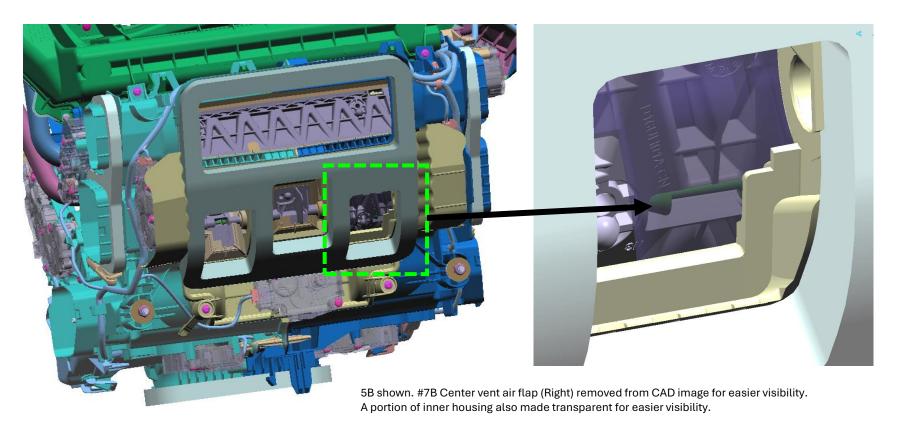
FLAP #5A/5B: Front Warm Temp. Mixing Flap Right (Mirrored Right to Left)

TWO Push Pins (one on LEFT side flap & one on RIGHT side flap)!

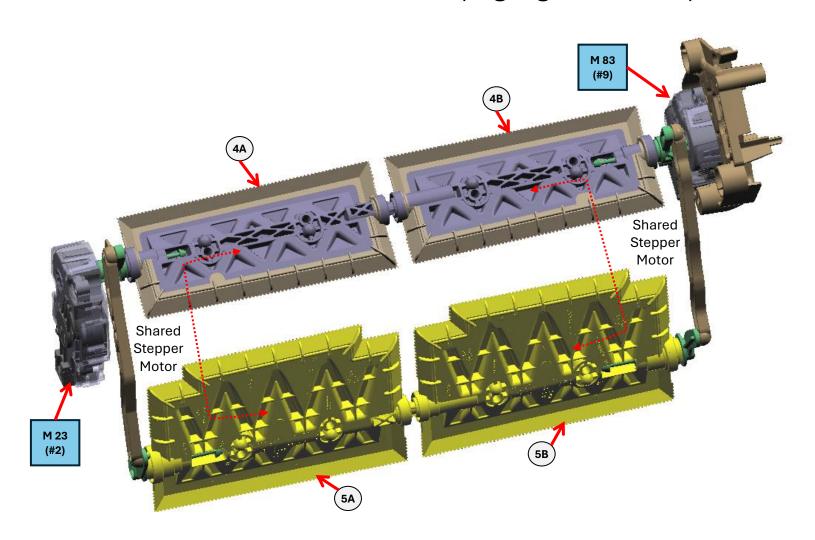
FLAP #5A/5B FLAP Kinematics Overview (Highlighted Yellow)

The linkage connection to the right front mixed air flap (5B) is the one we have found loose on most vehicles. For specific instructions on how to fix this flap, refer to **Attachment B64 05 25 RF Mix Flap**.

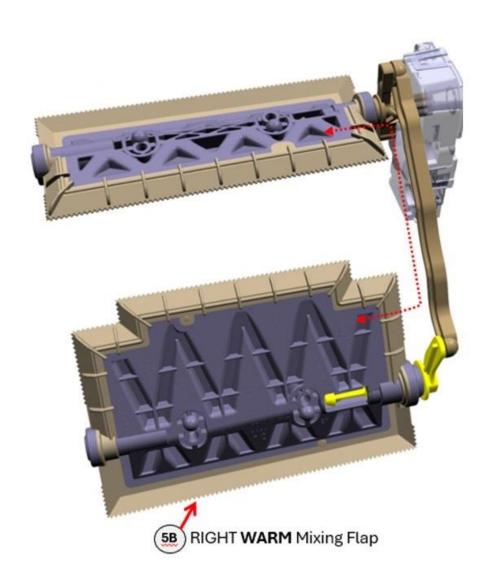
Right front warm air mixing flap 5B linkage repair.

- The initial service bulletin repair generally indicated to "push pin/linkage into flap".
- In some cases, that is NOT enough to ensure FULL engagement even if it sounds/feels like it could be. In some cases, it is actually **IMPOSSIBLE** to fully engage the pin/linkage simply by trying to push/clip it into the flap with your fingers (even when pushing as hard as possible-from the outside only).
 - *For a view of the linkage OUTSIDE the HVAC box see video:

Grab the warm mixing linkage and PUSH HARD INBOARD to FULLY ENGAGE the loose pin/linkage into the warm mixing flap #5B.

If you FAIL to secure/provide significant counterforce to the flap, at the same time you engage the pin/linkage, then it is possible for it to NOT fully engage even if it may feel like it is!

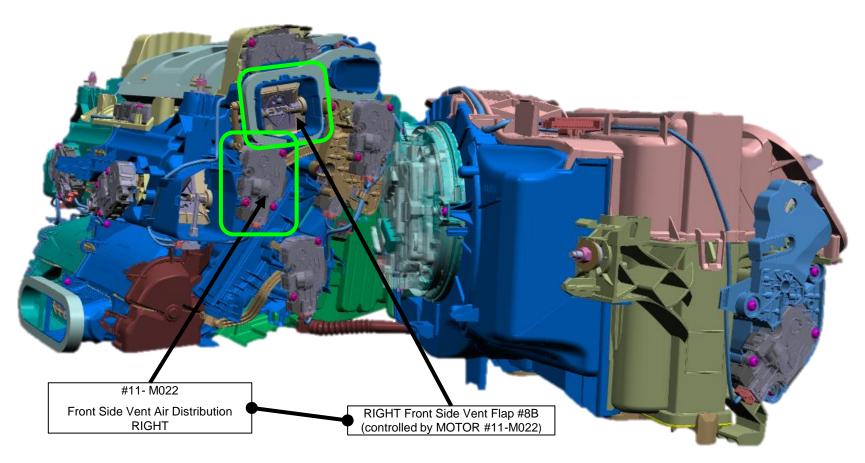
Reference Picture: F A- Remove MOTOR #11-M022

<u>Note</u>: This not the controlling motor for the mixing flaps. It is the controlling motor for the RIGHT, side vent air flap #8B. However, this motor is in the way & partially covering up the warm mixing linkage connection to flap. Removal of this motor is ok (if needed). If the warm mixing linkage to flap is loose, this motor will have to be removed later anyway to be able to fix the loose condition.

- Confirm NOK Condition (loose linkage to flap)- Minor Disassembly!
- C) In some cases, you may find it easier to remove motor #11/M022 for the "loose" inspection/confirmation.

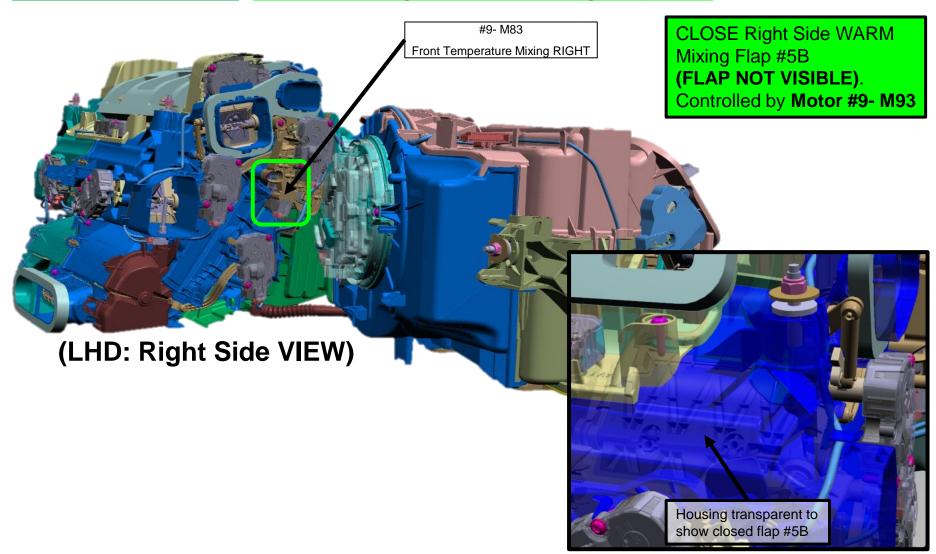
Reference Picture: I- CLOSE Right Warm Mixing Flap #5B

<u>NOTE</u>: The warm mixing flap #5B could inadvertently move to the open position since the flap and linkage are loose at this point. If this happens, push the pin/linkage in as far as you can and then rotate flap to completely close it again. This will make providing the necessary screwdriver counterforce easier.

*See Reference Picture: "I- CLOSE Right Warm Mixing Flap #5B"
