Trimark Entrance Door Latch

Bulletin Type:	TSB	Publication Date:	September 2025
Bulletin #(s):	25-004	Make(s):	Entegra Coach
Job Code(s):	9803627	Model(s):	Anthem, Aspire, Cornerstone, Cornerstone Reserve
Flat Rate(s):	9803627A .10 HR - Entrance Door Latch Inspection 9803627B .30 HR - Entrance Door Latch Inspection and Repair	Model Year(s):	2025 – 2026

Incident:	Exterior Entrance Door Lock-out
Affected Units:	2025 – 2026 Entegra Coach Anthem, Aspire, Cornerstone, Cornerstone Reserve
Parts Kit:25-004EC	Parts Kit #: 25-004EC
	Part Kit Contents: 1 - KIT,TSB 100-3100 RTROF TSB102
Misc. Tools & Supplies:	Refer to Instructions below
Parts Return Information:	Serial number of door

TRIMARK ENTRANCE DOOR LATCH INSPECTION

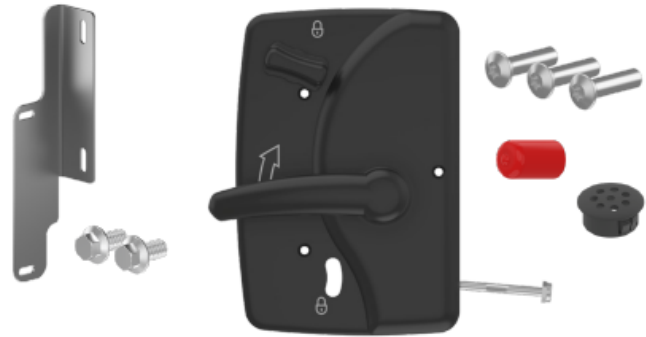
Kit Includes:

- Technical Service Bulletin
- Reimbursement Card
- L Bracket & 2 Fasteners
- Red Vinyl Cap (provided as spare)
- Inside Handle Assembly
- 3 Torx Head Screws (provided as spare)
- Plastic Cap
