Coolant leak at expansion reservoir level sensor connection

| Topic number | LI20.30-P-078666 |
| Validity | Model year 2025 GLE and GLS-class vehicles |

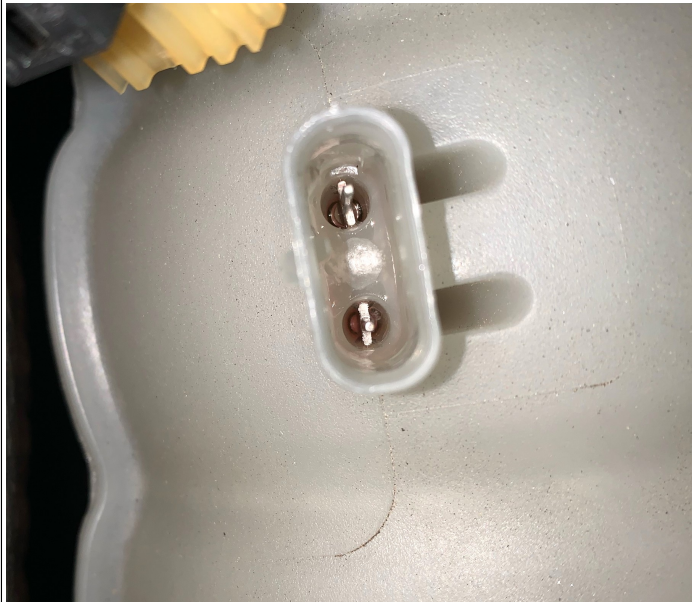
Level sensor connection.jpg

Coolant level warning in instrument cluster.  
Coolant odor or leaking from coolant expansion reservoir.

Coolant wicking through electrical contacts, or level sensor electrical connections not present in expansion reservoir.

Example of coolant at level sensor connection

- 1- Inspect expansion tank level sensor electrical connection for missing contacts. Additionally the triangular sticker may not be present on top of reservoir. See example of OK and NOK part.
- Replace the expansion reservoir if contacts are found to be missing. A TIPS case is not needed.
  - Proceed to step 3.
- 2- With contacts present, inspect coolant level sensor electrical connection for leakage past contact seals. Visible coolant at the connection indicates leakage.
- Capture photos if leakage is identified and create a TIPS case with the Powertrain team.
  - Replace the expansion reservoir.
- 3- Repair any damage to wiring or electrical contacts on wiring harness from S41 to N10/6.
- Check the front SAM N10/6 for coolant contamination and replace if necessary.
  - Inspect electrical connectors at base of A-pillar for contamination and repair/replace as necessary.
