Customer Service Notification

GranTurismo BEV Battery Fuse Box Retaining Nut Inspection

DATE: September 26, 2025

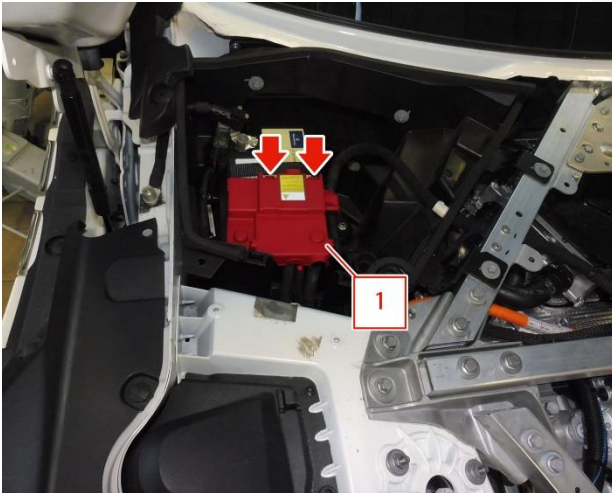
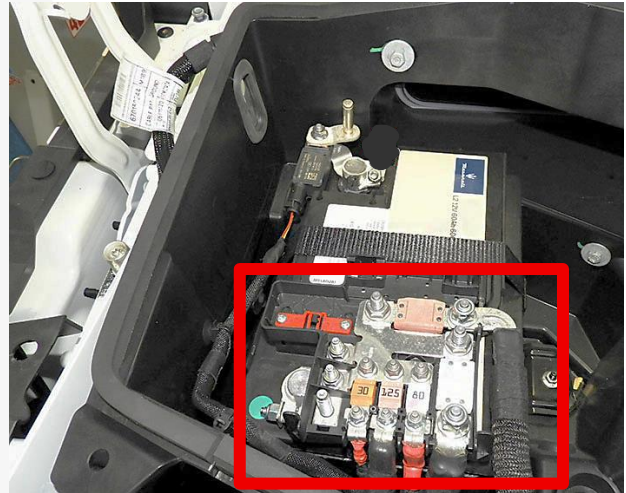
1. Always check ModisCS+ to see if the vehicle is involved in this action and if it has not been previously performed.
2. Disconnect the battery Workshop manual section 8.20.001 (Battery – Connecting/Disconnecting Power Supply).
3. Locate the fuse box on the 12V battery in the engine compartment.
4. Remove the control unit cover (1) Workshop Manual section 08.20.016 00 BATTERY ECU
