PRODUCT CAMPAIGN BULLETIN

APPLICABILITY: 2019-20MY Ascent
 2020-21MY Legacy 2.4L (turbo models)
 2020-21MY Outback 2.4L (turbo models)

SUBJECT: CVT Chain Guide Breakage

NUMBER: WRK-21/22R

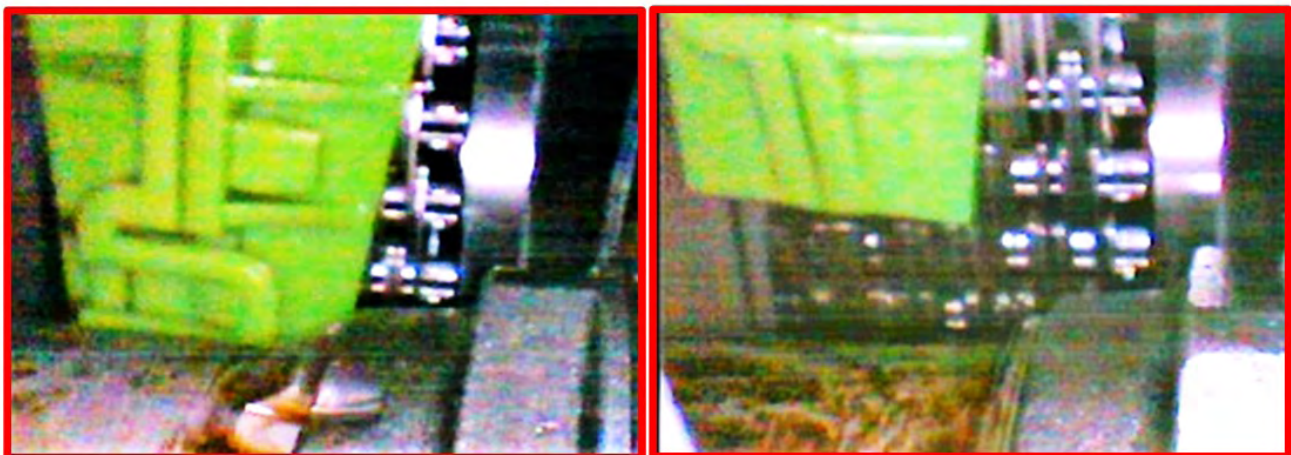
ONLY in a situation when no CVT chain slip is detected with SSM and the chain guide is found to be in the incorrect position during inspection, a clear photo or screenshot of the scope image is required to be stored and noted along with the previously mentioned items 1 through 3.

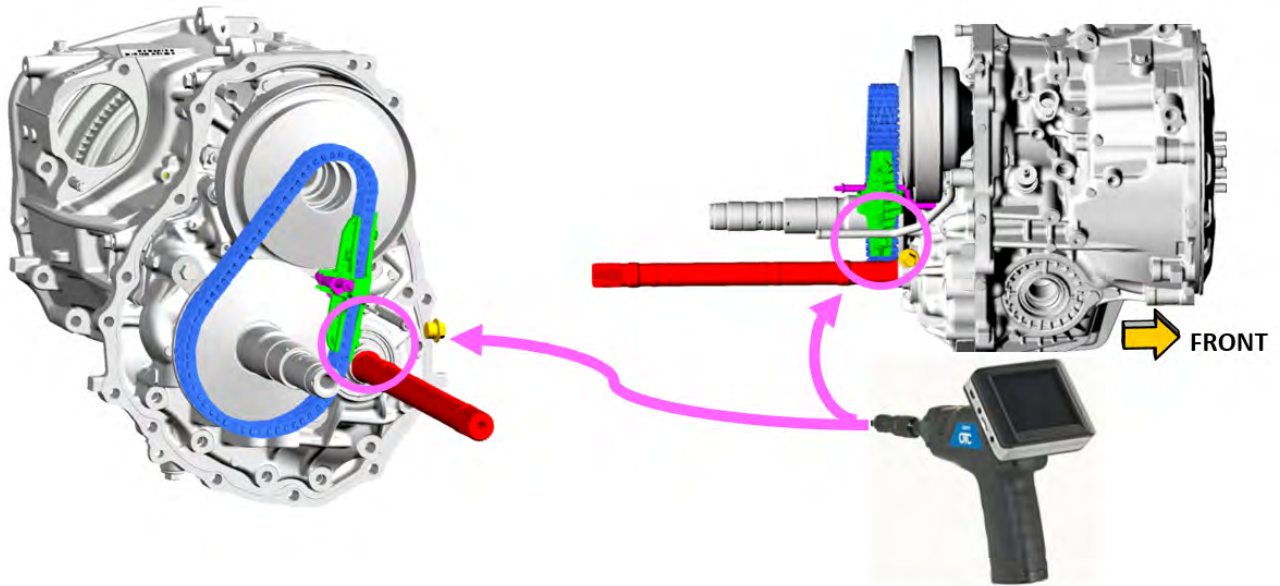
STEP 3E: Inspect the position of the lower end of the chain guide rail and the drive pinion shaft.
