Technical Service Bulletin

Topic	15 Oil leak from the cylinder head - 2.9 and 3.0 TFSI only
Market area	United States 444 Volkswagen of America, Inc. (6444)
Brand	Audi
Transaction No.	2053278/10
Level	EH
Status	Released for publishing
Release date	Sep 30, 2025

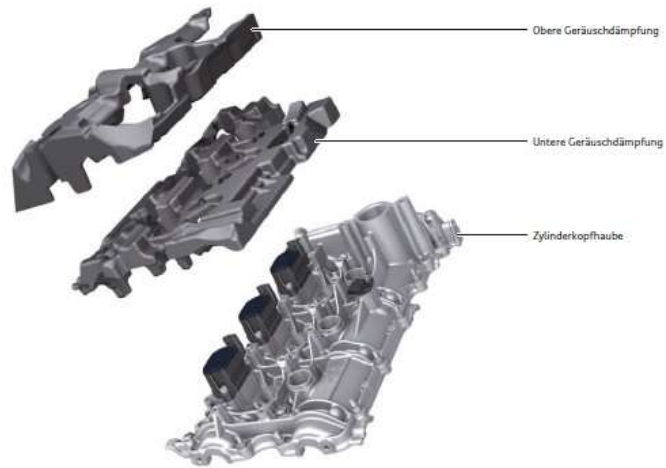
Figure 1. Removing the upper noise insulation.

2. Remove the upper noise insulation of the affected cylinder bank (Figure 1).

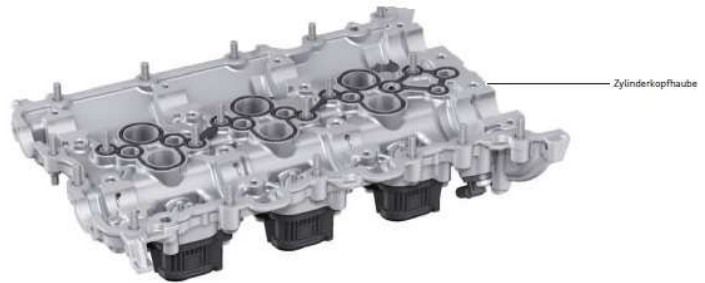
Figure 4. Remove the cylinder head cover and gasket.

6. Remove the cylinder head cover and the seal (Figure 4).

7. Inspect the gasket groove in the cylinder head cover and remove any casting residues with a suitable tool (Figure 5). The residues can be removed with a small flat screwdriver (Figure 6).
