Insufficient Heating Output Due To Broken Refrigerant Line Between Refrigerant Compressor And The condenser (Hot Gas Line)

Topic number	LI83.20-P-076623
Version	3
Function group	83.20 - Heating
Date	10/6/25
Validity	EQA (H243), EQB (X243)
Reason for change	Remedy

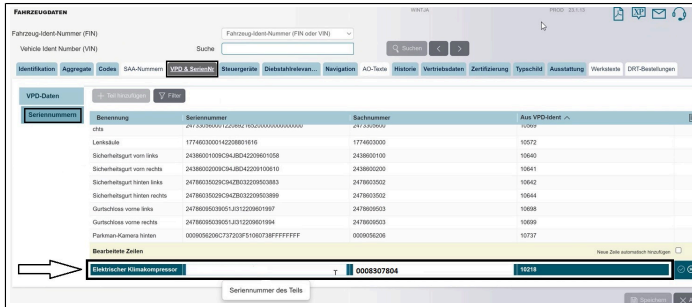
Attachments	
File	Description
Redocumentaion VeDoc.jpg

- Detailed description of the customer complaint and the workshop measures carried out
- Initial quick test
- Photos of the filter screen of the dryer cartridge
