CUSTOMER SUPPORT PROGRAM 22TE09

**HV FLOOR UNDER WIRE HARNESS AND REAR TRACTION MOTOR CABLE
CORROSION**

**CERTAIN 2022-2024 MODEL YEAR NX450H+
&
CERTAIN 2022-2024 MODEL YEAR RX450H+**

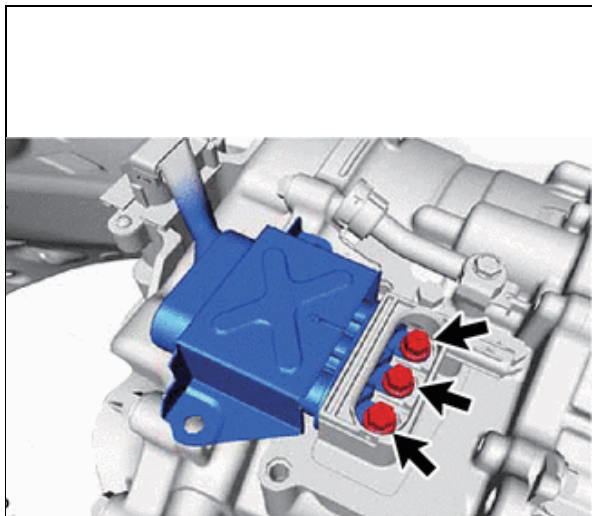
- Blowing air without cleaning first may cause dust and other foreign matter to enter the terminal.
- Dust or other foreign matter entering the terminal when installing the rear traction motor cable may cause a short or electrical leakage.

1. Install the Rear Traction Motor Cable onto the MGR

- a) Clean the area around the terminal of the rear traction motor cable, and then blow air on the terminal to remove dust and other foreign matter.

- b) Using an insulated tool, install the rear traction motor cable to the rear traction motor with transaxle assembly with the 3 bolts.

10 N·m {102 kgf·cm, 7 ft·lbf}

Torque is critical at this electrical connection. Ensure proper torque is applied to each bolt.
