GENERAL MOTORS  
DCS7346  
URGENT - DISTRIBUTE IMMEDIATELY

Subject: N232401570 - Service Update  
Cell Monitoring Unit Offline

# Service Update

## N232401570 Cell Monitoring Unit Offline

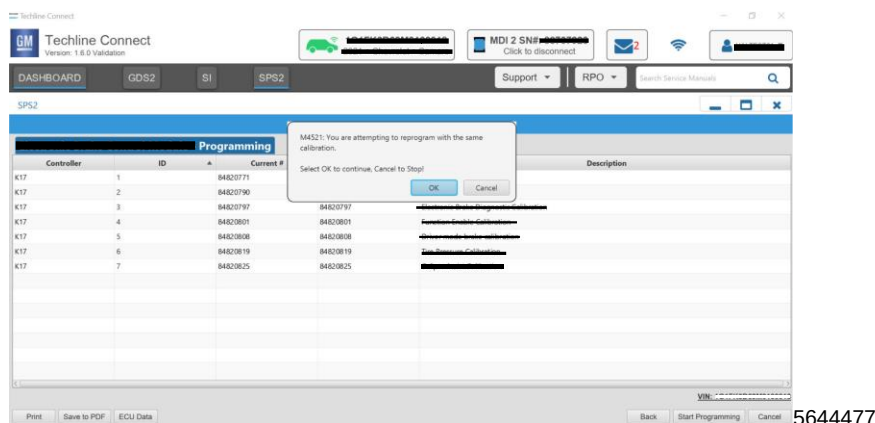
**Important:** Techline Connect screens shown above.

**Important:** If the same calibration/software warning is noted on the TLC Summary screen, select OK and follow screen instructions. After a successful programming event, the WCC is located in the Service Programming System dialogue box of the SPS Summary screen. No further action is required. Refer to the Warranty section of the bulletin.
