GROUP	MODEL
BOD	2021-2024MY Seltos (SP2)
NUMBER	DATE
326 (Rev 1, 10/20/2025)	July 2024

TECHNICAL SERVICE BULLETIN

HORN ASSEMBLY INSPECTION/REPLACEMENT

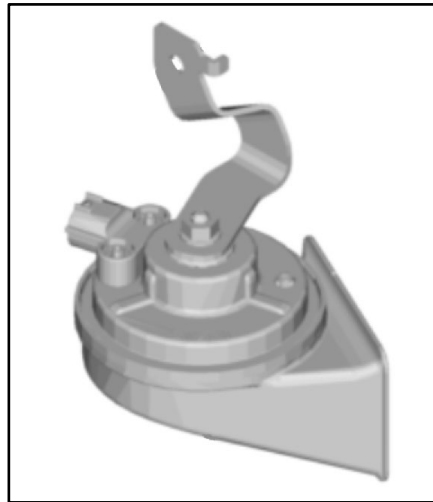
This bulletin provides information associated with the 'Warranty Extension Program' (WTY038) to inspect and, if necessary, replace the horn assembly on 2021-2024MY Seltos (SP2) vehicles produced from March 21, 2019 through June 21, 2024. The affected vehicles may experience a distorted or an inoperative horn sound caused by corrosion and dust inside the horn assembly. The warranty coverage for repairs related to the horn assembly has been extended from 5 years / 60,000 miles to 10 years / 120,000 miles, whichever comes first, starting from the date the vehicle was first put into service. Follow the procedure outlined in this publication to inspect and, if necessary, replace the horn assembly with a new one.
