Technical Service Bulletin

GROUP	NUMBER
CAMPAIGN	25-01-077G
DATE	MODEL(S)
OCTOBER 2025	GV70 (JK1) GV80 (JX1) GV80 COUPE (JX1)

SUBJECT: LOOSE WINDSHIELD GLASS GARNISH SEAL
(SERVICE CAMPAIGN T84G)

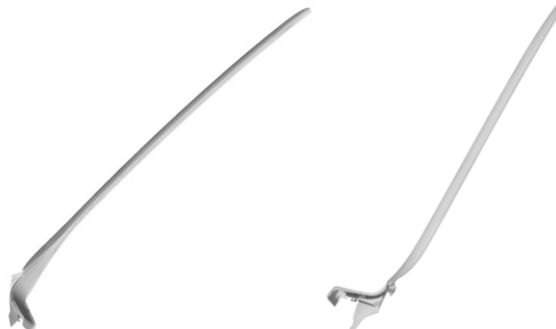
Model	Part Name	Part Number	Figure
GV70 (JK1)	Garnish Assy – Windshield Glass Kit	86130-AR400QQH

Description: Certain GV70 (JK1), GV80 (JX1), and GV80 Coupe (JX1) vehicles may exhibit a loose windshield glass garnish seal. This bulletin provides instructions to remove the old garnish and install new parts.
