SERVICE BULLETIN

APPLICABILITY: 2020-22MY Outback & Legacy
 2022-25MY BRZ
 2022-23MY WRX

NUMBER: 15-270-20R
DATE: 8/19/2020
REVISED: 10/10/25

SUBJECT: FOTA (Firmware Over-The-Air) Reprogramming for DENSO Gen 4 Audio / Navigation Infotainment Systems

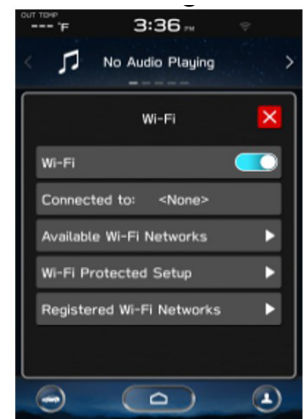
2. If you receive one of the following two messages during the update process:

- a. Check the internet connection to ensure it is active and shows full signal strength.
 - i. Select General tab under “Setting” screen and change the “Wi-Fi” to Off once then turn it back to On again.

- b. Try moving the vehicle closer to the WiFi source or if not possible, try a different WiFi connection such as a mobile hotspot.

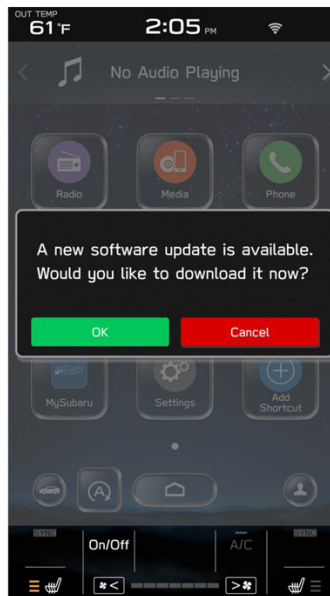
- a. If current software version is the latest, you don't need an update and no action is necessary.
- b. If the software version is not the latest, you are likely not eligible for FOTA update at this time. Please proceed with USB update following TSB 15-261-20.
4. If the "OK" button does not respond when I begin the update process:

- a. If CarPlay application is running at the time the pop-up screen comes up, disabled for OK operation. Please press the home button on the display, Software Updates, Update, and begin again.

- b. If this version is not shown, ensure the clock time is correct. b) The same for other cases. Please press the home button on the display, go to Settings Update, and begin again.

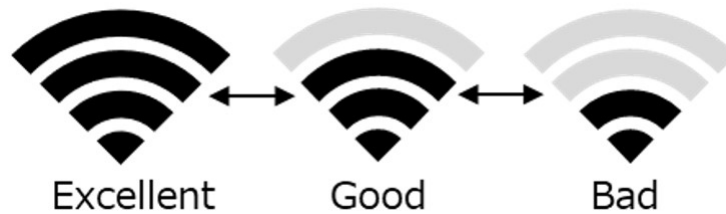
- 5. If the “progress bar” does not progress after selecting “Download” or, if you receive a “Connect to Wi-Fi” popup while downloading:

- a. Check your internet connection to ensure its active and shows full bars of connectivity.
- b. Try moving the vehicle closer to the Wi-Fi source. If that is not possible, try a different Wi-Fi connection such as a phone hotspot.

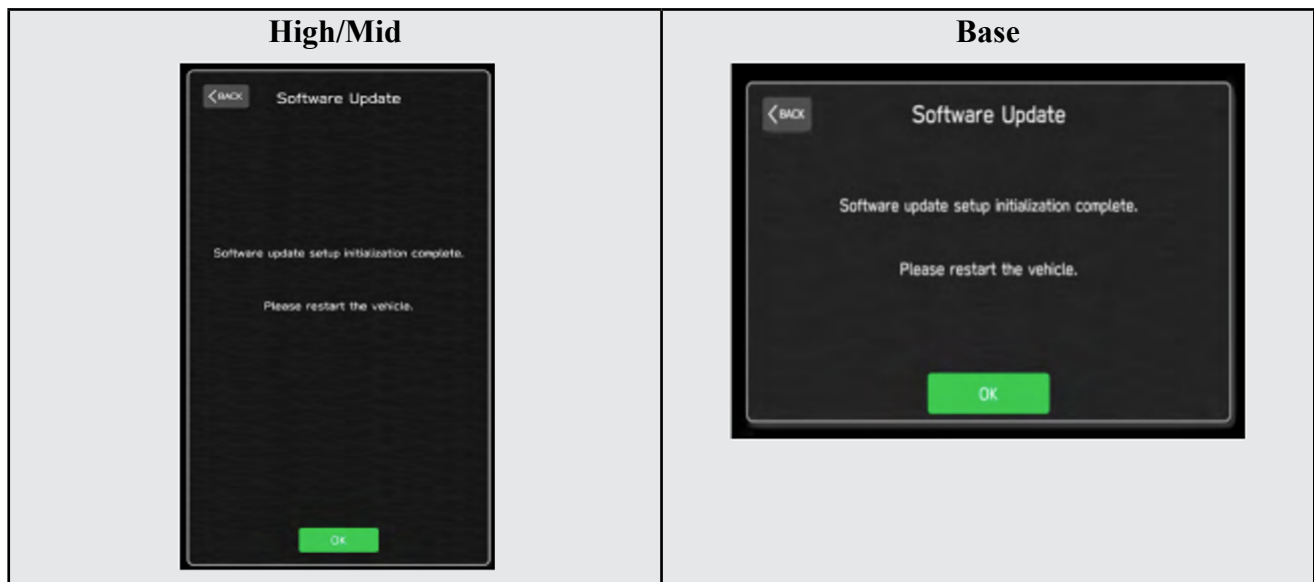
Follow this procedure in the RARE case of “Software update setup is initializing...” message is displayed: • If the screen shown below appears, WAIT for approximately 30 minutes or as long as necessary (waiting for longer than 60 minutes might indicate system malfunction).

The screens shown below will be displayed when the process completes.

1. Turn the ignition OFF, open the driver's door, close the driver's door and **WAIT** for 3 or more minutes before proceeding further.
2. Open the driver's door again and either turn the ignition ON (if a charger is connected) or start the engine.
3. Please proceed with USB Update following TSB 15-261-20.

IMPORTANT NOTE: If this procedure is required, contact Techline as additional action may be necessary
