## SERVICE BULLETIN

**APPLICABILITY:** 23-25MY Outback/Legacy Models (including Wilderness models)  
 23-25MY Ascent Models  
 24-26MY Impreza  
 24-26MY Crosstrek (including Wilderness models)  
 24-25MY WRX  
 25-26MY Forester

**NUMBER:** 15-305-22R  
**DATE:** 11/15/22  
**REVISED:** 10/16/25

**SUBJECT:** Reprogramming File Availability for Optimization of Gen 4.5 Denso CP1.5 Infotainment Systems

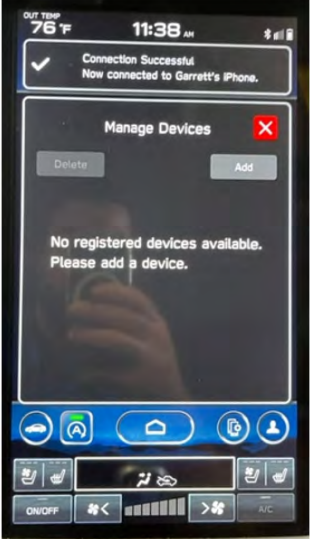
Number	Category	Symptoms to be Improved:
6	Display	<p>The registered mobile device information is not displayed on the Manage Devices screen.            (This occurs when the name or device ID of a mobile device contains a character code that cannot be displayed.)            (only applicable to HIGH and MID trim)</p>

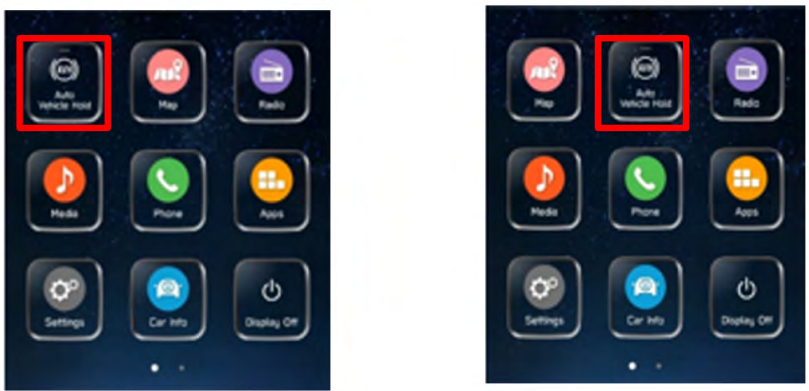
Number	Category	Symptoms to be Improved:
6	Display	<p>The AVH icons on the HOME screen are initially lined up next to the Valet-Mode icon. However, in some cases they are placed at the top (upper left corner of the first page) or next to the MAP icon. (only applicable to HIGH and MID trim)</p>

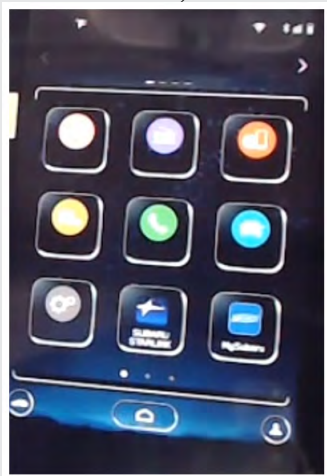
<p>After switching the clock function to AUTO, the CID screen display may become distorted. (only applicable to HIGH and MID trim)</p>

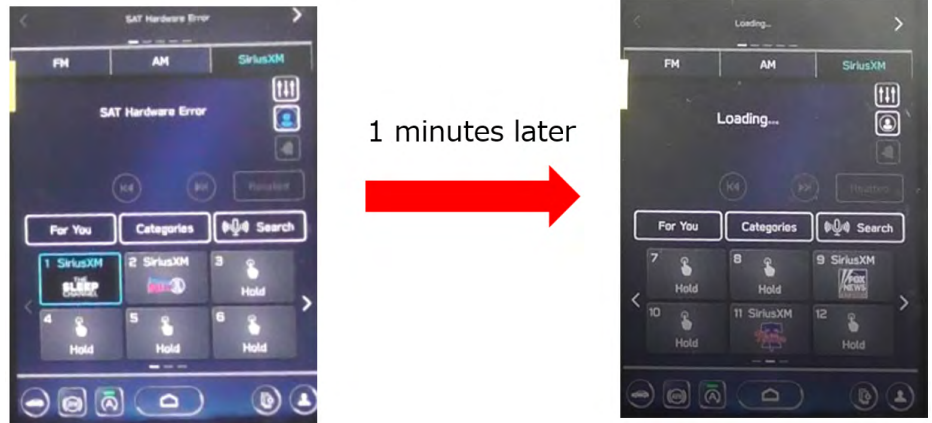
<p>It may take accessive time to start the CID screen after ignition on.</p>
7	SXM	<p>The first time ignition on after the CCU software update added the SXM360 functionality, the SXM playback screen may remain at “Loading...” after the CCU software update.</p>

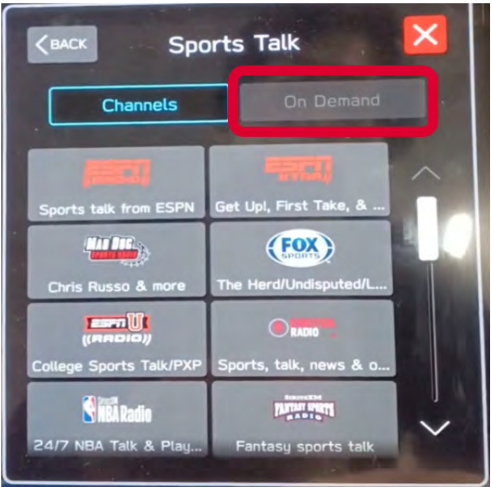
Number	Category	Symptoms to be Improved:
7	SXM	<p>In the SXM screen, the On Demand button in the upper right corner is grayed out and cannot be operated in the Sports→ Sports Talk screen. (only applicable to HIGH and MID trim)</p>

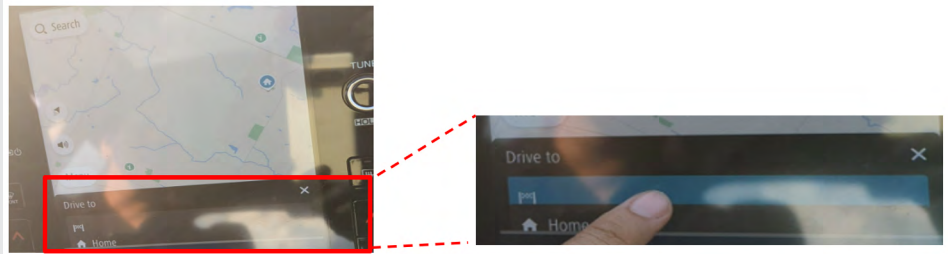
8	Navi	<p>After booting, the Map screen may not appear even if the Map icon on the Home screen is pressed. (only applicable to HIGH trim)</p> <p>Three destination suggestion displays in the navigation system are sometimes displayed overlapping each other. Originally, up to three destination suggestions are displayed at the bottom of the screen when the navigation system is started. (only applicable to HIGH trim)</p>

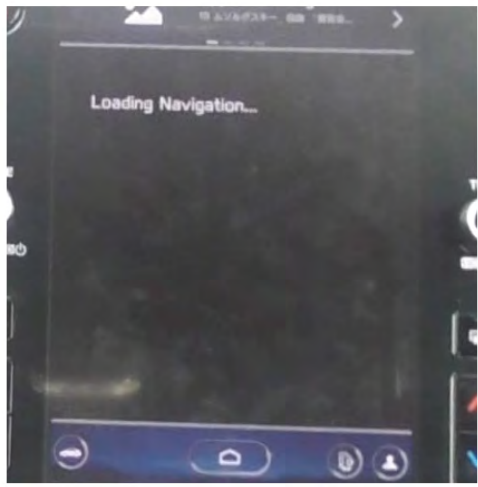
Number	Category	Symptoms to be Improved:
8	Navi	<p>When turning ignition off and on while the Map screen is displayed, the message ""Loading Navigation..."" may remain on the screen, and the Map screen may not be displayed. (only applicable to HIGH trim)</p>

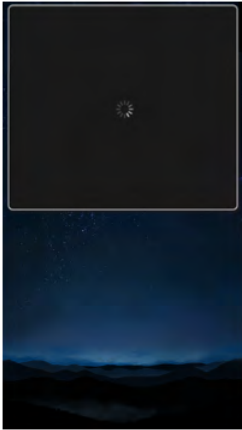
<p>After engine starts, only the black frame of the Caution screen display may remain on the CID screen. The rear view camera can be displayed by shifting to shift R.</p>

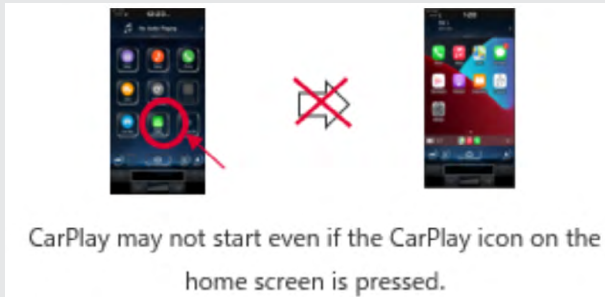
<ul style="list-style-type: none"> <li>- When starting the engine with the iPhone connected via USB, CarPlay may not start even if the CarPlay icon on the home screen is pressed. (This can be resolved by reinserting the USB cable.)</li> </ul> <div data-bbox="696 1482 1297 1776" style="text-align: center;">

<p>CarPlay may not start even if the CarPlay icon on the home screen is pressed.</p> </div>		
<ul style="list-style-type: none"> <li>- When WirelessCarPlay is disconnected due to radio interference, we have incorporated improvements to avoid radio interference and make it easier to reconnect (not applicable to BASE trim)</li> </ul>

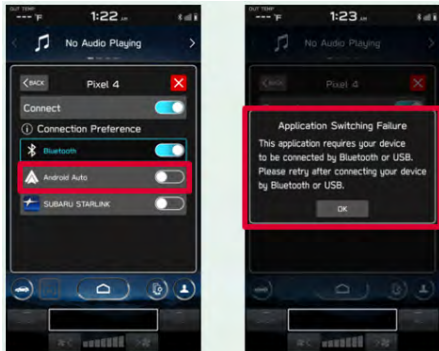
<p>- When you toggle on Android Auto from the Manage Device screen in CID while the Android device is not connected via USB, there may be a failure to start Wireless Android Auto (not applicable to BASE trim)</p>

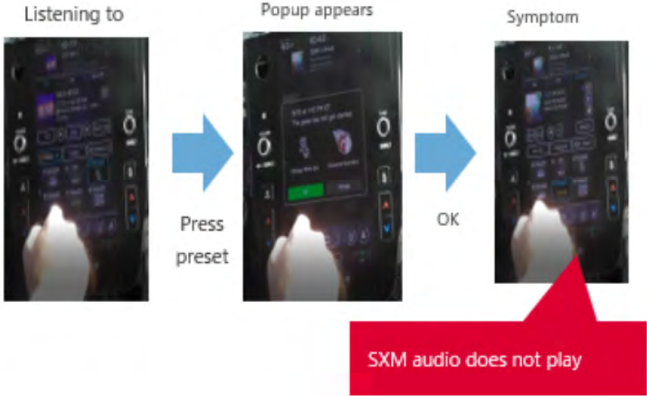
<p>- While listening to the radio (FM/AM) and attempting to select a sports team channel (SXM channel) from the presets, if the chosen team has a scheduled game on that day but it hasn't started yet a popup screen displaying the game schedule appears. However, after the popup screen appears, the system returns to the previously played channel, and the SXM audio does not play (not applicable to WRX).</p>

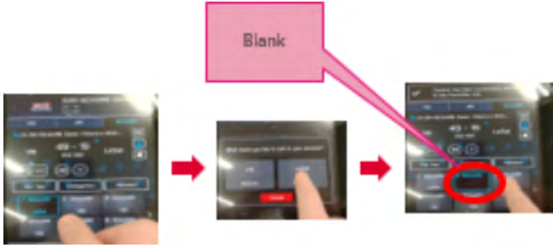
<p data-bbox="500 663 1497 814">- When registering SXM sports team channels to the radio preset buttons if a team for which logo image cannot be captured is registered, the channel short name will not be displayed on the registered button and the button will be blank (not applicable to BASE trim)</p>

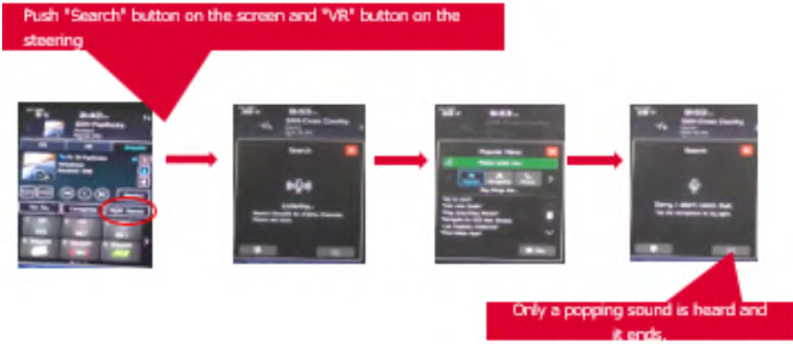
<p data-bbox="500 1430 1497 1541">- The voice recognition function encounters an error and ends, when initiating the SXM Search feature simultaneously with the activation of the CCU unit's voice recognition</p>

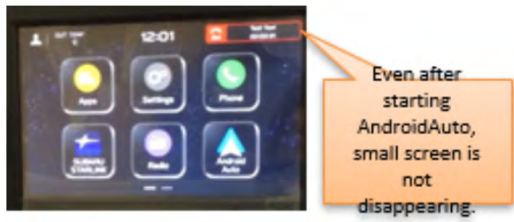
Number	Category	Symptoms to be Improved:
11	Display Appearance	<p>- The call screen reduction appears in the Status Bar while connected to Android Auto. Originally, when Android Auto is activated during a hands-free call, the call screen reduction should disappear (only applicable to BASE trim).</p>

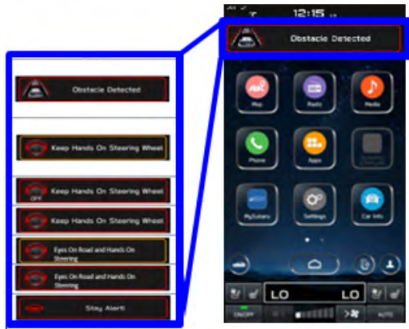
<p>- If the language setting of the CID is changed while an alarm message by the Driver Monitoring System(DMS) is displayed on the CID, the alarm will be hidden (not applicable to BASE trim)</p>

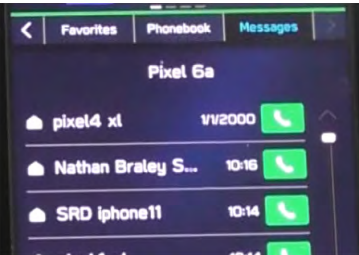
</div> </div> <p>- The date for the message is displayed as 1/1/2000 instead of the correct date. This occurs on some models of phones with Android OS 13 or later.</p> <div style="text-align: center;">

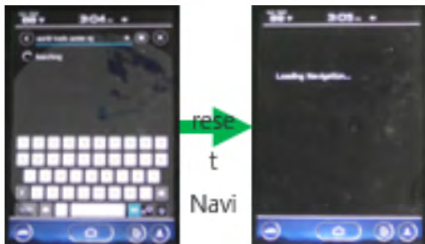
12	Touch Operation	<p>- Suddenly, the touch screen on the CID (Central Information Display) becomes unresponsive, even though the screen display remains normal. (not applicable to WRX)</p> <p>- CID doesn't respond to touch (The screen is displayed and sound is played, but only the operations are not available)</p>
13	Navi Operation	<p>- When repeatedly entering text on the destination search screen, the screen may freeze, and the navigation application restarts (only applicable to HIGH trim)</p> <div style="text-align: center;">

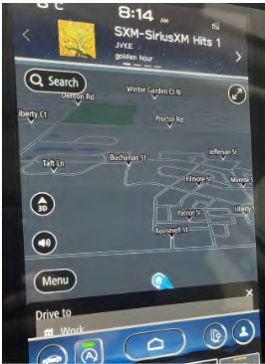
<p>- In the navigation screen, the bottom of the destination suggestion list's popup screen is cut off and not fully displayed (only applicable to HIGH trim)</p>

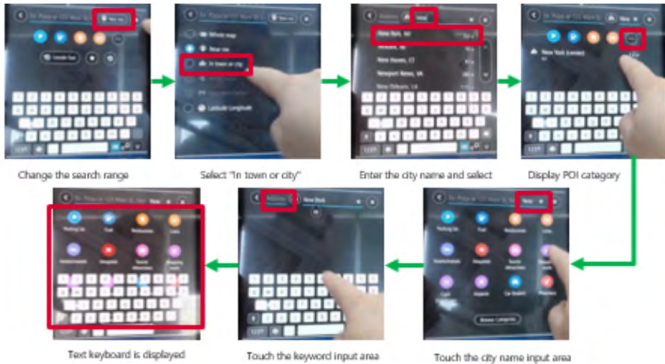
</div> <p>- Even when pressing the Map icon the map does not appear and it remains stuck on the 'Loading Navigation' message. This issue occurs due to a corrupted file that stores settings and destination history (only applicable to HIGH trim).</p> <p>- The text keyboard which should not be displayed appears on top of the list of POI categories (only applicable to HIGH trim) when performing the steps below:</p> <ol style="list-style-type: none"> <li>Narrowing down the search range within a specific city in the navigation destination search.</li> <li>Move to the POI category screen.</li> <li>Touch the city name input area, then the keyword input area, in that order.</li> </ol> <div data-bbox="667 1104 1328 1465" style="text-align: center;">

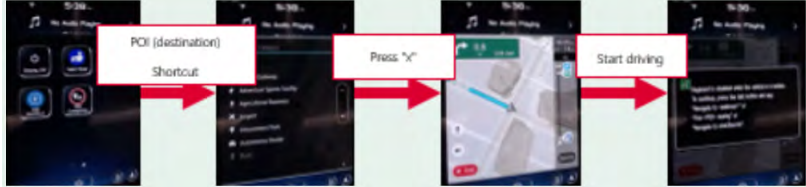
Number	Category	Symptoms to be Improved:
13	Navi Operation	<p>- "Keyboard is disable while the vehile is in motion"" is displayed on the screen when performing the steps below (only applicable to HIGH trim) :</p> <ol style="list-style-type: none"> <li>1. Press the POI (destination) Shortcut on the home screen to display the list of destinations.</li> <li>2. Press "x" to clear the list.</li> <li>3. Start driving with the Map screen displayed.</li> </ol>

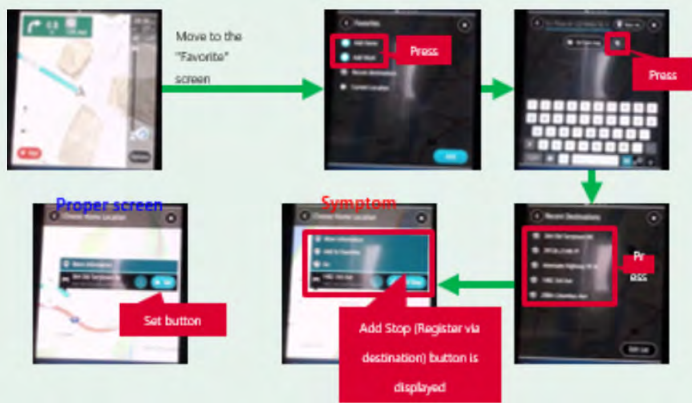
<p>- Add Stop (Register via destination) button is displayed instead of Set button and Favorite registration for Home/Work cannot be done after performing the steps below moving to the ""Favorite"" screen with the navigation destination set (only applicable to HIGH trim) :</p> <ol style="list-style-type: none"> <li>1. Press Add Home/Work</li> <li>2. Select a location from the Destination History screen</li> </ol>

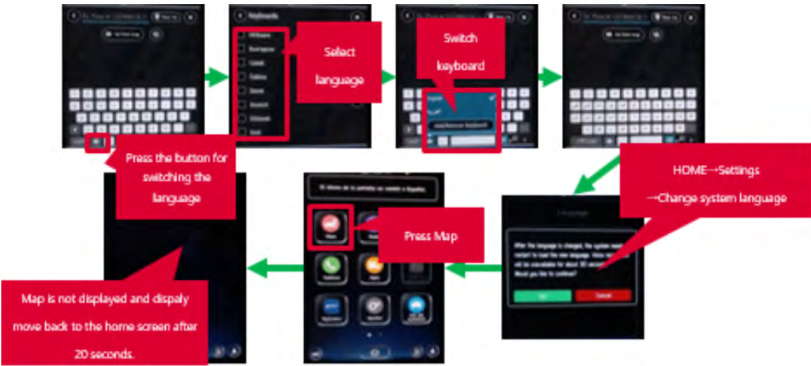
<p>- Map is not displayed when Map is pressed from the home screen if switching the language used for the text input keyboard on the search screen of the navigation application (only applicable to HIGH trim)</p>

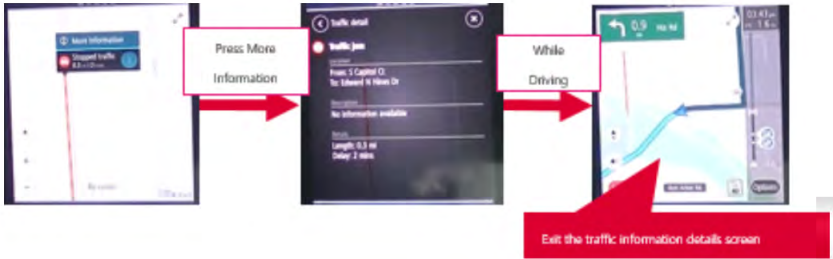
</div> </div> <p>- When using voice recognition to search for a destination based on a Point of Interest (POI) category name (such as "gas station"), the search results may display facilities that have names partially matching the POI category name in addition to the facilities within that specific category (only applicable to HIGH trim)</p> <p>- While parked or driving, touch the traffic information icon on the map or the traffic information icon on the route bar and display the traffic information details screen. If you start driving with this screen displayed, it will exit the traffic information details screen and transitions back to the map screen (only applicable to HIGH trim)</p> <div style="text-align: center;">

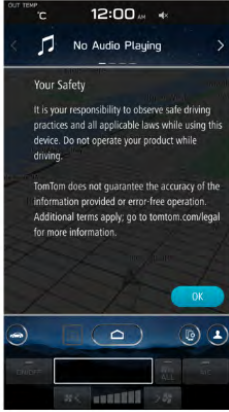
Number	Category	Symptoms to be Improved:
13	<b>Navi Operation</b>	<p>- The requirement to press ""OK"" on the Your Safety screen during the initial navigation launch sometimes wasn't displayed (only applicable to HIGH trim).</p> <p>Before the change: If the navigation app was launched for the first time from any icon other than the Map icon on the Home screen (e.g., through a rest suggestion feature) the Your Safety screen would not appear and navigation functionality could not be initiated.</p> <p>After the change: Even if the navigation app is launched for the first time from an icon other than the Map icon on the Home screen, the Your Safety screen will be displayed.</p>

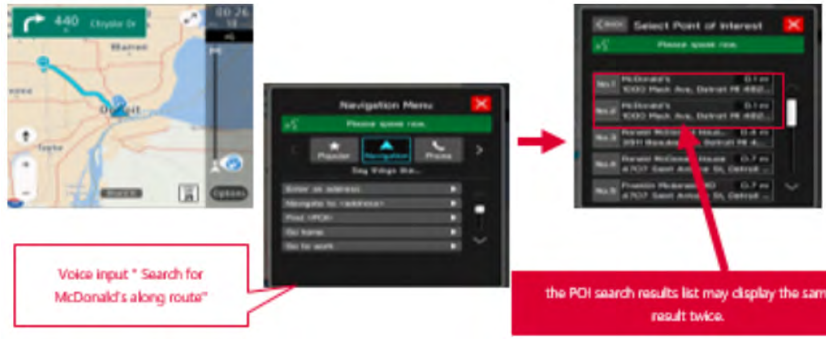
Number	Category	Symptoms to be Improved:
13	Navi Operation	<p>- When using voice recognition during navigation to say 'Search for **** along route,' the POI search results list may display the same result twice (only applicable to HIGH trim)</p>

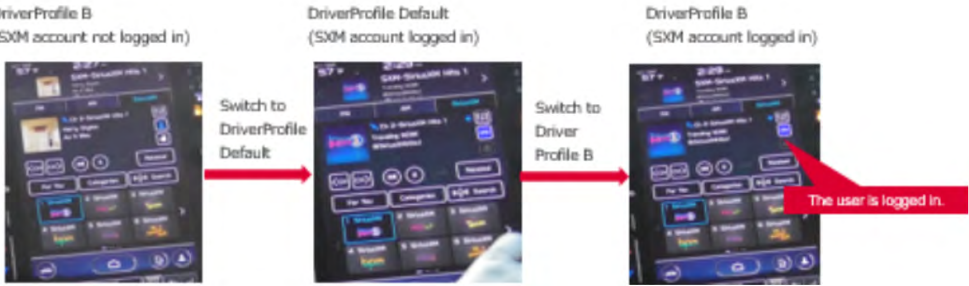
<ul style="list-style-type: none"> <li>- Switching the Driver Profile user causes the user to be logged into SXM even though he/she was not logged into the SXM account as the user after the switch</li> </ul>

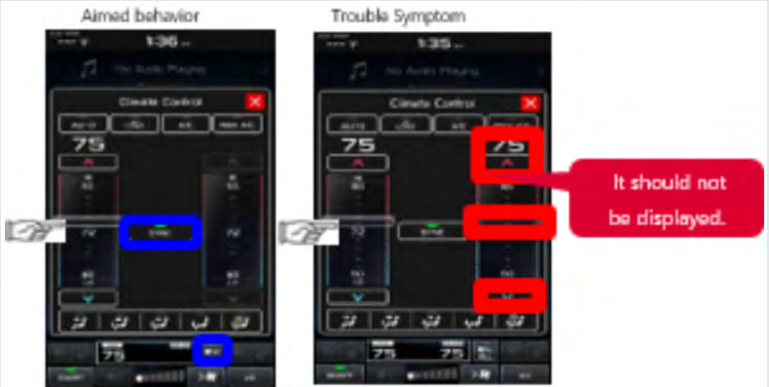
<p>- In the maintenance schedule settings screen despite setting a date the configured date is not displayed and is replaced with hyphens (not applicable to WRX)</p>
24	Air Conditioner	<p>- With the air conditioning SYNC enabled and the single-seat focus set to the driver's seat tapping the temperature adjustment bar on the driver's side unexpectedly displays the temperature adjustment bar for the passenger's side, which should not be displayed (only applicable to BASE trim)</p>

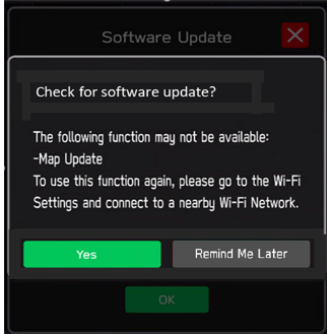
Number	Category	Symptoms to be Improved:
26	Software Update	<p>- To use FOTA (Firmware update Over The Air) for CCU software update via DCM (Data Communication Module) it is necessary to switch from the Wi-Fi communication settings for MapUpdate to the DCM communication settings. To notify the customer about this switching, the below message screen pops up a new CCU software becomes available from the server. (not applicable to BASE trim)</p>

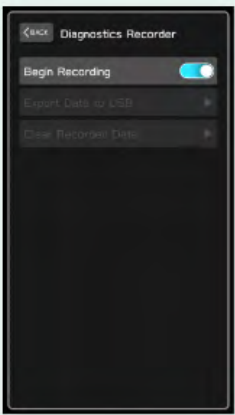
10	<p>Update against vulnerability in security of Bluetooth connection.</p>
11	<p>When getting CCU USB logs at the Diagnostics Recorder screen in the Dealership Mode, it was necessary to turn off "Begin Recording" to "Export Data to USB." And after the log acquisition, it was necessary to turn "Begin Recording" ON again. The system interface is improved so that "Begin Recording" is automatically switched ON after log acquisition has been accomplished.</p> <div data-bbox="786 1522 1019 1934" style="text-align: center;">

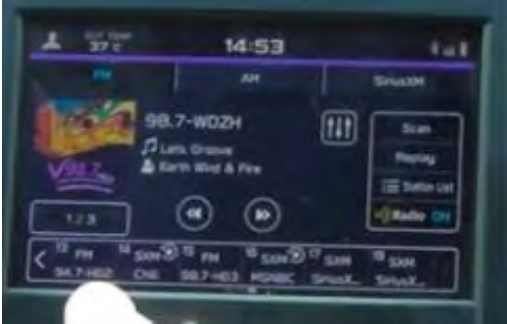
Number	Symptoms to be Improved:
8	Android Auto Wireless (AAW) cannot be connected.
9	Android Auto Wireless (AAW) cannot be started from “Manage Devices” Screen.
10	Sound volume control does not work while using Android Auto. It is caused by data communication error between Android device and CCU.
11	Cyclic short noise like a drilling or vibration is heard from speakers.
12	<p>Sound is lost when changed to Subchannel 2 right after a preset HD radio channel has been selected.</p>

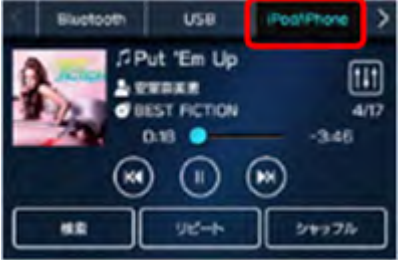
Number	Symptoms to be Improved:
1	<p>iPod/iPhone tab in Media screen cannot be selected, when connected by USB.</p> <p>The symptom occurs when the iPhone is connected to CP1.5 via Bluetooth in parallel to USB connection by error. (It is supposed to be connected either via Bluetooth or by USB.)</p>

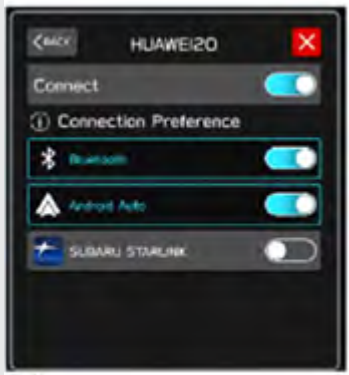
2	<p>On the “Manage Devices” screen Bluetooth cannot be selected as connection preference.</p>

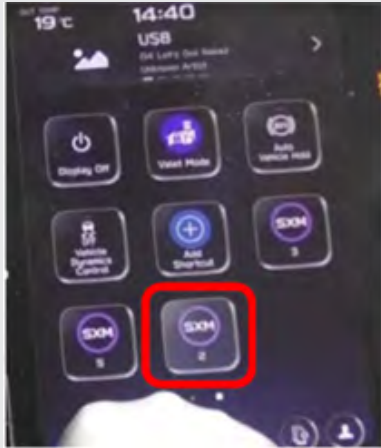
Number	Symptoms to be Improved:
6	<p>SXM station shortcut created by the customer does not work when the SXM has not been used as audio source after the Ignition Switch was turned on in the ignition cycle.</p>

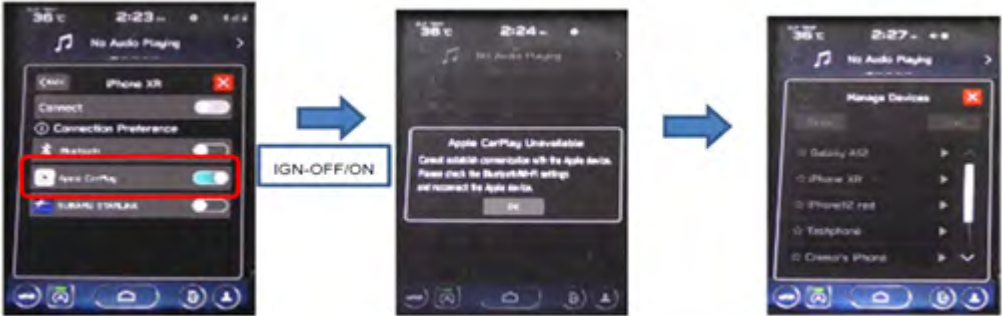
7	<p>Manage Device Screen becomes dark and inoperative when Ignition Switch is turned Off and On while starting CarPlay by CID operation.</p>

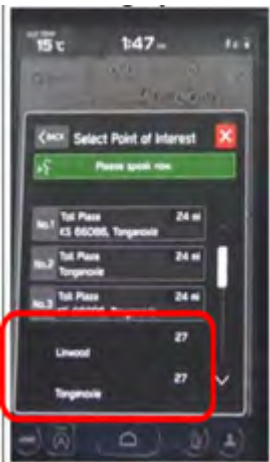
8	<p>Cannot connect to CarPlay via wireless connection. This symptom possibly occurs after the Ignition Switch was turned Off and On abruptly.</p>
9	<p>POI Search Result shows only city names and distances (without unit) when voice recognition POI search with Category name like “Find toll gate” is used.</p>

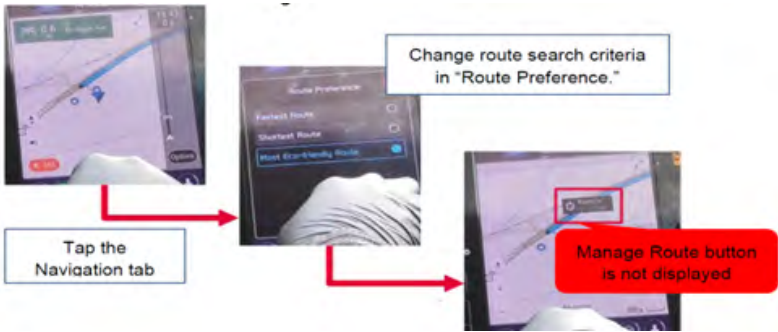
Number	Symptoms to be Improved:
10	Navigation restarts itself, when the letters are rashly entered or deleted using keyboard function to search destination.
11	<p>“Manage Route” button is not displayed when touching the route line on Navigation system, when the route search criteria got changed in the Route Preference Screen after a route had been searched.</p>

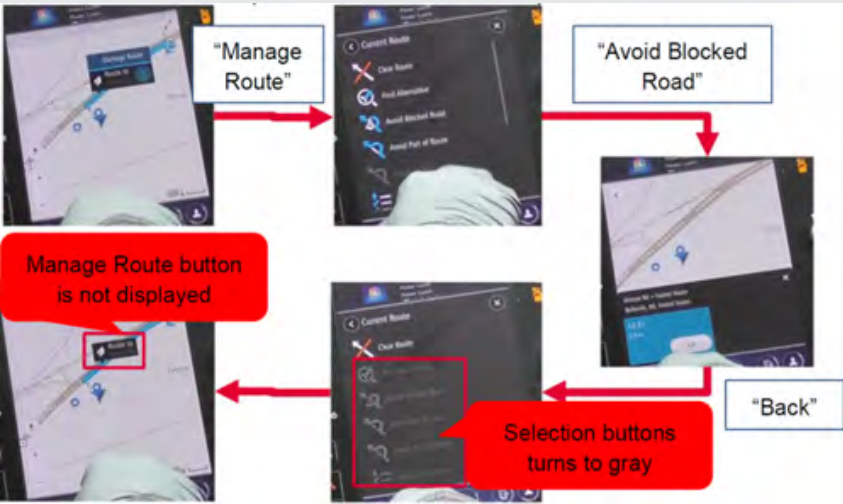
12	<p>“Manage Route” button is not displayed and buttons on the Current Route Screen become unselectable (turns to grayish fill) when the Navigation system is operated in the sequence of “Manage Route” &gt; “Avoid Blocked Road” (in the Current Route Screen) &gt; “Back.”</p>

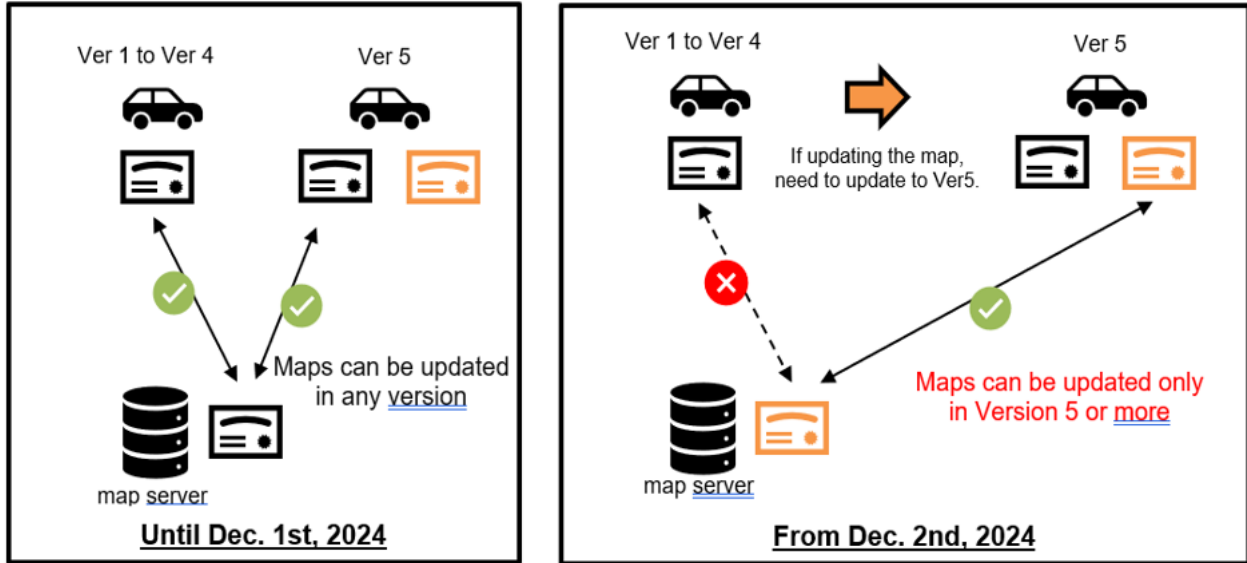
**IMPORTANT NOTE:** The certificate of the data distribution server for the map update service by Map OTA (MOTA) will be changed **from Dec 1<sup>st</sup>, 2024**, and the previous server certificate will no longer be eligible after **2<sup>nd</sup> December, 2024**. To get the MOTA service on and **after Dec 2<sup>nd</sup>, 2024, Ver. 5 software that includes new server certificate should be installed in advance.**
