Technical Service Bulletin

| Subject: REAR SUBWOOFER AUDIO SOUND PAUSES AT HIGH VOLUME LEVEL (Bose® AUDIO ONLY) | Bulletin No.: 09-040/25 |
| | Last Issued : 10/23/2025 |

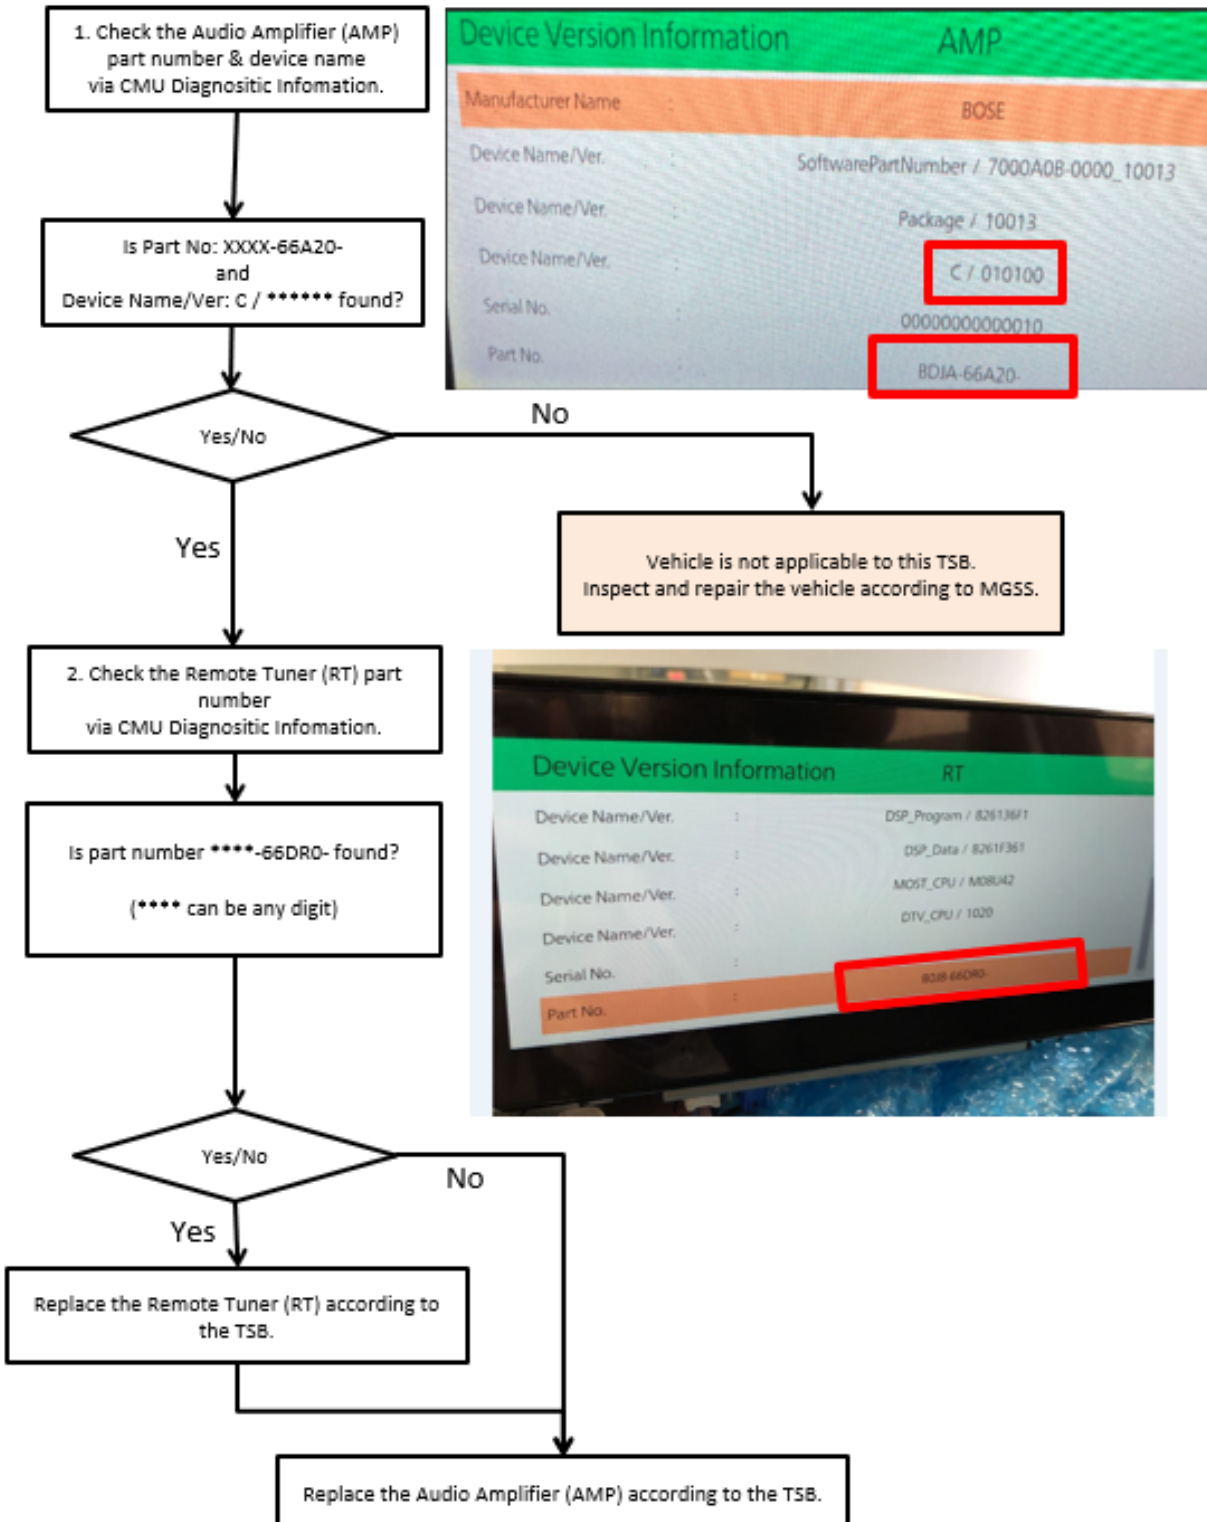
Applicable vehicles will require Audio Amplifier (AMP) replacement. Some vehicles will require Audio Amplifier (AMP) AND Remote Tuner (RT) replacement. Review the repair summary below to determine the repair requirements for the subject vehicle.

1. Verify customer concern.
 2. Confirm the audio amplifier (AMP) part number following steps a-f below.
 - a. Turn ignition ON (or ACC) with the push button start.
 - b. Press and hold the Volume Mute, Music and Favorite buttons at the same time and hold them all for 3-5 seconds.
- The "Factory/Service Inspection" screen will appear.
