Technical Service Bulletin

Topic	35 Gearbox Malfunction Warning, DTC P0C2900 in the TCM
Market area	United States 444 Volkswagen of America, Inc. (6444)
Brand	Audi
Transaction No.	2050723/8
Level	EH
Status	Released for publishing
Release date	Oct 17, 2025

A3 USA MY17-18 with DQ381, PR Code 0IJ

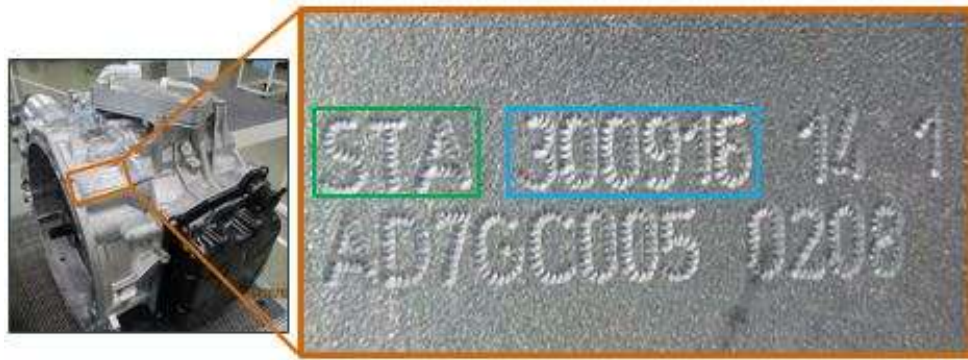
Figure 2. Transmission identification example.

Explanation of data on gearbox:

Gearbox code: STA (green box)

Gearbox Production Date: 300916 = 30.09.2016 (blue box). Date format: Day/Month/Year.

- If the gearbox production date is after 26.09.2017, this TSB does not apply. Proceed according to Guided Fault Finding. Please note that in this case, the costs for the repair cannot be billed under this TSB.
- If the gearbox production date is on or before 26.09.2017, continue as described below.
