## Technical Service Bulletin

<b>Topic</b>	60 A6 Avant: water under front trim
<b>Market area</b>	United States 444 Volkswagen of America, Inc. (6444)
<b>Brand</b>	Audi
<b>Transaction No.</b>	2069594/2
<b>Level</b>	EH
<b>Status</b>	Released for publishing
<b>Release date</b>	Oct 17, 2025

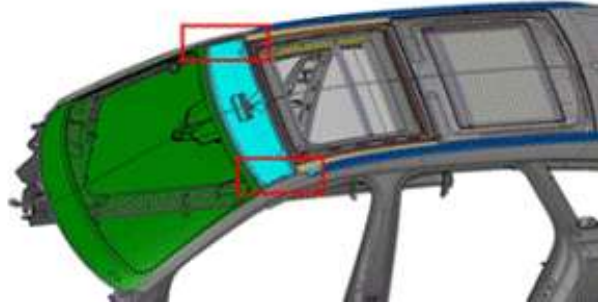
1. Figure 1 shows the area of the vehicle described.

**Figure 1.** Area of roof described.

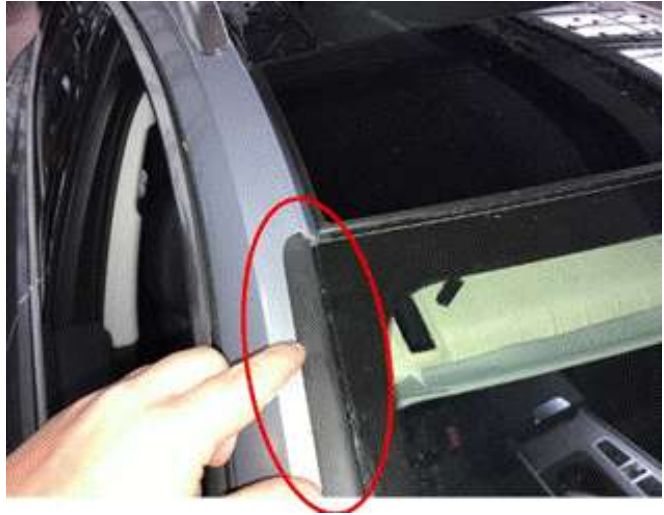
**Figure 5.** Water deflector.

Remove the water deflector on the windscreen. Refer to the instructions in the Workshop Manual if necessary. (Figures 5, 6 and 7).

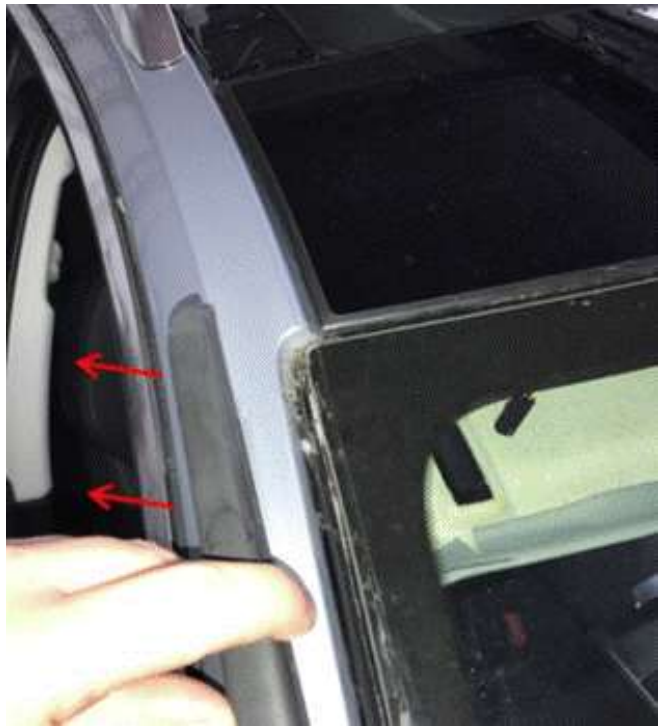
**Figure 6.** Water deflector removed.

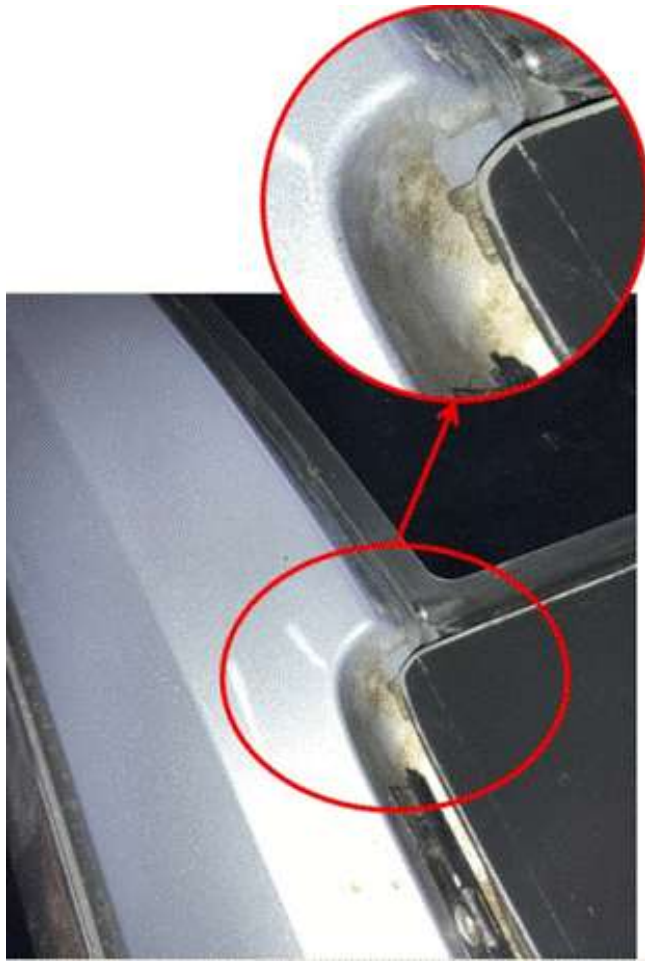
**Figure 9.** *Dirt removed.*

6. Now take a pneumatic gun and loosen the dirt. **The pneumatic gun must also be held pointed upwards so that the dirt under the front trim is also loosened.** (Figures 8 and 9).

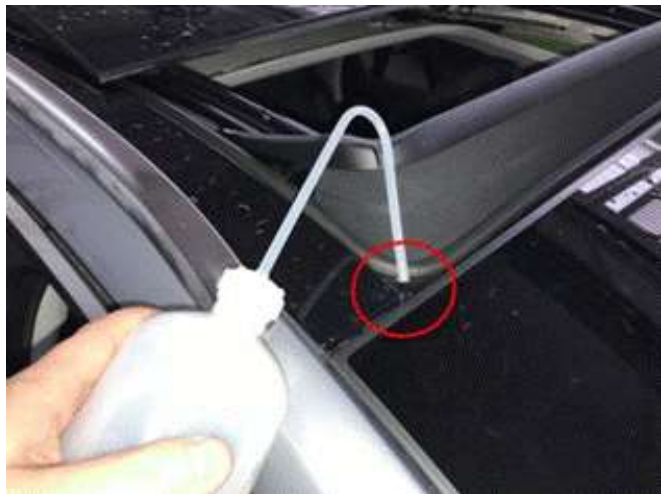
**Figure 10.** *Rinsing the drainage channels.*

7. The sunroof frame area must then be cleaned thoroughly from above with water and detergent. (Figures 10, 11 and 12).

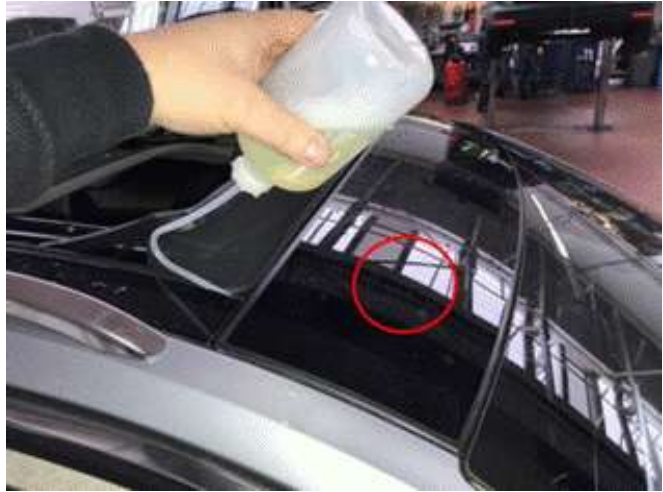
**Figure 11.** Rinsing the drainage channels.

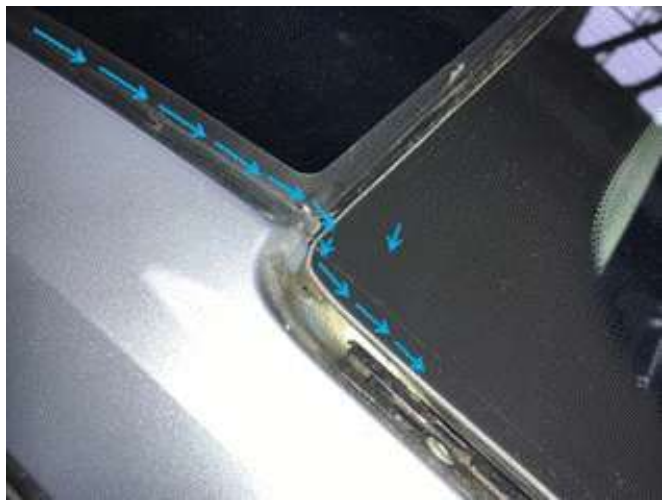
**Figure 12.** Drainage channels rinsed.

8. If necessary, repeat the cleaning procedure multiple times until no more dirt particles are visible.

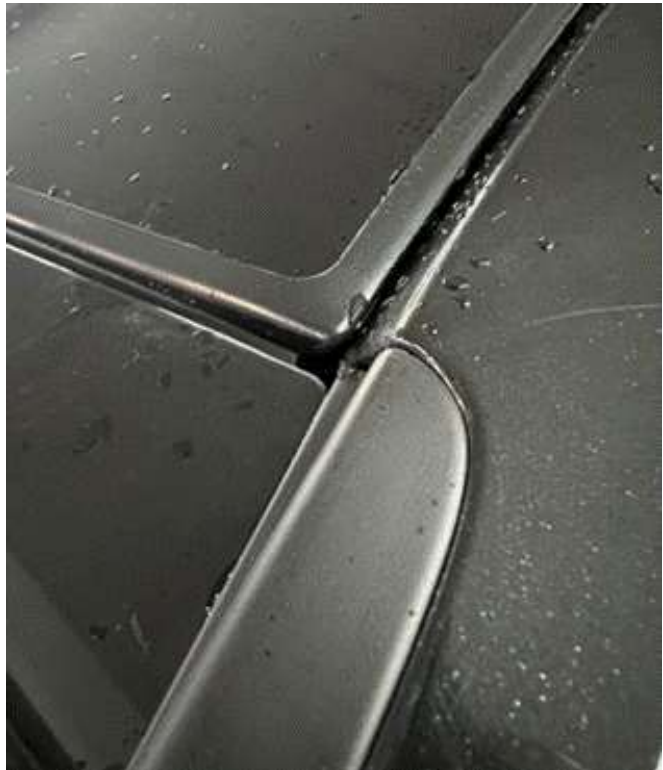
Figure 15. Water deflector reinstalled.

10. Finally, fit the water deflector on the A-pillar again. (Figure 15).
