Technical Service Bulletin

Transaction No.: 2079645/1

01-25-06 - Misfire Due To Excess Intake Flashing

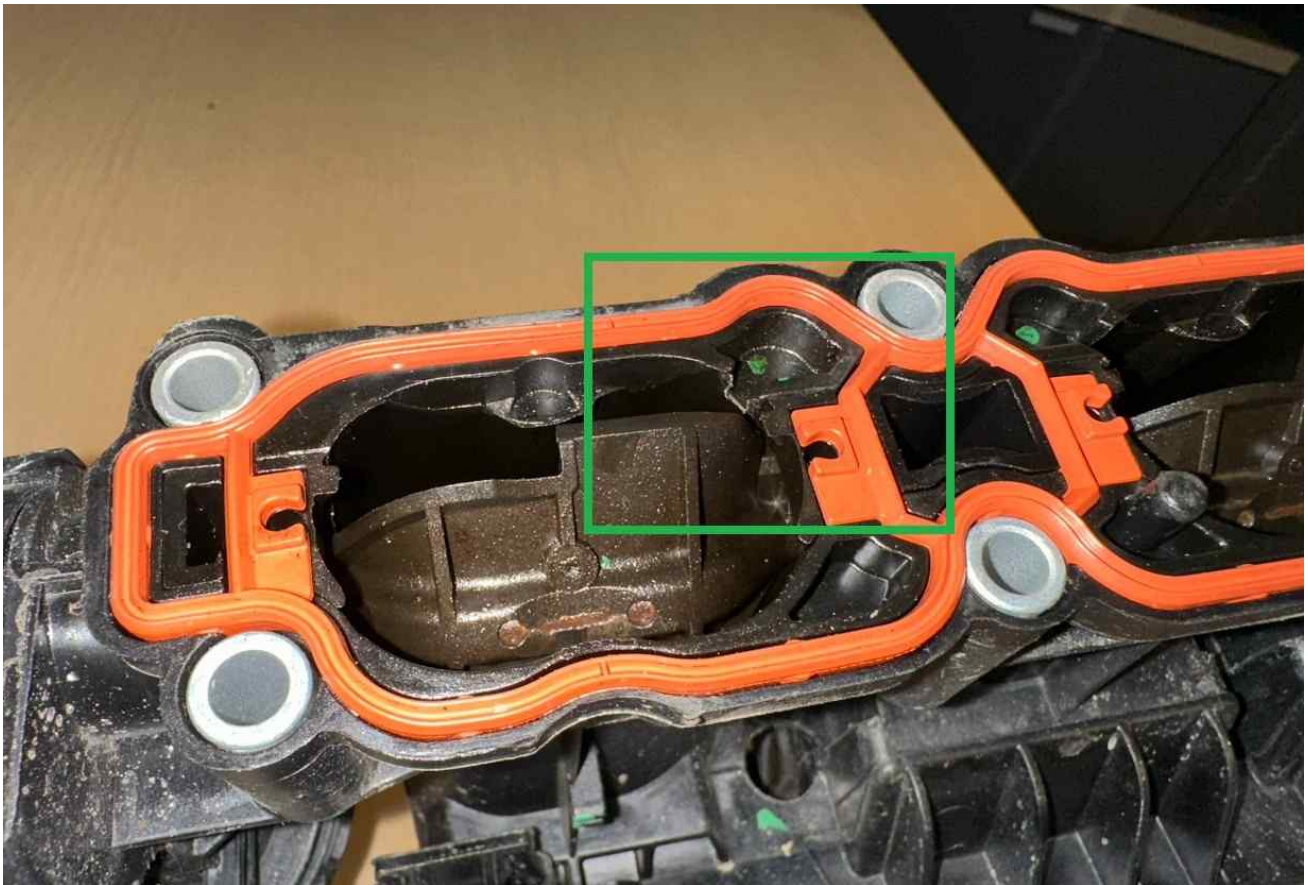
Figure 5:

Using a piece of white paper to set the removed flashing on is an easy way to keep track of the removed material.

To prevent possible engine damage, ensure that none of the removed flashing falls into the intake manifold runners!
