# Service Bulletin

Bulletin No.: PIC6628A

**Subject: Windshield to Dash Valence Foam Seal Mis-positioned**

Brand:	Model:	Model Year:		VIN:		Engine:	Transmission:
		from	to	from	to		
Cadillac	OPTIQ	2025 - 2026		All	All	All	All

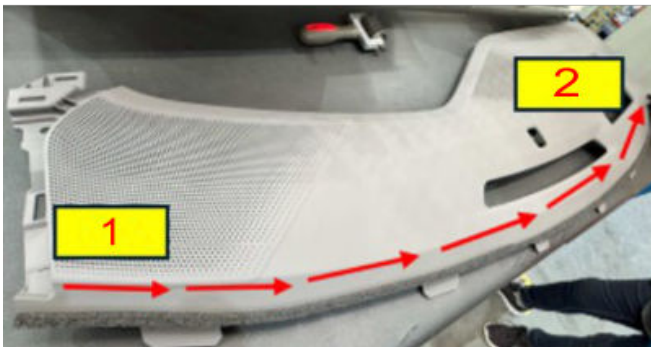
7012507

2.3 Use caution! Any more abrasive or harsh chemicals will remove the paint on this painted part!! Be very careful not to damage the paint in view of the customer, see image below.

2. Remove the foam seal and clean adhesive from surface.

2.1 Apply isopropyl alcohol (90% or better) to surface that will be cleaned.

2.2 Use shop cloth to scrub surface until no adhesive residue is observed.

2.4 A heat gun could be used (on a low setting) if the adhesive is not removing easily with alcohol alone. Again, use caution not to overheat / damage the part.

2.5 Wipe surface dry to remove debris.
