Vehicle does not start due to interlock failure

Topic number	LI54.10-P-080004
Version	1
Function group	54.10 - Battery, power supply, voltage converter
Date	11/11/25
Validity	243 with SA codes BAD or BAE
Reason for change

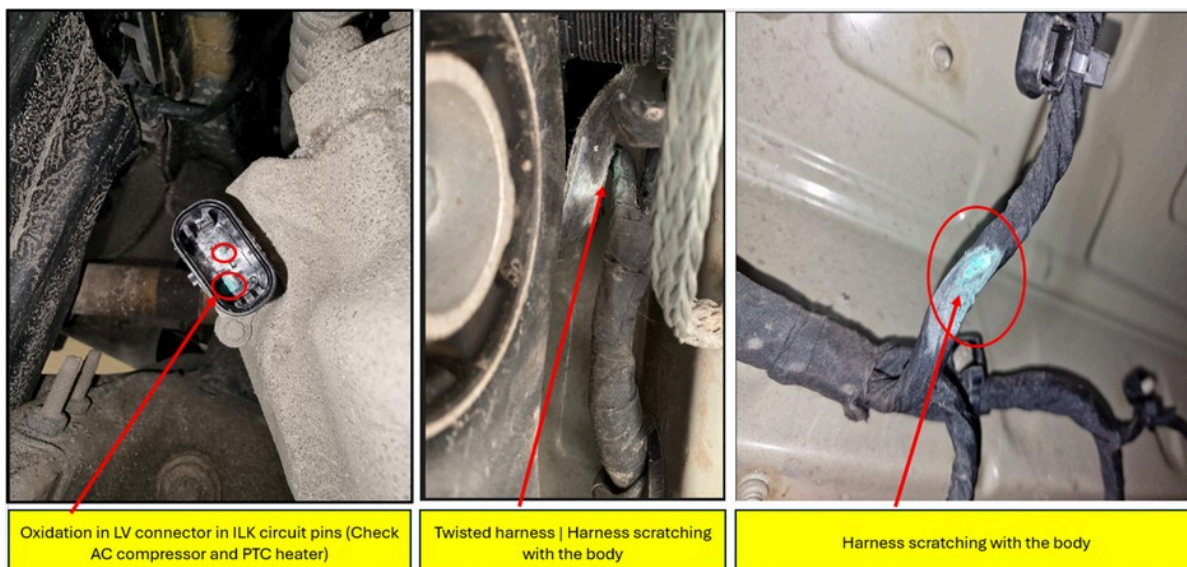
Additional check points for interlock issues

- Oxidation in interlock circuit pins of the low voltage connectors in the components
- Twisted harness
- Harness scratching with the body
- Wiring harness chafed/cut at the ECUs
- Broken interlock connector
- Improperly connected HV connectors
- Interlock pins on HV components are bent or deformed

Remedy 2:
