# Keystone RV Company

## SERVICE ADVISORY # 25-473

### Sun Deck Balcony Hardware

# ADDING SPRING ASSIST/REPLACING HARD STOP LINKAGE ARMS ON THE SUN DECK BALCONY

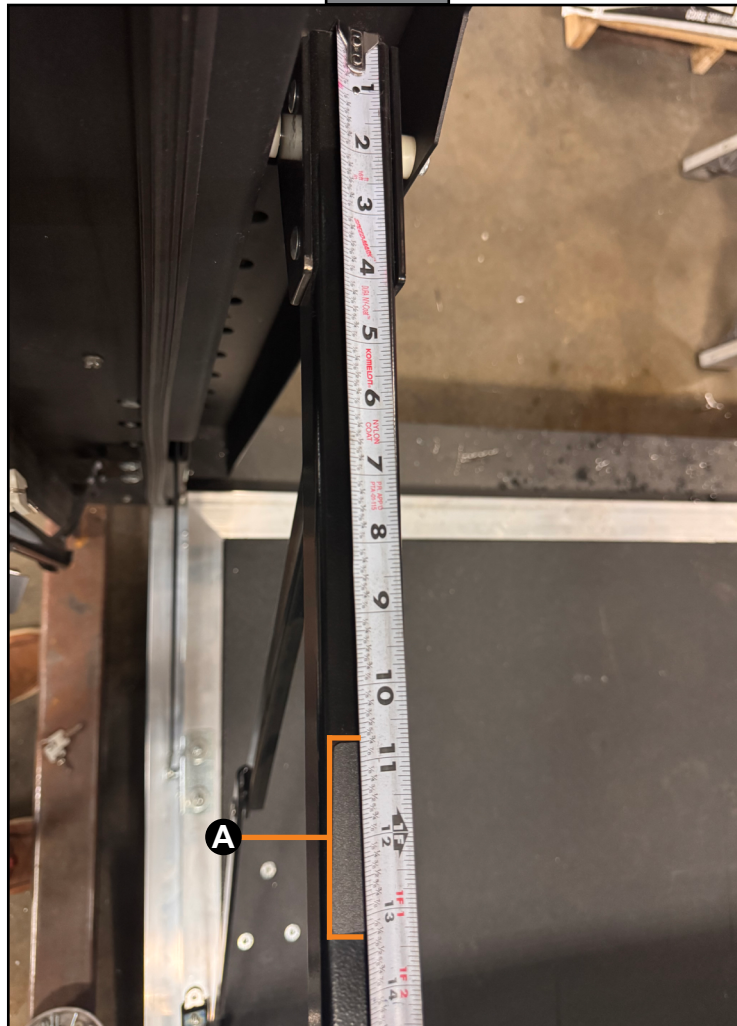
Fig. 11

**Spring assist must be added to both sides of the balcony jamb to be effective. Failure to install spring assist on each side of the jamb may result in the twisting of the balcony deck and/or glass panel, and will not allow the spring assist to function as intended.**

7. Repeat this procedure on the other side of the balcony to install the other spring assembly and cover sticker
