# Service Bulletin

Bulletin No.: 22-NA-007

**Subject: Poor Engine Performance in Extremely Cold Weather Conditions for LE2 Engines, Charge Air Cooler (CAC) Icing - Malfunction Indicator Lamp (MIL) Illuminated, DTC P0299, P0234, P0236, P2227, and/or P00C7 Set**

Brand:	Model:	Model Year:		VIN:		Engine:	Transmission:
		from	to	from	to		
Chevrolet	Cruze	2016	2019	—	—	1.4L Turbo (LE2)	—

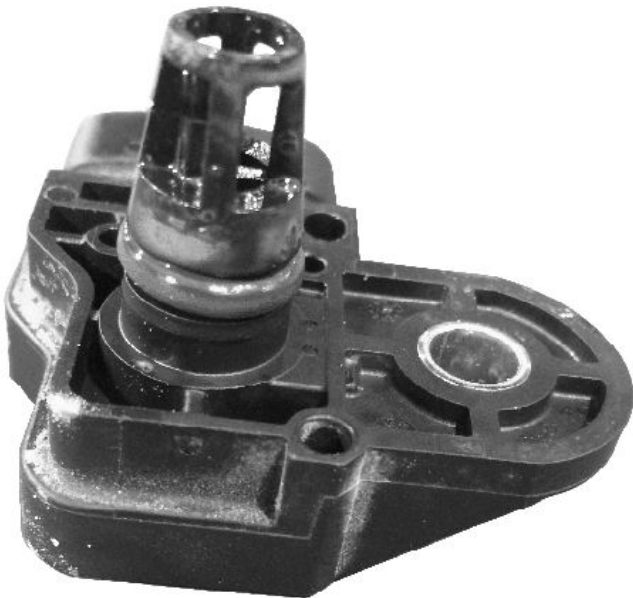
4910683

1. Remove the turbocharger air pressure sensor (3). Refer to *Turbocharger/Supercharger Boost Pressure Sensor Replacement* in SI.

**Important:** Due to the sensitivity of the sensor, **Do Not** use any chemical cleaners including water and **Do Not** use compressed air to remove contaminants.

2. Inspect the sensor for any contaminants.

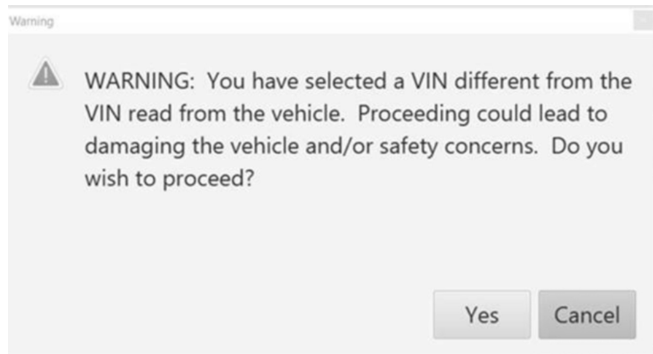
5877000

**Important:** If the vehicle VIN DOES NOT match, the message below will be shown.

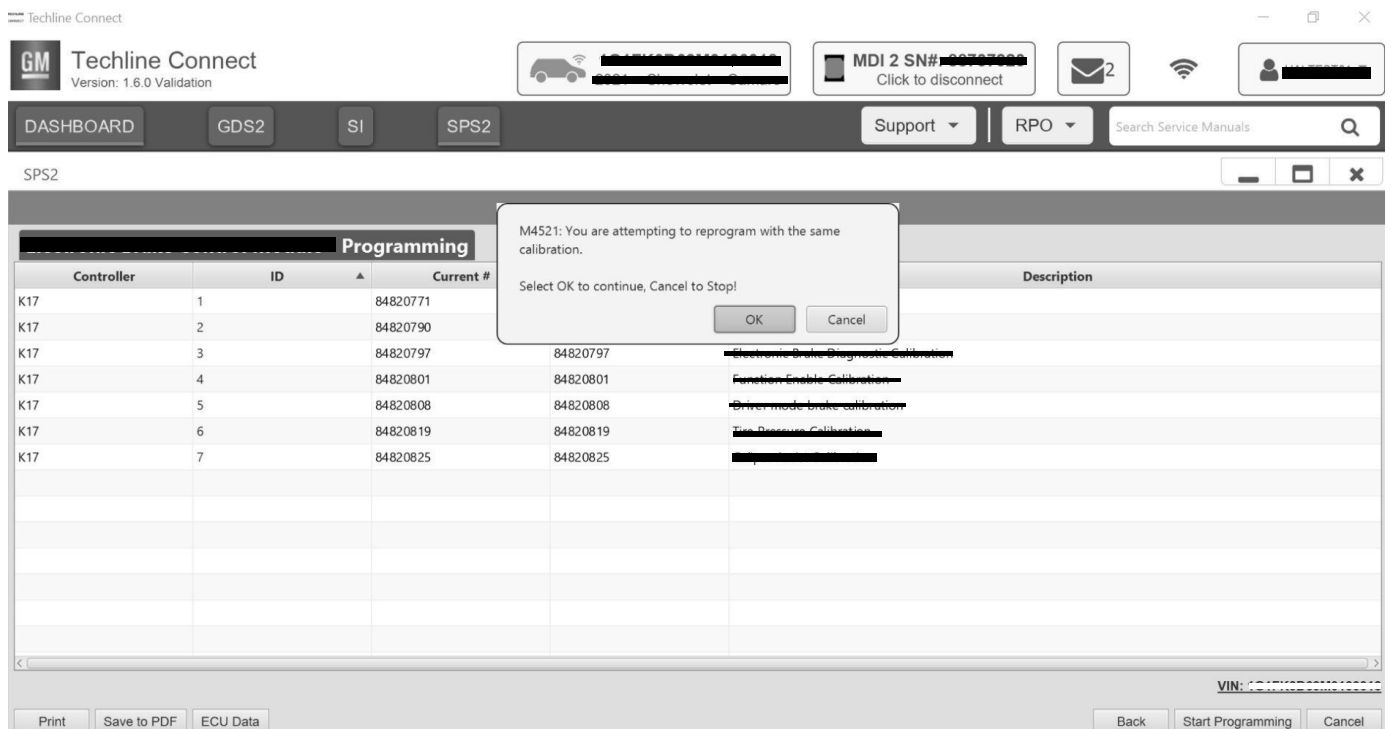
5644477

**Important:** Techline Connect screen shown above.

**Important:** If the same calibration/software warning is noted on the TLC or SPS Summary screen, select OK and follow screen instructions. After a successful programming event, the Warranty Claim Code (WCC) is located in the Service Programming System dialogue box of the SPS Summary screen. Document the WCC on the job card. No further action is required. Refer to the Warranty Information section of the bulletin.
