Service Bulletin

Bulletin No.: 24-NA-227

Subject: Vibration Rattle or Boom at 1800 to 2000 RPM

Brand:	Model:	Model Year:		VIN:		Engine:	Transmission:
		from	to	from	to		
Chevrolet	Equinox	2025	2026	—	—	—	—
GMC	Terrain	2025	2026	—	—	—	—

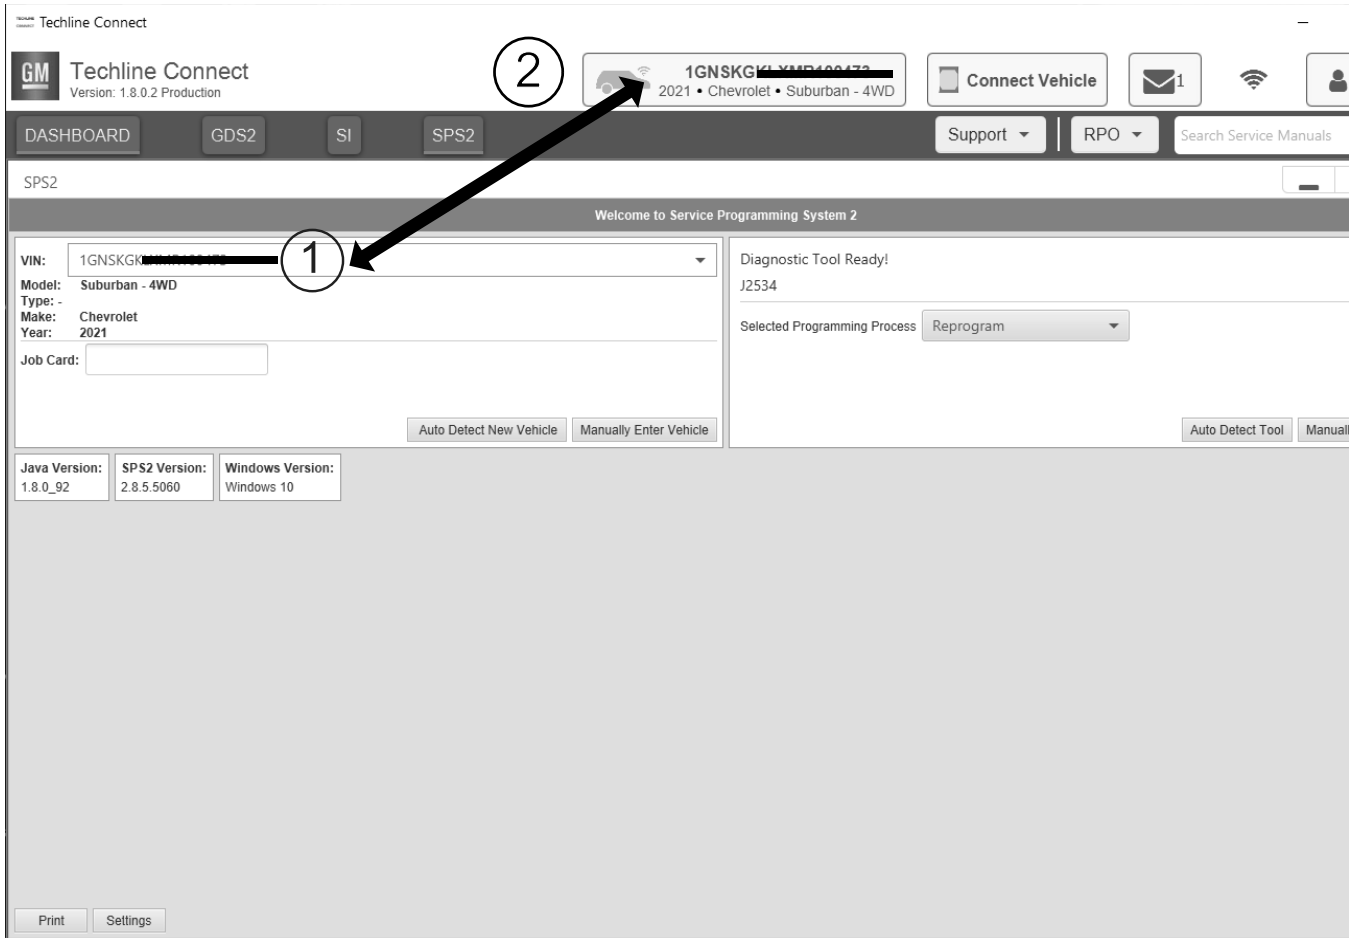
5743643

Caution: Be sure the VIN selected in the drop-down menu (1) is the same as the vehicle connected (2) before beginning programming.
