GROUP	MODEL
ENG	2021-2024MY K5 (DL3a) w/Theta III 2.5L T-GDI
NUMBER	DATE
260	November 2025

## TECHNICAL SERVICE BULLETIN

### ITM REPLACEMENT AND ECM LOGIC IMPROVEMENT (CA2511)

This bulletin provides information to replace the Integrated Thermal Management Module (ITM) and then upgrade the Engine Control Module 'ECM' system software on certain K5 (DL3a) vehicles, in the event the Multifunction Indicator Lamp (MIL) is illuminated with DTC(s) P218100, P2181F0, and/or P2181F1 stored. This condition may occur due to degradation of the diaphragm inside the ITM. There are no drivability or other symptoms associated with this condition. Follow the procedure outlined in this publication to replace the ITM and upgrade the ECM software in 'Manual Mode' only. Refer to [SST081](#) for software upgrade instructions using Kia Diagnostic System (KDS) tablet and VCI-II and confirm the Upgrade Event Number/Name, ROM ID Information, and Manual Mode passwords on the applicable vehicle.

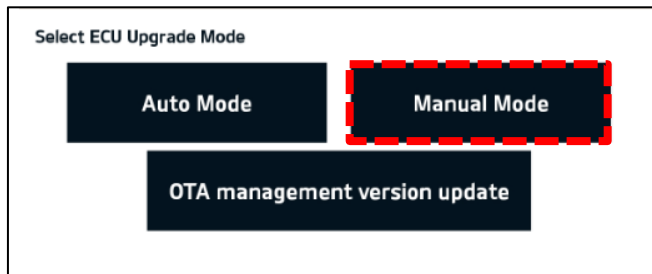
The ECU and TCM **MUST** be programmed in **Manual Mode ONLY** using the KDS 2.0 download as described in this bulletin.

The required software must be installed by selecting the **'Manual Mode'** ECU Upgrade option.

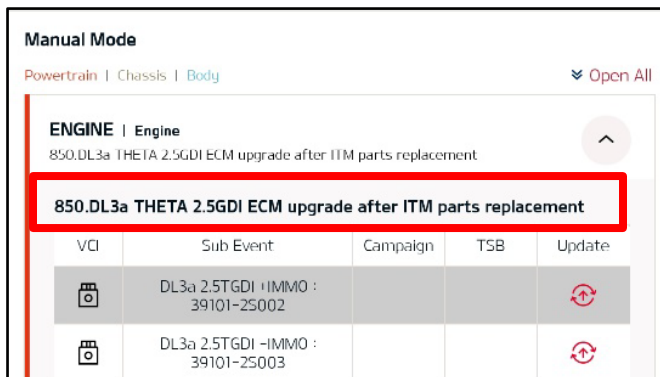
Select the applicable **'ECM' system** module and the Event Group.

- **850.DL3a THETA 2.5GDI ECM Upgrade After ITM Parts Replacement**

Verify the affected vehicle Calibration Identification of the applicable ECU ROM ID and reference the Information Table on page 4 as necessary.
