GROUP	MODEL
BOD	2026MY K5 (DL3)
NUMBER	DATE
346	November 2025

TECHNICAL SERVICE BULLETIN

SERVICE ACTION: REAR SEAT CARPET FLOORMAT INSPECTION AND REPLACEMENT (SA628)

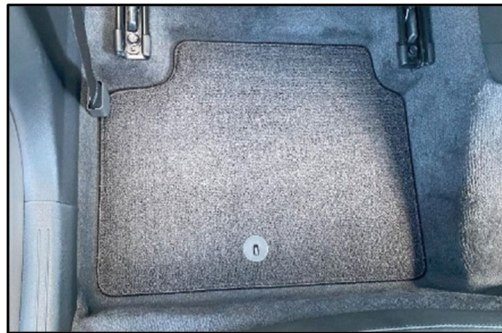
This **Dealer Stock Service Action** Technical Service Bulletin provides information to inspect the rear carpet floormats on certain 2026MY K5 (DL3) vehicles:

- Produced from SOP through July 2025, equipped with hooks on the rear floor; and
- Equipped with the incorrect **Port Installed Option Carpeted Floormats (PIO Code: CF)** where rear floormats are missing positioning grommets; and
- Dealer Stock vehicle.

Follow the procedure outlined in this publication to inspect the rear carpet floormats for the positioning grommet. If it is missing, the rear carpet floormats should be replaced. Before conducting the procedure, verify that the vehicle is included in the list of affected VINs in Dealer stock only.
