## SERVICE BULLETIN

**APPLICABILITY:** 23-25MY Outback/Legacy Models (including Wilderness models)  
 23-25MY Ascent Models  
 24-26MY Impreza  
 24-26MY Crosstrek (including Wilderness models)  
 24-25MY WRX  
 25-26MY Forester  
 26MY Forester Wilderness

**NUMBER:** 15-305-22R  
**DATE:** 11/15/22  
**REVISED:** 11/14/25

**SUBJECT:** Reprogramming File Availability for Optimization of Gen 4.5 Denso CP1.5 Infotainment Systems

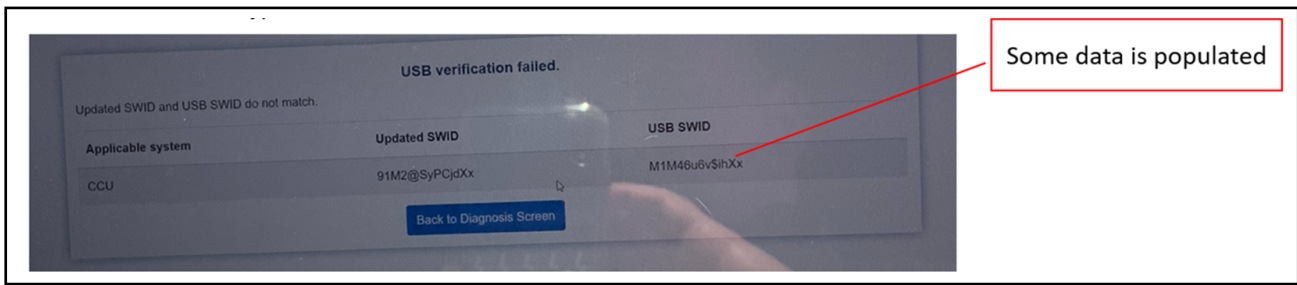
**IMPORTANT NOTE:** In rare cases when the CCU does not complete the USB authentication check in time resulting in the message box below.

This is not to be confused with a typical USB verification failure due to data mismatch.

The recovery steps are outlined below.

- Perform a soft reset of the CP1 by holding down the CID volume knob. Please leave USB Drive connected.
- Once the CP1 has restarted, retry step ii on the previous page and then press the “Start Reprogramming” button. Please wait for 2 minutes after CP1 has restarted, before press the “Start Reprogramming” button.
- If the same failure is encountered again, please proceed with the diagnostic of failure by checking the USB drive data integrity.

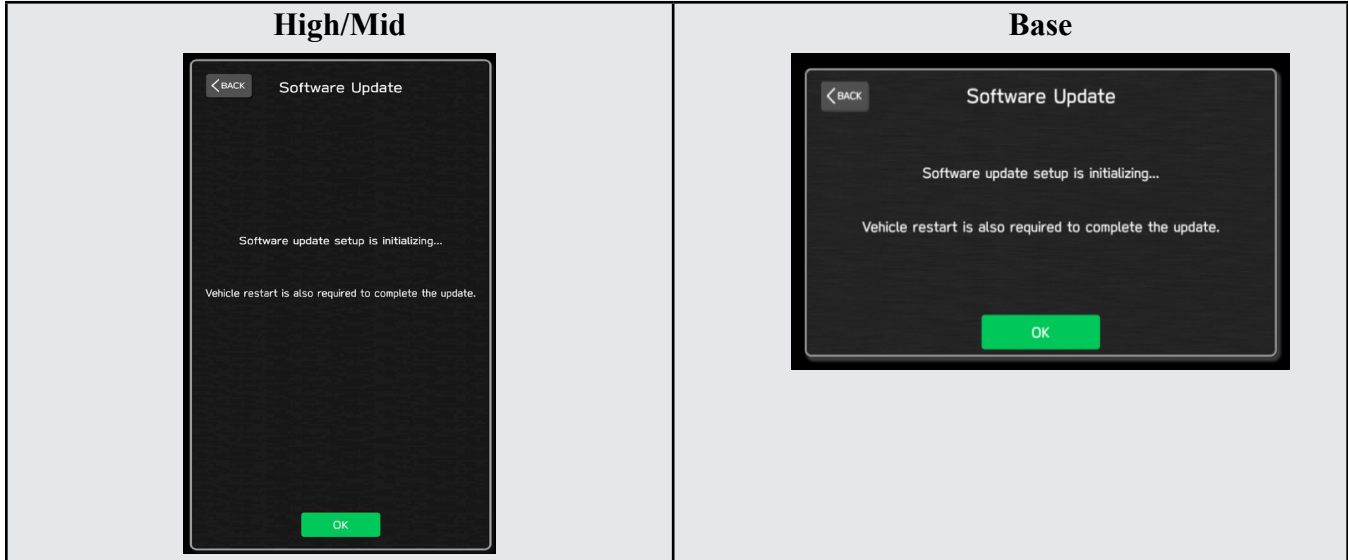
Follow this procedure in the RARE case of “Software update setup is initializing...” message is displayed:

- If the screen shown below appears, **WAIT** for approximately 30 minutes or as long as necessary (waiting for longer than 60 minutes might indicate system malfunction). In that case please perform recovery according to the instructions in [Appendix 6 \(page 30\)](#) to allow the Software update setup initialization process to complete.

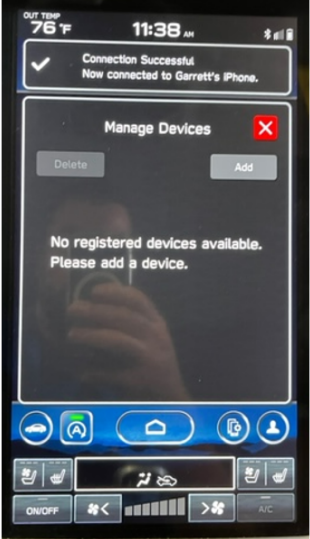
Number	Category	Symptoms to be Improved:
6	Display	<p>The registered mobile device information is not displayed on the Manage Devices screen.            (This occurs when the name or device ID of a mobile device contains a character code that cannot be displayed.)            (only applicable to HIGH and MID trim)</p>

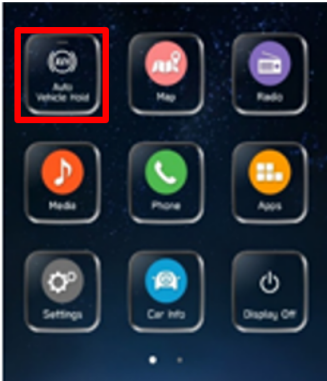
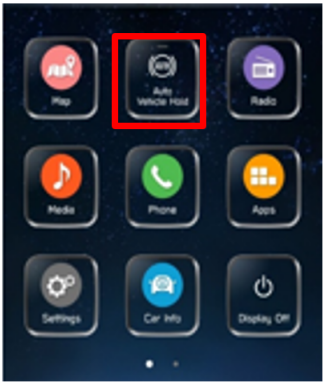
Number	Category	Symptoms to be Improved:
6	Display	<p>The AVH icons on the HOME screen are initially lined up next to the Valet-Mode icon. However, in some cases they are placed at the top (upper left corner of the first page) or next to the MAP icon. (only applicable to HIGH and MID trim)</p> <div style="display: flex; justify-content: space-around; align-items: center;">

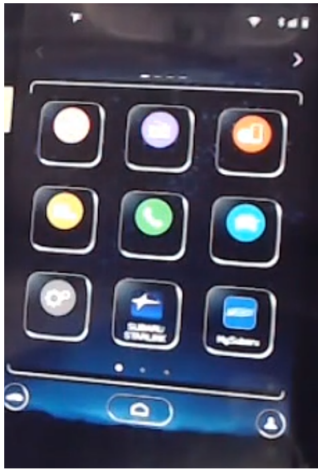
</div> <p>After switching the clock function to AUTO, the CID screen display may become distorted. (only applicable to HIGH and MID trim)</p> <div style="text-align: center;">

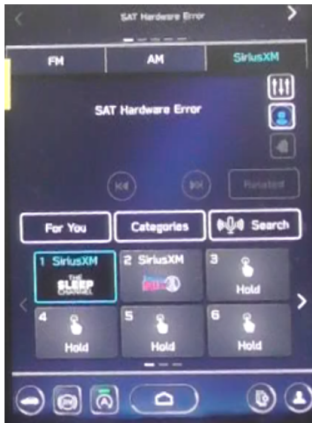
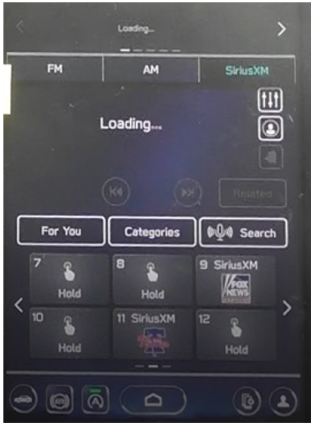
</div> <p>It may take accessive time to start the CID screen after ignition on.</p>
7	SXM	<p>The first time ignition on after the CCU software update added the SXM360 functionality, the SXM playback screen may remain at “Loading...” after the CCU software update.</p> <div style="display: flex; align-items: center; justify-content: center;"> <div style="text-align: center;">

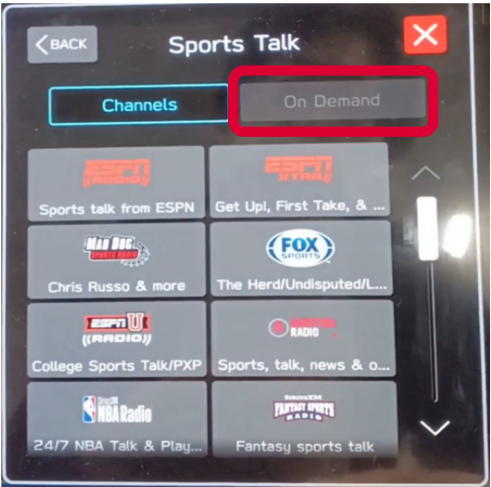
Number	Category	Symptoms to be Improved:
7	SXM	<p>In the SXM screen, the On Demand button in the upper right corner is grayed out and cannot be operated in the Sports→ Sports Talk screen. (only applicable to HIGH and MID trim)</p>

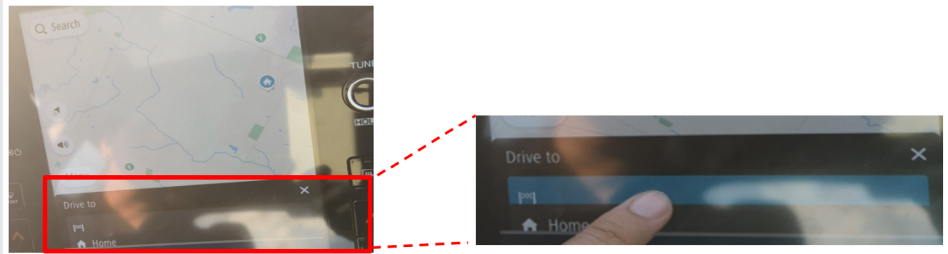
8	Navi	<p>After booting, the Map screen may not appear even if the Map icon on the Home screen is pressed. (only applicable to HIGH trim)</p> <p>Three destination suggestion displays in the navigation system are sometimes displayed overlapping each other. Originally, up to three destination suggestions are displayed at the bottom of the screen when the navigation system is started. (only applicable to HIGH trim)</p>

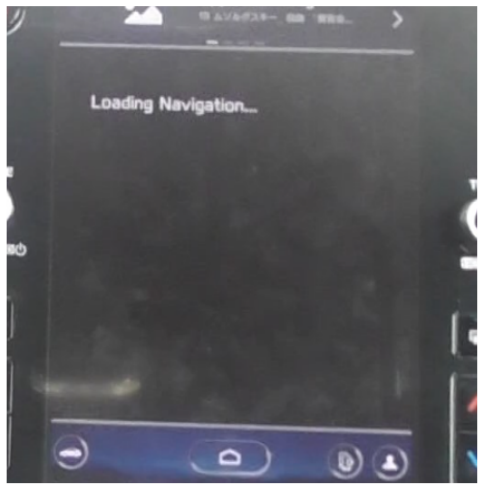
Number	Category	Symptoms to be Improved:
8	Navi	<p>When turning ignition off and on while the Map screen is displayed, the message ""Loading Navigation..."" may remain on the screen, and the Map screen may not be displayed. (only applicable to HIGH trim)</p>

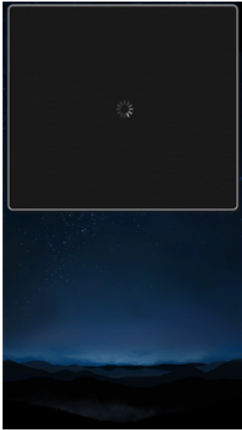
<p>After engine starts, only the black frame of the Caution screen display may remain on the CID screen. The rear view camera can be displayed by shifting to shift R.</p>

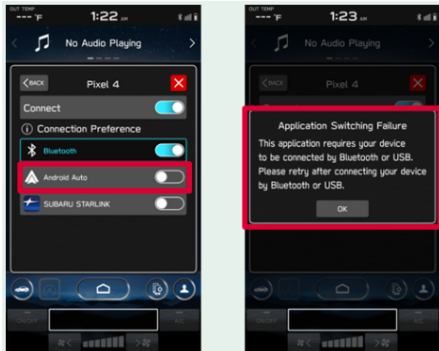
<p>- When you toggle on Android Auto from the Manage Device screen in CID while the Android device is not connected via USB, there may be a failure to start Wireless Android Auto (not applicable to BASE trim)</p>

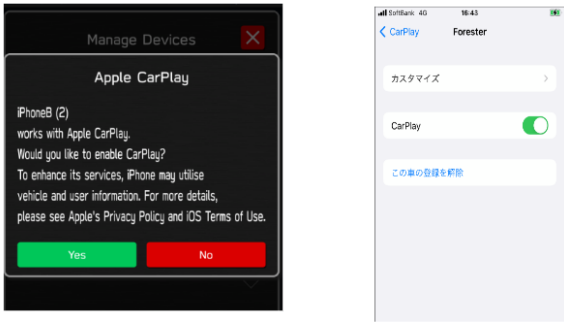
7	Bluetooth	<p>- Bluetooth connection may not become active, and it may become impossible to switch Bluetooth-connected devices, when following steps below (turning on/off the connection)(not applicable to WRX): With the CarPlay usage confirmation screen displayed on the CCU, press the 'Yes' button. Almost simultaneously, on the iPhone's settings screen, turn off the CarPlay toggle switch.</p>

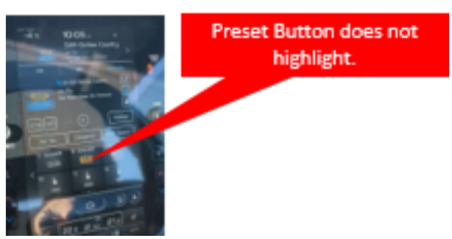
Number	Category	Symptoms to be Improved:
7	Bluetooth	<p>- Address vulnerabilities in the Bluetooth encryption mechanism (only applicable to BASE trim)</p> <p>- If the Bluetooth connection fails due to the loss of the link key in the phone, the following message should be changed to be displayed.</p> <p>Before:  Connection unsuccessful  Please try again later</p> <p>After:  Connection unsuccessful  Please try deleting and then re-pairing your device</p>
8	Radio	<p>- When pressing a preset button for a registered radio channel, you can play the channel. But the button you pressed does not highlight, and you cannot operate through presets using the steering wheel controls (not applicable to WRX)</p> <div data-bbox="776 695 1224 932" style="text-align: center;">

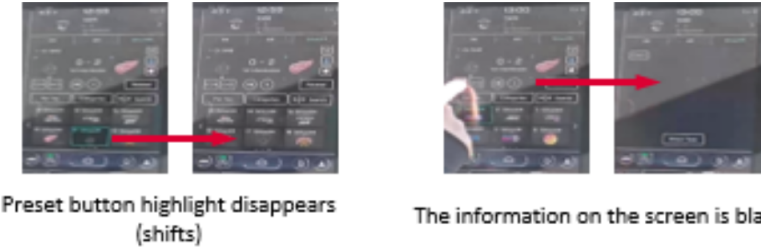
9	SXM	<p>- Following symptoms might be observed, when the SXM satellite channel and SXM IP channel are registered alternately in the radio preset registration and the preset channel selection is switched continuously using the steering wheel (not applicable to BASE trim):</p> <ol style="list-style-type: none"> <li>1. The highlight of the radio preset disappears (It shifts from the currently selected preset)</li> <li>2. Information on the radio screen becomes blank</li> <li>3. SXM sound is interrupted</li> <li>4. The channel does not change even if the preset button is pressed</li> </ol> <div data-bbox="613 1577 1370 1822" style="text-align: center;">

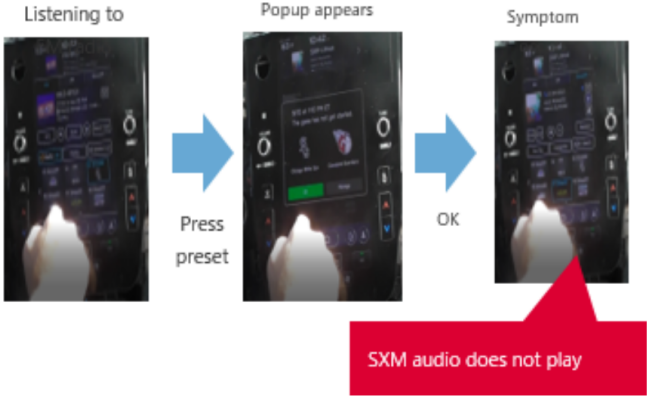
<p>- While listening to the radio (FM/AM) and attempting to select a sports team channel (SXM channel) from the presets, if the chosen team has a scheduled game on that day but it hasn't started yet a popup screen displaying the game schedule appears. However, after the popup screen appears, the system returns to the previously played channel, and the SXM audio does not play (not applicable to WRX).</p>

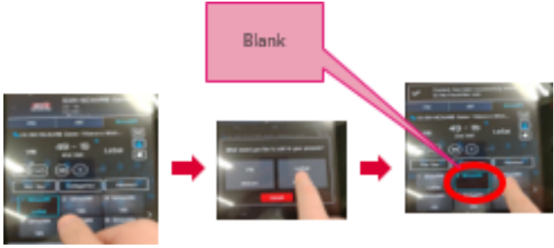
<p>- When registering SXM sports team channels to the radio preset buttons if a team for which logo image cannot be captured is registered, the channel short name will not be displayed on the registered button and the button will be blank (not applicable to BASE trim)</p>

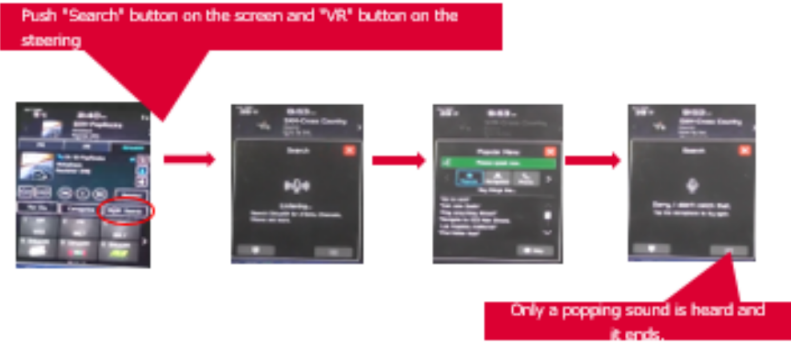
<p>- The voice recognition function encounters an error and ends, when initiating the SXM Search feature simultaneously with the activation of the CCU unit's voice recognition</p>

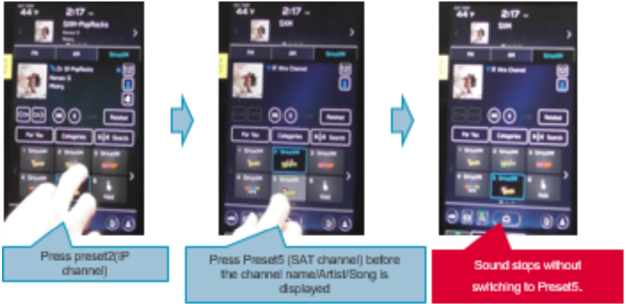
Number	Category	Symptoms to be Improved:
9	SXM	<p>- When switching to the SAT channel (satellite channel) immediately after selecting the IP channel (Internet channel) on the SXM360, song information is not displayed and audio playback stops (not applicable to BASE trim)</p>

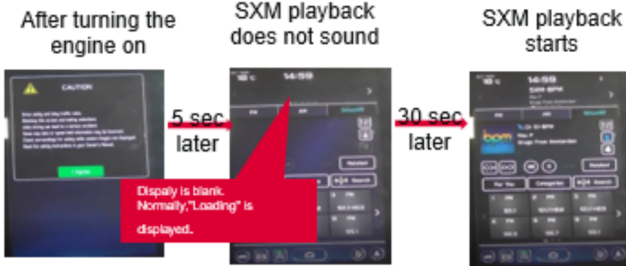
<p>- After turning the engine on, "Loading" should appear on the channel information screen until SXM playback starts, but it does not appear and remains blank</p>

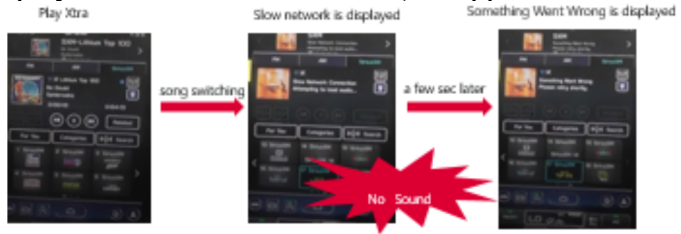
Number	Category	Symptoms to be Improved:
9	SXM	<p>- SXM sound stops sounding after conditions listed below:</p> <ol style="list-style-type: none"> <li>1. Register FM station A, an SXM sports channel that is not in the middle of a game, and FM station B in the order in which they are listed in the radio presets.</li> <li>2. Use the steering wheel switch to switch from FM station A to FM station B, skipping the SXM sports channel that is not in the middle of a game.</li> <li>3. Just before the playback of FM station B starts, operate the steering switch seek to return to the previous channel.</li> </ol> <p>- While playing SXM's Xtra channel, "Slow Network" --&gt; "Something Went Wrong" is displayed and no sound is heard (not applicable to BASE trim)</p>

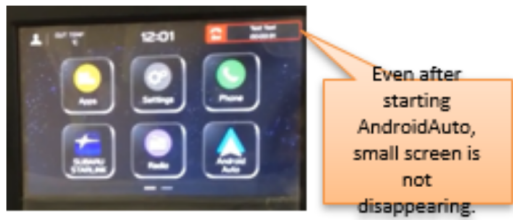
Number	Category	Symptoms to be Improved:
11	Display Appearance	<p>- The call screen reduction appears in the Status Bar while connected to Android Auto. Originally, when Android Auto is activated during a hands-free call, the call screen reduction should disappear (only applicable to BASE trim).</p>

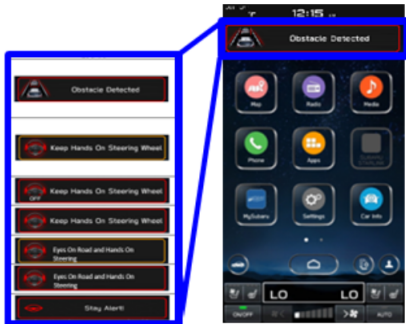
<p>- If the language setting of the CID is changed while an alarm message by the Driver Monitoring System(DMS) is displayed on the CID, the alarm will be hidden (not applicable to BASE trim)</p>

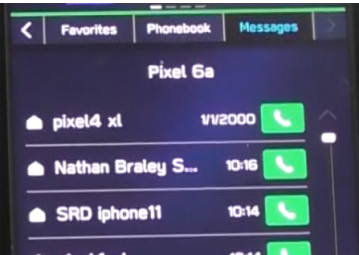
</div> </div> <p>- The date for the message is displayed as 1/1/2000 instead of the correct date. This occurs on some models of phones with Android OS 13 or later.</p> <div style="text-align: center;">

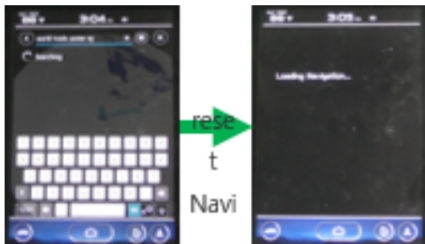
12	Touch Operation	<p>- Suddenly, the touch screen on the CID (Central Information Display) becomes unresponsive, even though the screen display remains normal. (not applicable to WRX)</p> <p>- CID doesn't respond to touch (The screen is displayed and sound is played, but only the operations are not available)</p>
13	Navi Operation	<p>- When repeatedly entering text on the destination search screen, the screen may freeze, and the navigation application restarts (only applicable to HIGH trim)</p> <div style="text-align: center;">

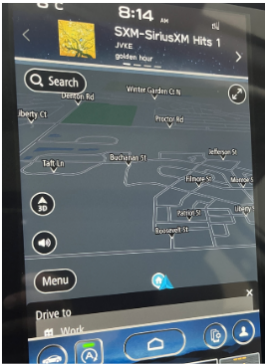
<p>- In the navigation screen, the bottom of the destination suggestion list's popup screen is cut off and not fully displayed (only applicable to HIGH trim)</p>

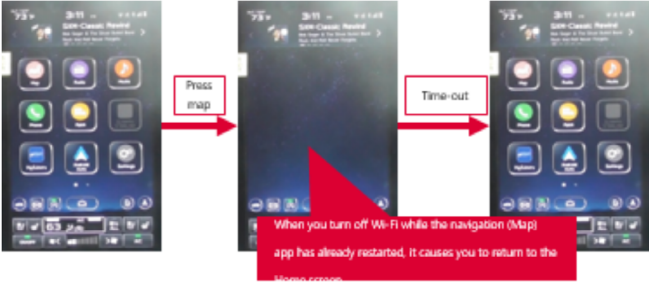
Number	Category	Symptoms to be Improved:
13	<b>Navi Operation</b>	<p>- During map data updates, if you switch off the Wi-Fi function from the Settings screen pressing the Map icon on the Home screen doesn't display the Map screen for a while (only applicable to HIGH trim)</p> <div style="text-align: center;">

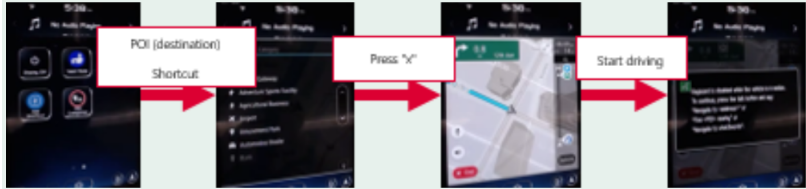
Number	Category	Symptoms to be Improved:
13	Navi Operation	<p>- "Keyboard is disable while the vehile is in motion"" is displayed on the screen when performing the steps below (only applicable to HIGH trim) :</p> <ol style="list-style-type: none"> <li>1. Press the POI (destination) Shortcut on the home screen to display the list of destinations.</li> <li>2. Press "x" to clear the list.</li> <li>3. Start driving with the Map screen displayed.</li> </ol>

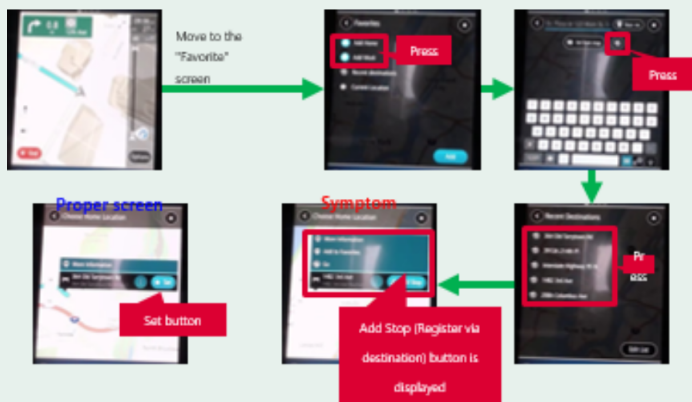
<p>- Add Stop (Register via destination) button is displayed instead of Set button and Favorite registration for Home/Work cannot be done after performing the steps below moving to the "Favorite" screen with the navigation destination set (only applicable to HIGH trim) :</p> <ol style="list-style-type: none"> <li>1. Press Add Home/Work</li> <li>2. Select a location from the Destination History screen</li> </ol>

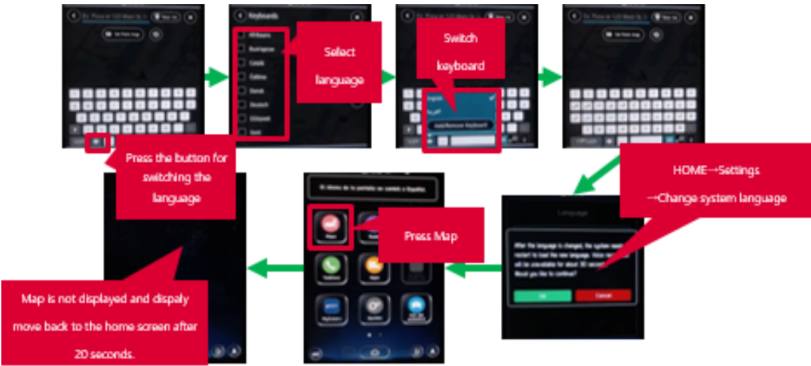
<p>- Map is not displayed when Map is pressed from the home screen if switching the language used for the text input keyboard on the search screen of the navigation application (only applicable to HIGH trim)</p>

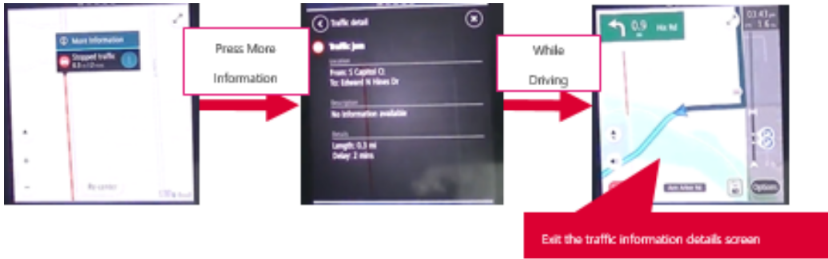
</div> </div> <p>- When using voice recognition to search for a destination based on a Point of Interest (POI) category name (such as "gas station"), the search results may display facilities that have names partially matching the POI category name in addition to the facilities within that specific category (only applicable to HIGH trim)</p> <p>- While parked or driving, touch the traffic information icon on the map or the traffic information icon on the route bar and display the traffic information details screen. If you start driving with this screen displayed, it will exit the traffic information details screen and transitions back to the map screen (only applicable to HIGH trim)</p> <div style="text-align: center;">

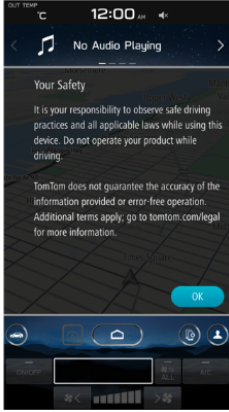
Number	Category	Symptoms to be Improved:
13	<b>Navi Operation</b>	<p>- The requirement to press ""OK"" on the Your Safety screen during the initial navigation launch sometimes wasn't displayed (only applicable to HIGH trim).</p> <p>Before the change: If the navigation app was launched for the first time from any icon other than the Map icon on the Home screen (e.g., through a rest suggestion feature) the Your Safety screen would not appear and navigation functionality could not be initiated.</p> <p>After the change: Even if the navigation app is launched for the first time from an icon other than the Map icon on the Home screen, the Your Safety screen will be displayed.</p>

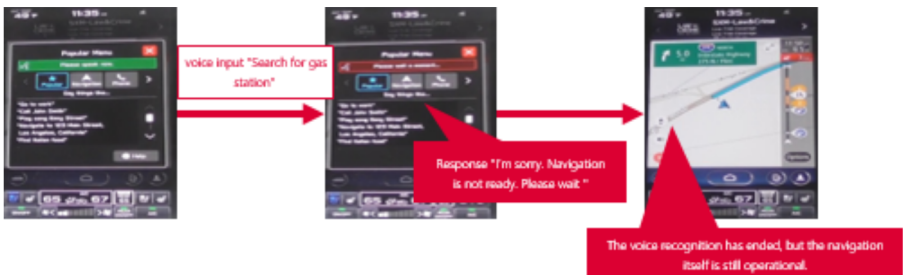
<p>- When searching for navigation POIs using voice recognition, the response is "Navigation is not ready" and POI search may not start (only applicable to HIGH trim)</p>

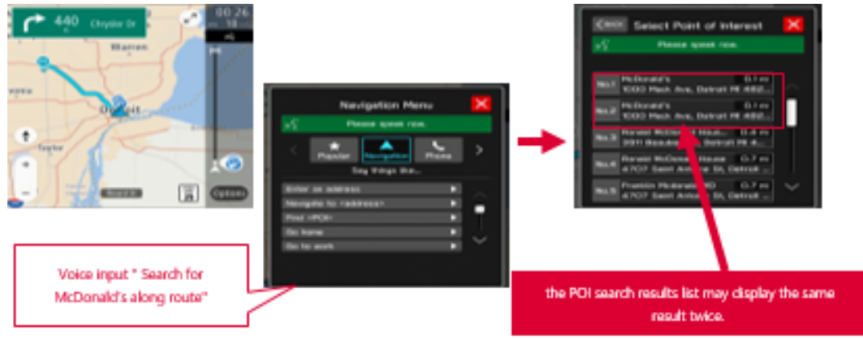
Number	Category	Symptoms to be Improved:
13	Navi Operation	<p>- When using voice recognition during navigation to say 'Search for **** along route,' the POI search results list may display the same result twice (only applicable to HIGH trim)</p>

<p>Voice input " Search for McDonald's along route"</p> <p>the POI search results list may display the same result twice.</p>
14	Audio/Voice Recognition	<p>- USB audio is activated by voice recognition command ""play artist xxx"" or ""play album xxx"". The last song played by USB audio is played, not the song commanded by voice. (only if the same USB is used) (not applicable to WRX)</p>
15	Voice Guidance	<p>- While driving with a navigation route set, there are instances where the voice guidance may not correctly pronounce "mile." It mispronounces "mile" as "me" (only applicable to HIGH trim)</p>
16	Voice Recognition	<p>- After setting a route in the navigation system and activating voice recognition function, the route guidance is not canceled even "Cancel Route" or "Delete Destination" is completed (only applicable to HIGH trim)</p> <p>- When you say ""Call *****" using voice recognition, the meter display shows "Please wait a moment," but the call cannot be made (not applicable to WRX) (Note: ""*****" indicates an actual phone number or contact name you are trying to call)</p> <p>- Starting the CCU (Cockpit Control Unit) voice recognition while using the SXM Voice Search function results in an error and ends the voice recognition (not applicable to BASE trim)</p>

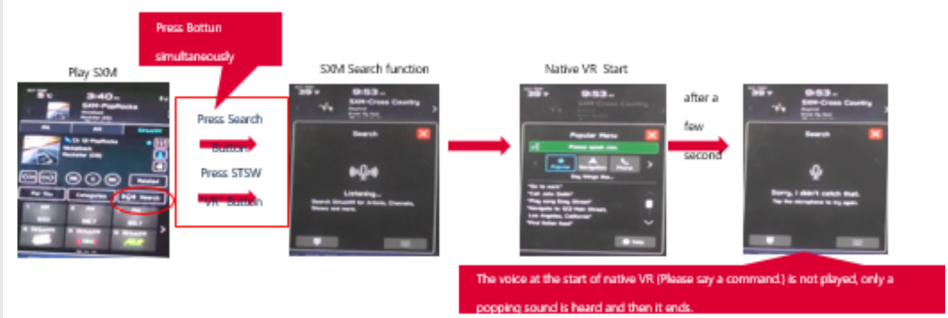
<p>Press Bottom simultaneously</p> <p>Press Search</p> <p>Press STSW</p> <p>Press Bottom</p> <p>Press Bottom</p> <p>after a few seconds</p> <p>The voice at the start of native VR (Please say a command.) is not played, only a popping sound is heard and then it ends.</p> <p>- When operating the navigation system via voice recognition, certain regional place names (states, cities, etc.) are not recognized (only applicable to HIGH trim)</p>

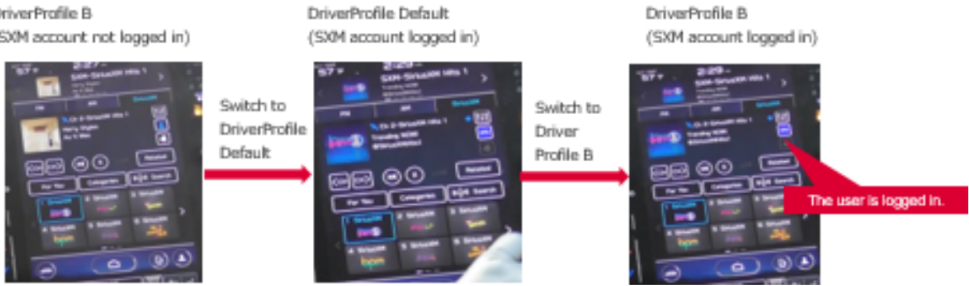
<ul style="list-style-type: none"> <li>- Switching the Driver Profile user causes the user to be logged into SXM even though he/she was not logged into the SXM account as the user after the switch</li> </ul>

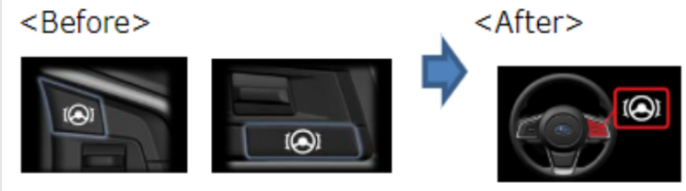
Number	Category	Symptoms to be Improved:
22	Meter Display	<p>- Change the image of steering switch in the meter interrupt screen from individual zoomed images to an image of the entire steering wheel and the symbol (not applicable to WRX)</p> <p>Previously: different switch images were used depending on the model line and equipment grade.</p> <p>After: a common image is used regardless of the model or the grade.</p>

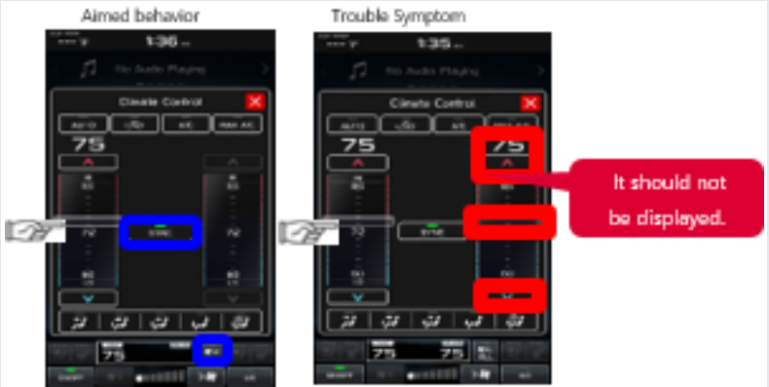
<p>- In the maintenance schedule settings screen despite setting a date the configured date is not displayed and is replaced with hyphens (not applicable to WRX)</p>
24	Air Conditioner	<p>- With the air conditioning SYNC enabled and the single-seat focus set to the driver's seat tapping the temperature adjustment bar on the driver's side unexpectedly displays the temperature adjustment bar for the passenger's side, which should not be displayed (only applicable to BASE trim)</p>

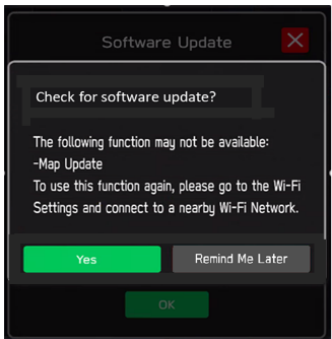
Number	Category	Symptoms to be Improved:
26	Software Update	<p>- To use FOTA (Firmware update Over The Air) for CCU software update via DCM (Data Communication Module) it is necessary to switch from the Wi-Fi communication settings for MapUpdate to the DCM communication settings. To notify the customer about this switching, the below message screen pops up a new CCU software becomes available from the server. (not applicable to BASE trim)</p>

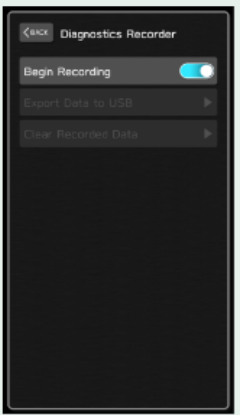
10	<p>Update against vulnerability in security of Bluetooth connection.</p>
11	<p>When getting CCU USB logs at the Diagnostics Recorder screen in the Dealership Mode, it was necessary to turn off ""Begin Recording"" to ""Export Data to USB.""</p> <p>And after the log acquisition, it was necessary to turn ""Begin Recording"" ON again.</p> <p>The system interface is improved so that ""Begin Recording"" is automatically switched ON after log acquisition has been accomplished.</p> <div data-bbox="786 1522 1024 1934" style="text-align: center;">

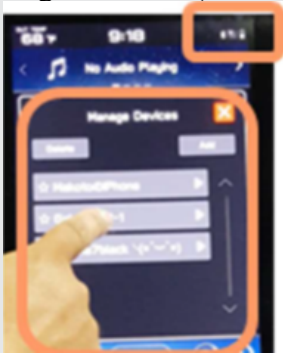
Number	Symptoms to be Improved:
1	CID goes black and does not accept any control.
2	Audio playing while CID shows black display
3	CID reboots.
4	“Manage Devices” is grayed out and cannot establish Bluetooth connection.
5	When the Bluetooth connection is cancelled manually on the mobile phone side during hands-free calling, the Bluetooth connection is disabled for that particular mobile phone. Even when it occurs, the connection can be reestablished by deleting the device in “Manage Devices” and register the device again by adding operation.
6	Bluetooth connection fails against the device that was paired before and “Manage Devices” is grayed out.
7	<p>Bluetooth connection is disabled with a discrepancy in the display of status bar (showing Bluetooth devices being connected) and the “Manage Devices” screen (showing no Bluetooth devices being connected.)</p>

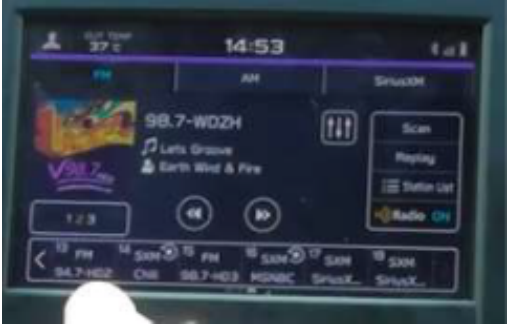
Number	Symptoms to be Improved:
8	Android Auto Wireless (AAW) cannot be connected.
9	Android Auto Wireless (AAW) cannot be started from “Manage Devices” Screen.
10	Sound volume control does not work while using Android Auto. It is caused by data communication error between Android device and CCU.
11	Cyclic short noise like a drilling or vibration is heard from speakers.
12	<p>Sound is lost when changed to Subchannel 2 right after a preset HD radio channel has been selected.</p>

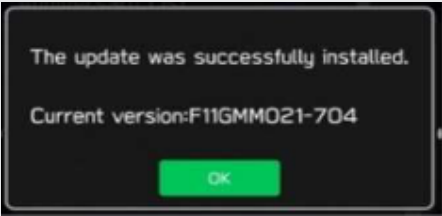
13	After the destination is set on Navi screen, voice recognition command of “Find <POI category> along route” is made, search results are not given in order of distance.
14	When “Call” button is pressed in “Confirm Destination” screen of Navigation system (to call the destination site,) the call can be made but the screen does not transit to phone call screen.
15	<p>Popup of “The update was successfully installed” is not displayed after reboot (IG-OFF and ON) operation of FOTA (Firmware Over The Air) update.</p>

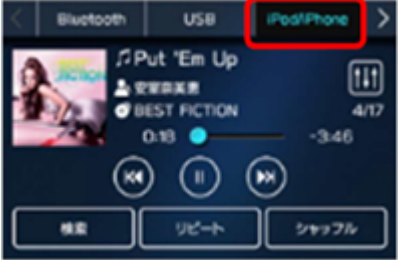
Number	Symptoms to be Improved:
1	<p>iPod/iPhone tab in Media screen cannot be selected, when connected by USB.</p> <p>The symptom occurs when the iPhone is connected to CP1.5 via Bluetooth in parallel to USB connection by error. (It is supposed to be connected either via Bluetooth or by USB.)</p>

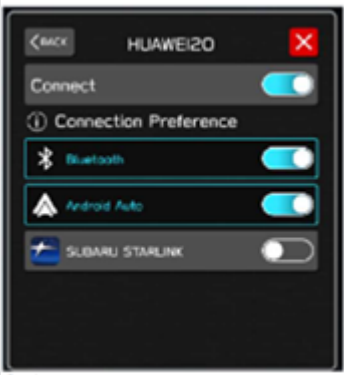
2	<p>On the “Manage Devices” screen Bluetooth cannot be selected as connection preference.</p>

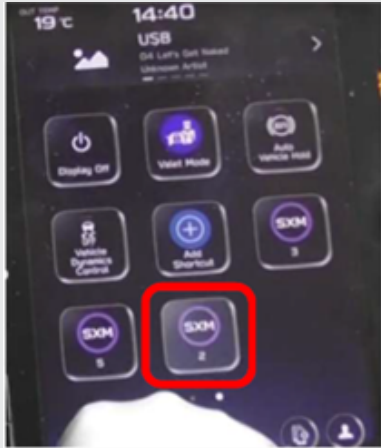
Number	Symptoms to be Improved:
6	<p>SXM station shortcut created by the customer does not work when the SXM has not been used as audio source after the Ignition Switch was turned on in the ignition cycle.</p>

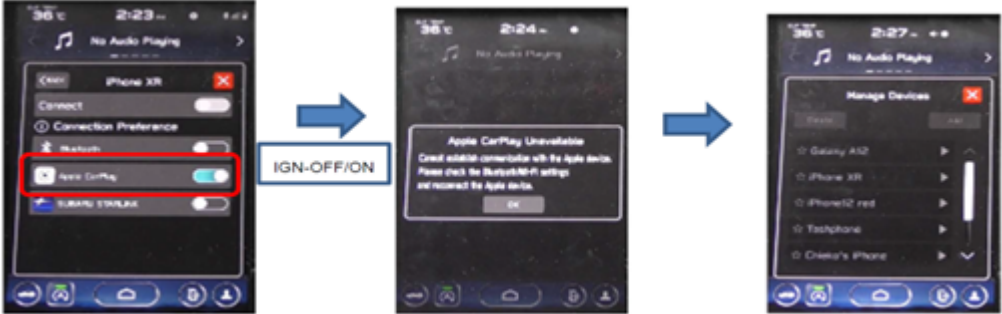
7	<p>Manage Device Screen becomes dark and inoperative when Ignition Switch is turned Off and On while starting CarPlay by CID operation.</p>

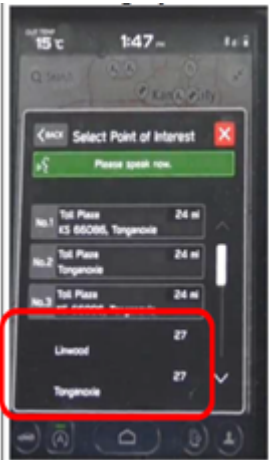
8	<p>Cannot connect to CarPlay via wireless connection. This symptom possibly occurs after the Ignition Switch was turned Off and On abruptly.</p>
9	<p>POI Search Result shows only city names and distances (without unit) when voice recognition POI search with Category name like “Find toll gate” is used.</p>

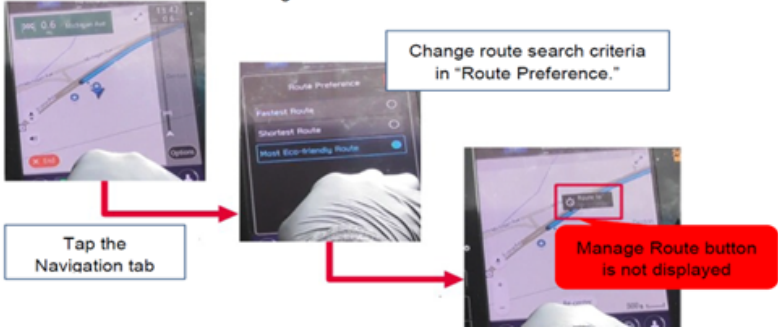
Number	Symptoms to be Improved:
10	Navigation restarts itself, when the letters are rashly entered or deleted using keyboard function to search destination.
11	<p>“Manage Route” button is not displayed when touching the route line on Navigation system, when the route search criteria got changed in the Route Preference Screen after a route had been searched.</p>

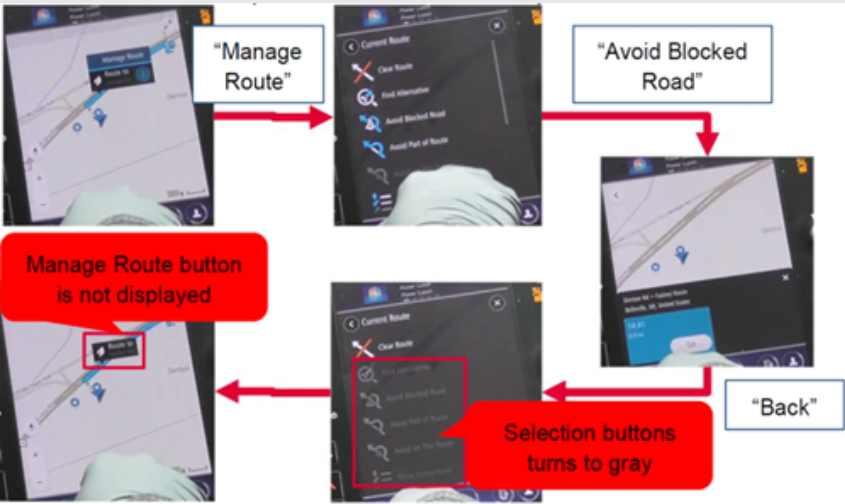
12	<p>“Manage Route” button is not displayed and buttons on the Current Route Screen become unselectable (turns to grayish fill) when the Navigation system is operated in the sequence of “Manage Route” &gt; “Avoid Blocked Road” (in the Current Route Screen) &gt; “Back.”</p>
