## SERVICE BULLETIN

**APPLICABILITY:** 2024MY Crosstrek & Impreza **NUMBER:** 09-118-24R

**SUBJECT:** DTCs P2404 & P0087 / Reprogramming Files **DATE:** 04/05/24

**REVISED:** 11/20/25

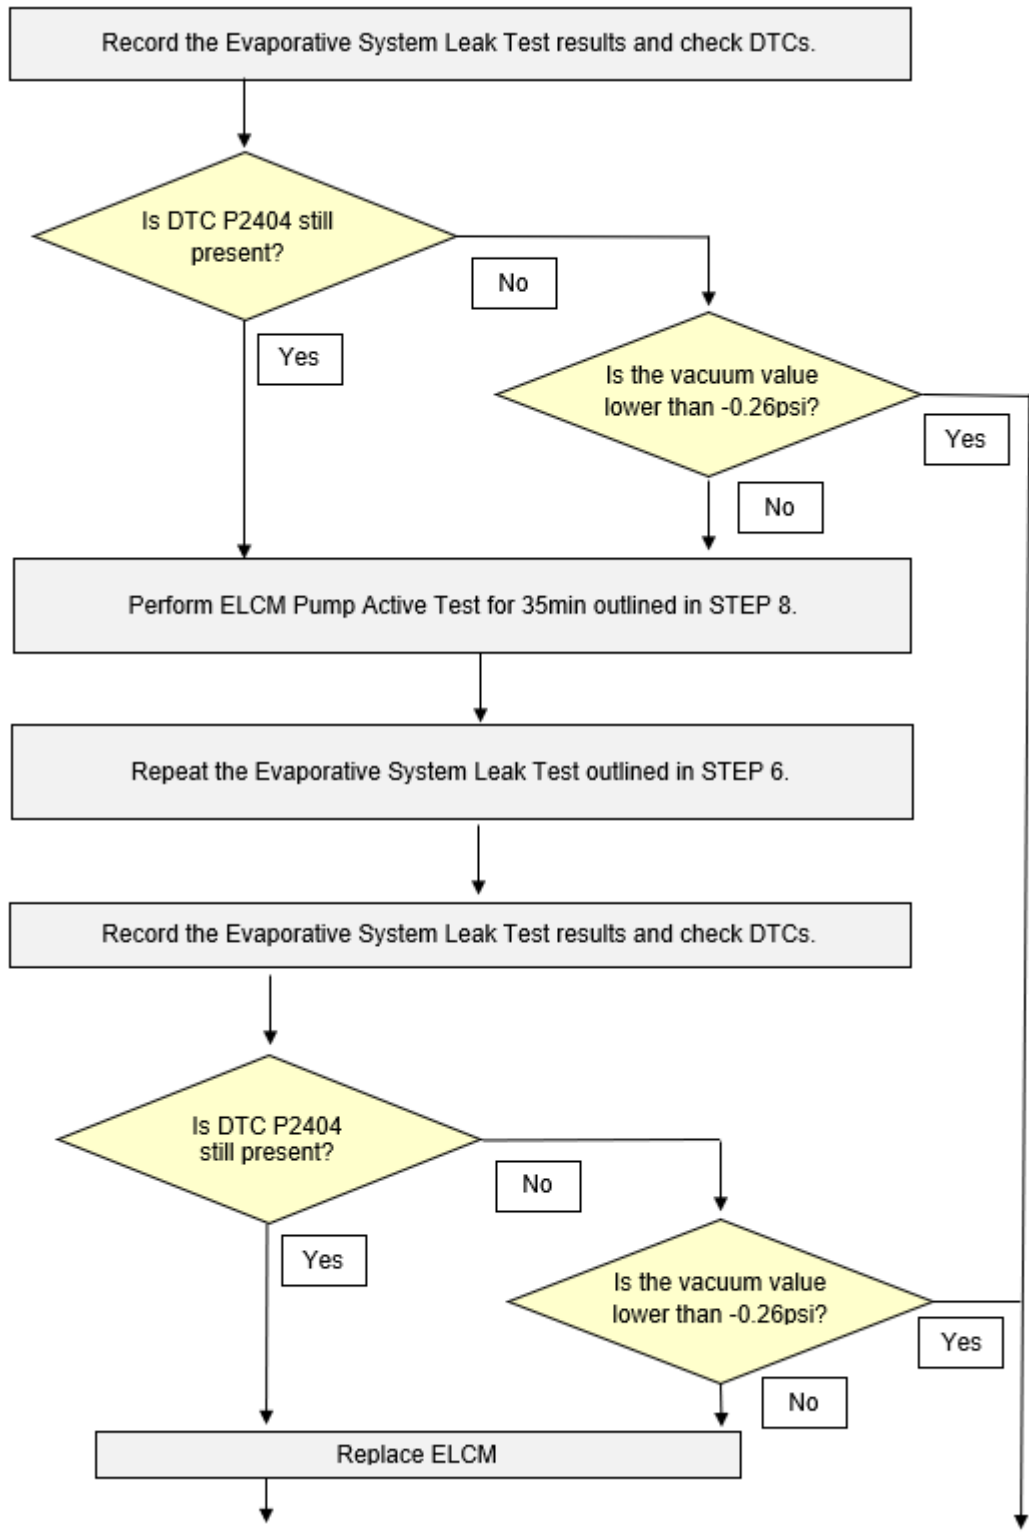
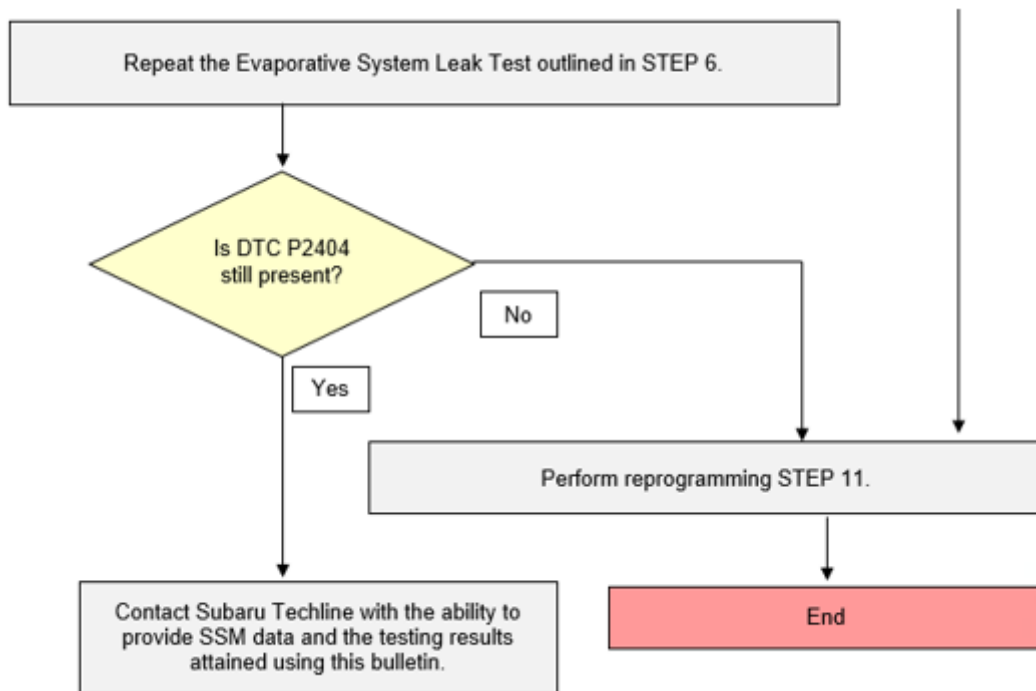
**SERVICE PROCEDURE FLOWCHART:**

This bulletin announces diagnostic procedures and availability of new Engine Control Module (ECM) reprogramming files to address DTC P2404 (Evap System Leak Detection Pump Sense Circuit Range/Performance) detection. In rare cases, the internal pump for the Evaporative Leak Check Module (ELCM) system can seize temporarily. The new files contain enhanced logic to prevent the ELCM pump from seizing. In addition, the logic further stabilizes the fuel pressure to reduce any hesitation during acceleration and prevent DTC P0087 detection. If P2404 and/or P0087 is found in the fault memory, follow the procedures outlined below.
