## Dinette Right-Seat Brace Bolt Torque

Rapid Response Quality Alert 26-01

WGO Model Year	Revision	Make	Model	Model Code(s) (Floorplan)	WGO Built/ Manufacturing Dates
2026	2	Winnebago	Revel	B44	7/28/2025 – 9/22/2025

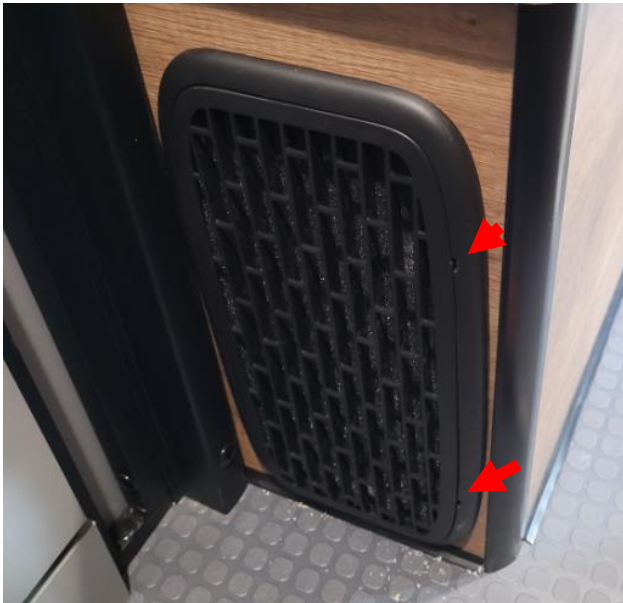
Figure 8:  
Plastic cover, red arrows are pointing to slots

1. Now remove the plastic cover. There are slots on the sides of the inner piece to pop it out.
2. Next remove the rest of the plastic cover. There are four screws holding it in. There will be a foam piece that sits between the plastic cover pieces.

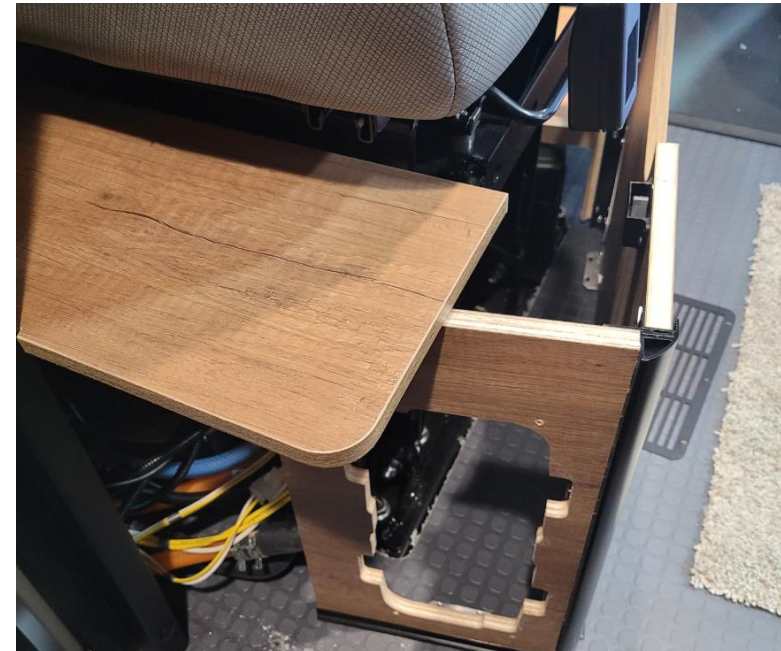
Figure 11:  
Dinette seat cabinetry is now loose.

1. Remove the two screws on the silver bracket.
2. The cabinetry will now be loose. Carefully pull it away from the seat as shown in the photo as far as you can

1. Check all four bolts with the torque wrench and if not at the spec tighten with the 76.6 NM torque wrench until it clicks. Torque mark the bolt after. If it already had a torque mark on it, then use a different color marker than what was on it.
2. With Loctite 243 add the Loctite to the top of the nut at least halfway around. This allows the Loctite to seep from the top of the nut into the threads.
3. Clean up any mess on the floor with a tissue before moving the cabinetry back in place.
