Technical Service Bulletin

GROUP SUSPENSION	NUMBER 25-SS-003H
DATE NOVEMBER 2025	MODEL(S) SANTA CRUZ (NXT)

SUBJECT: REAR SUSPENSION CLUNK OR THUMP NOISE -
REAR SHOCK ABSORBER REPLACEMENT

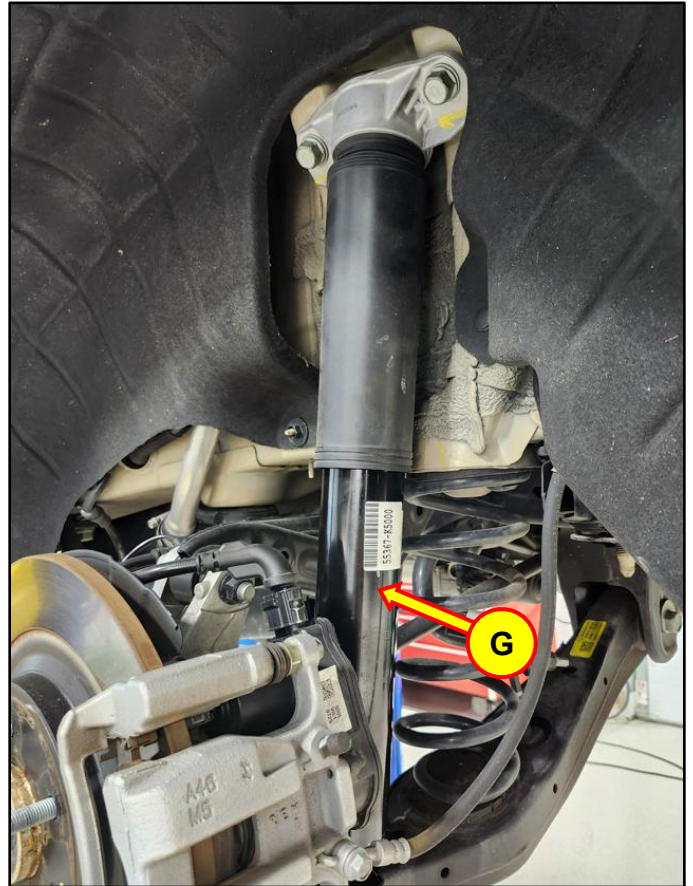
3. Visually inspect rear suspension components listed below for visible issues, damage, etc.

- If **NO** damage or visible issues are found with any components, then both rear shock absorbers (G) **MUST** be replaced. Proceed to [Shock Absorber Replacement](#).
- If damage or issues are found, diagnose and repair as necessary. Then retest for the clunk/thump noise.
 - If the noise is resolved, then the service procedure is complete.
 - **If the clunk/thump noise is still present**, then proceed to [Shock Absorber Replacement](#).
